DAILY FIELD OBSERVATION REPORT

Project: Birch Lane Drainage Improvements
Client: Town of Cumberland
GP Field Rep: Ben Grondin (BG)
Weather: Sunny
Time onsite: 12:00 PM – 2:15 PM (BG)

GPCEI Project No: 1636.55
Visit Date: June 13, 2017
Report Date: June 15, 2017
Temp. Range: 65-75°F

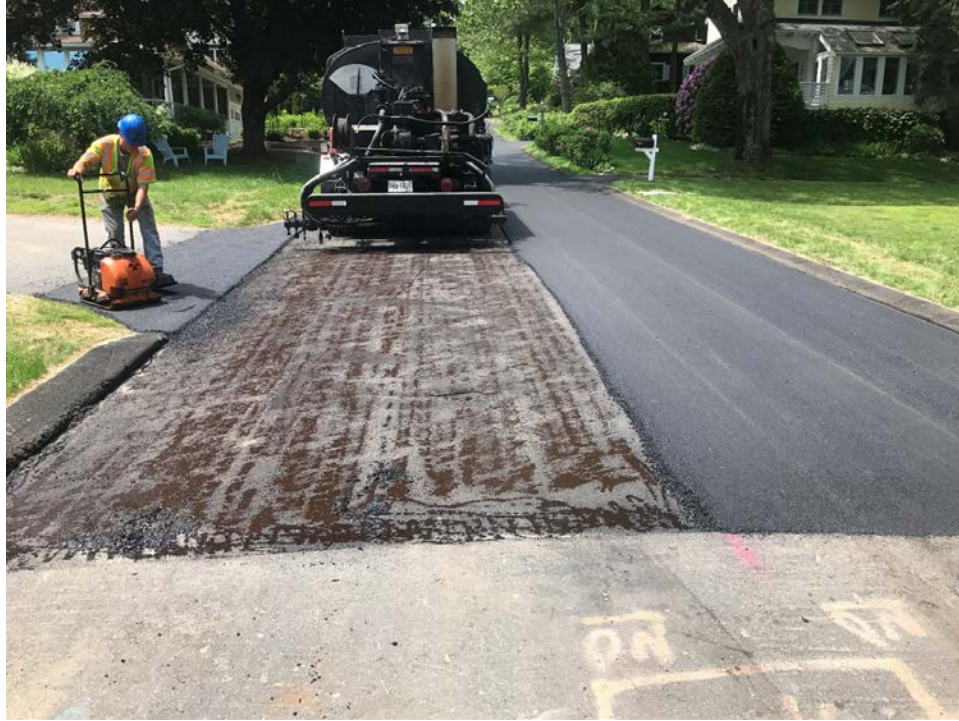
- Existing pavement on Birch Lane was cleaned and tacked prior to placing 9.5mm HMA.
- 9.5mm HMA in driveway aprons were compacted with plate wacker only.

Photo 1 – Tack placed on Birch Lane prior to 9.5mm HMA.

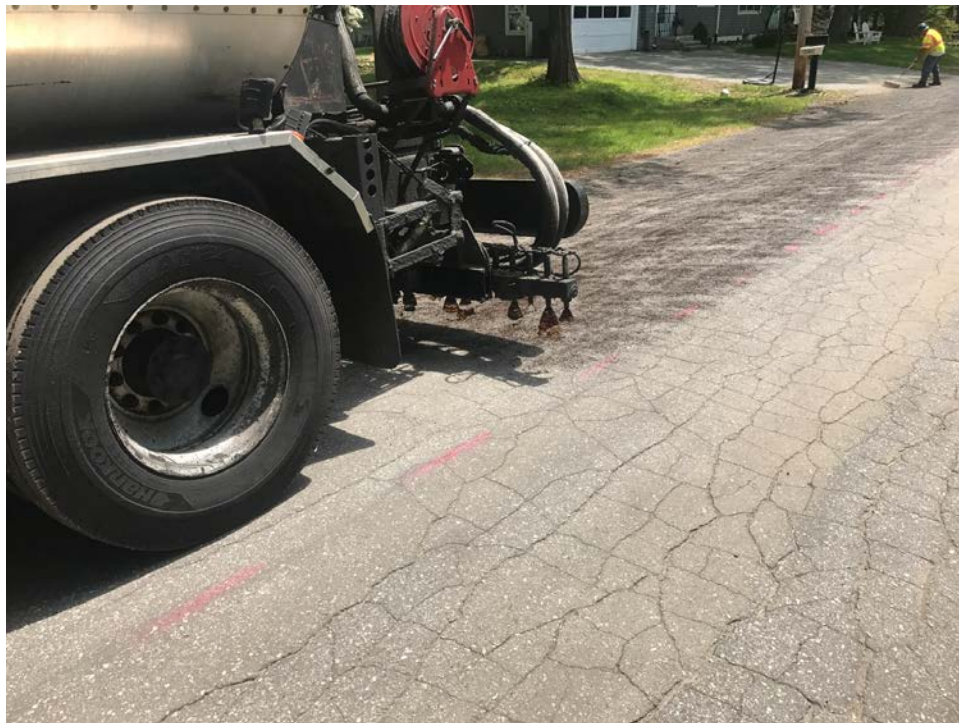
- Sylvan Street was cleaned and tacked prior to drag shim.
- Depth of drag shim varies on Sylvan Street due to the existing condition of the Street.
- BG observed drag shim of the easterly side of the street only before leaving the site.

Photo 2 – Crew cleaning and tacking Sylvan Street.

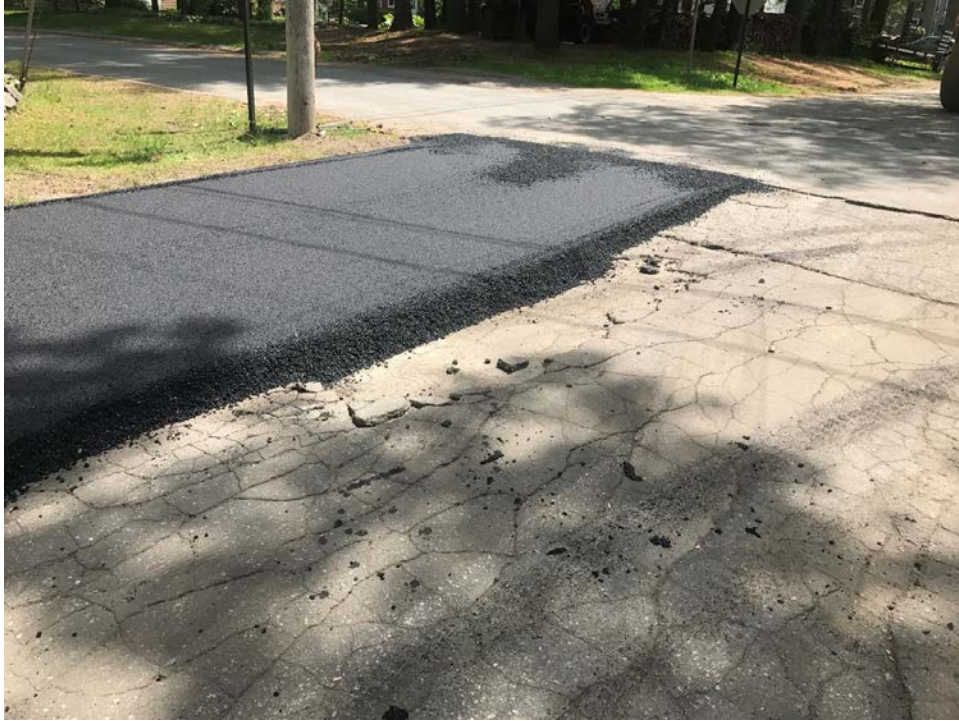
Photo 3 – Pavement depth on Slyvan Street.

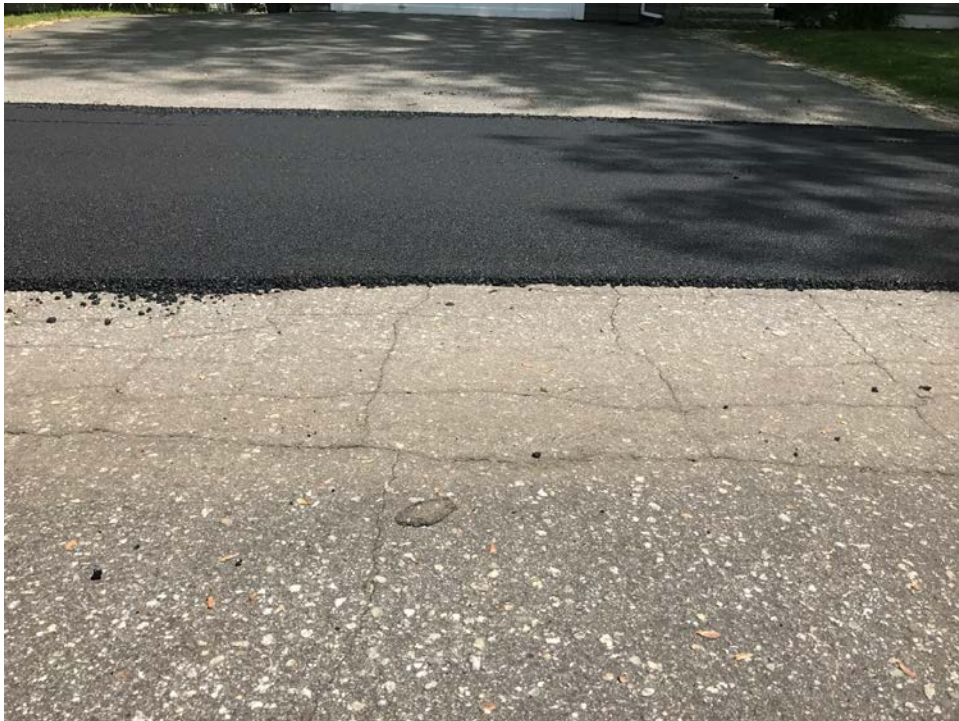
Photo 4 – Pavement depth on Slyvan Street.
