## FIELD OBSERVATION REPORT

Project: Longmeadow Rd & Ole Musket Rd – Drainage Improvements  
Client: Town of Cumberland  
GP Field Rep: Sam Foglio (SF)  
Weather: Rain, Cloudy  
Time onsite: 9:30 AM – 10:30 AM/ 3:30 PM – 3:45 PM  
Contractor: A.H. Grover, Inc.  
Distribution: File; Town of Cumberland

GP Project No: 3656  
Visit Date: April 17, 2023  
Report Date: April 18, 2023  
Temp. Range: 45-50°F

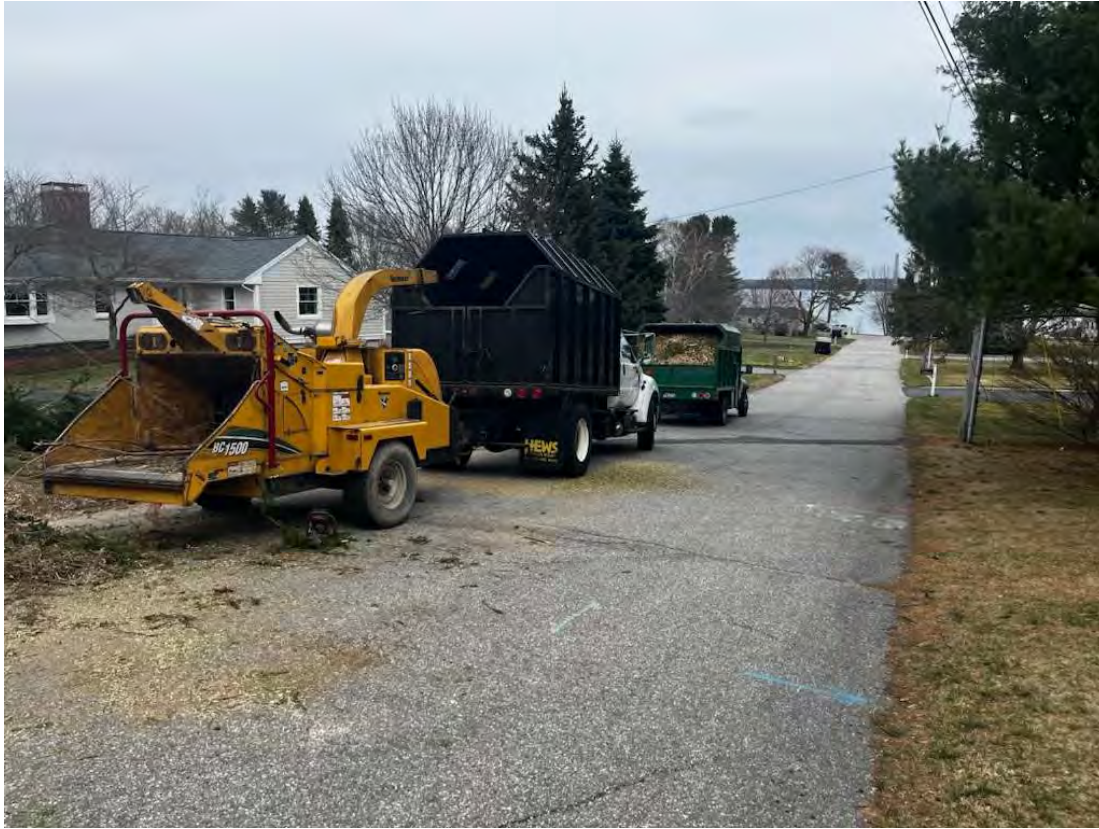
- It was observed that on 04/11/23, the three evergreen trees located at 12 Longmeadow Drive were removed. (Photo 1)
- Prior to arrival in the morning, A.H. Grover, Inc. had saw cut Longmeadow Rd, approximately 5 feet wide where stormdrain and structures are proposed. (Photo 2)

Photo 1 – Evergreen trees removed from 12 Longmeadow Drive. The woodchipper appeared to feed directly into the bed of a truck where the chippings were collected and hauled off-site.

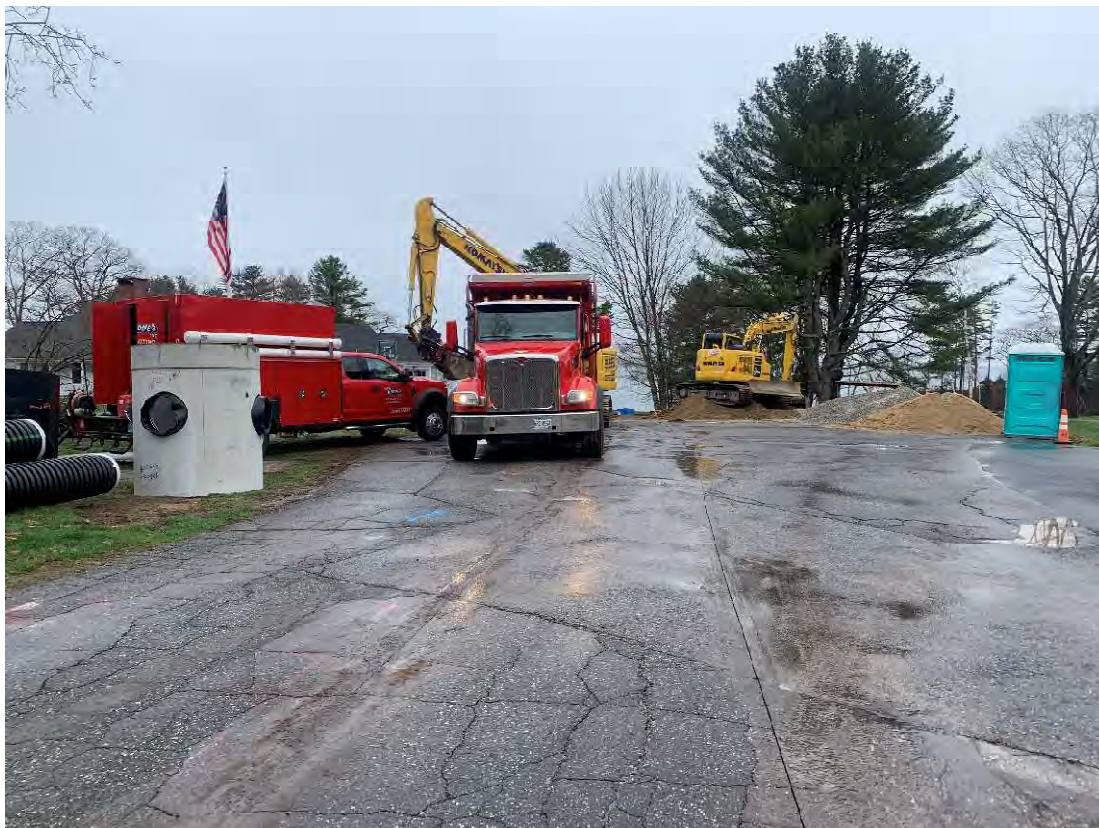
Photo 2 – Saw cut for trench area on Longmeadow Rd

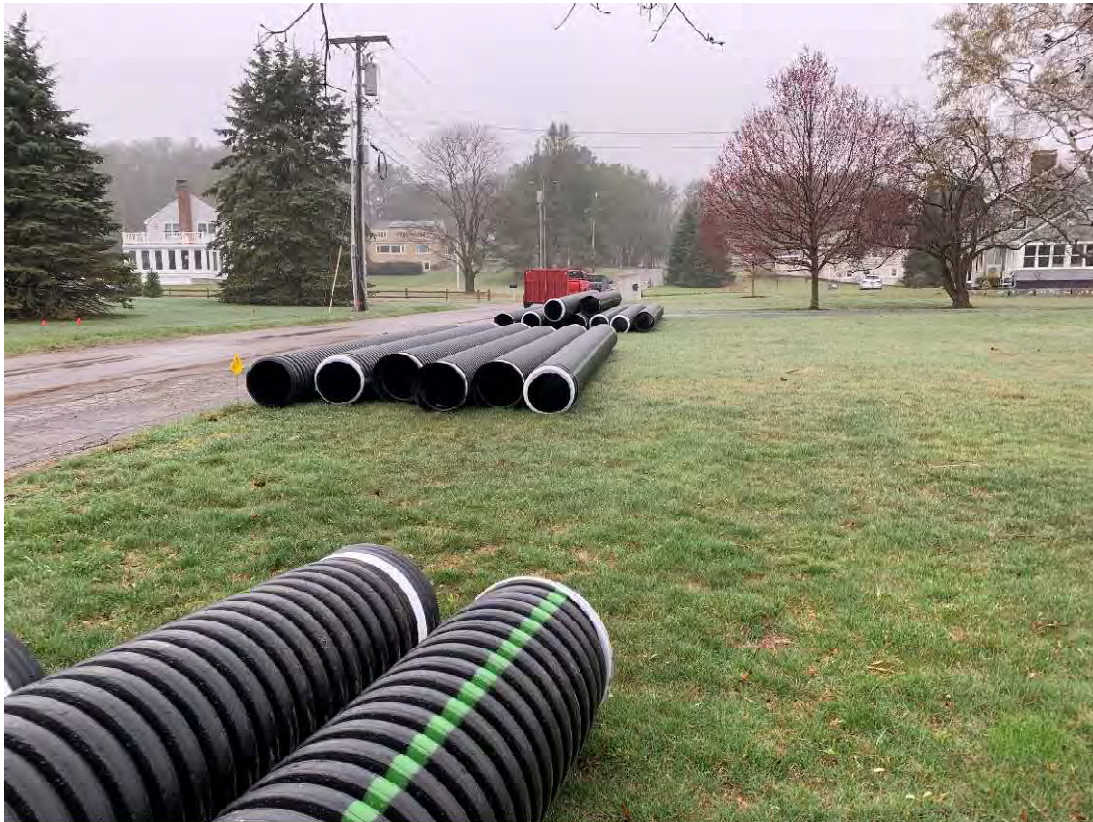
- Storm drain pipes and structures are have been stored a long the right-of-way in areas where they are proposed, but not placed in areas that appear to place a direct burden on vehicle traffic and homeowners. (Photo 3)

Photo 3 – Stormdrain pipe stored in open areas.

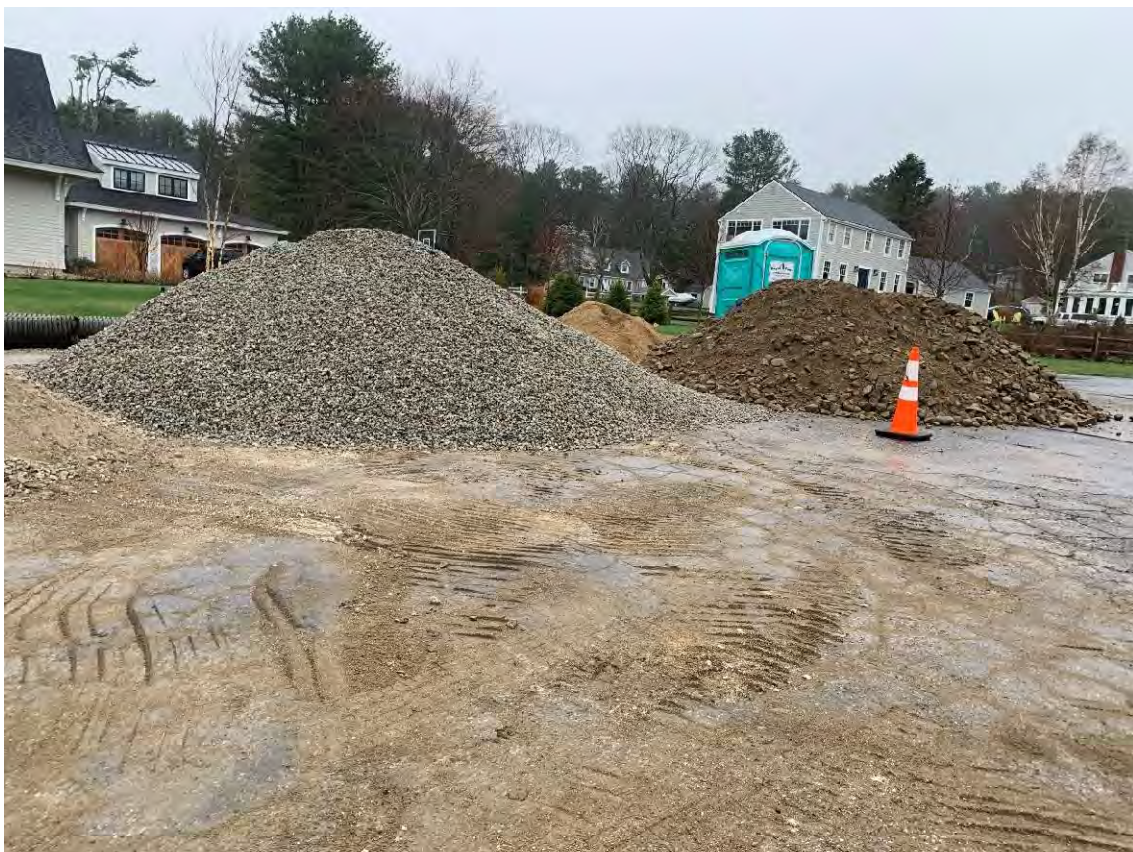
- Gravel stockpiles are located in the cul-de-sac area. (Photo 4)
- While on-site in the morning, crew members with A.H. Grover actively installed 15" SD from Exist. CB 1 towards CB 11.

Photo 4 – Stockpiles located in the cul-de-sac.

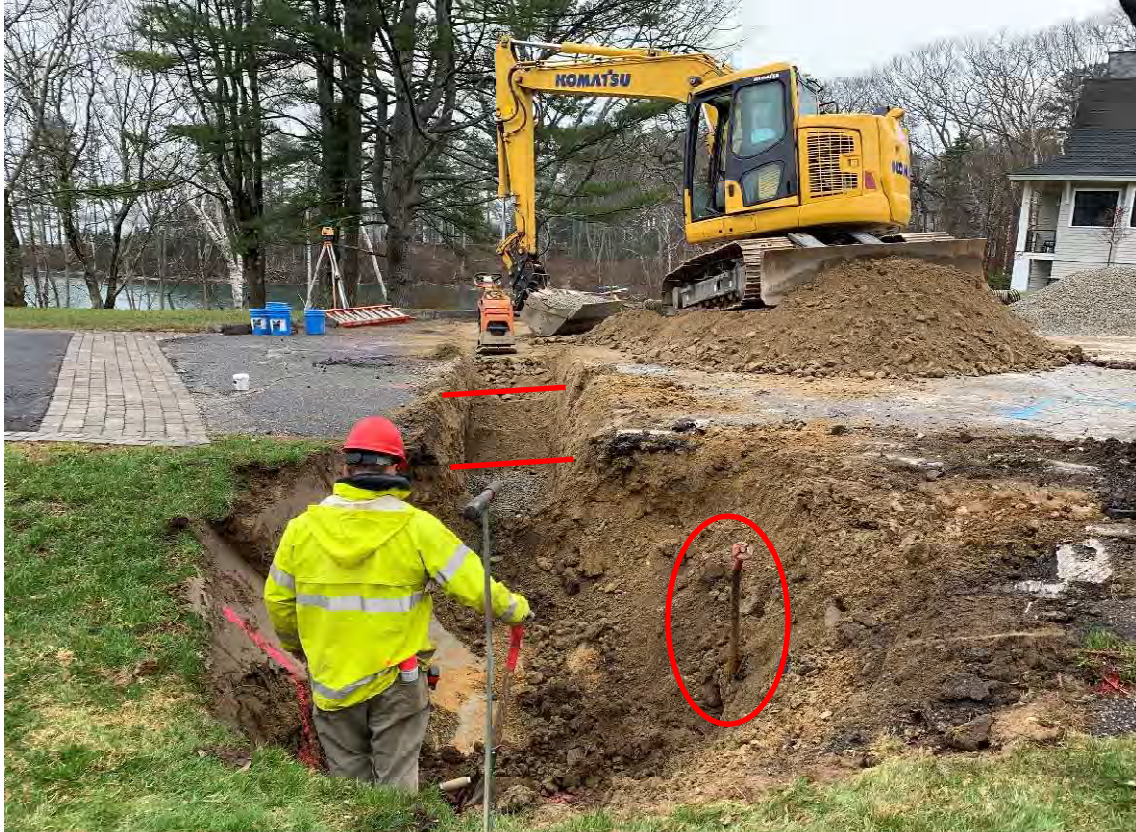
- The 15" SD was embedded with material consistent with MEDOT 703.22 Type C ¾" Crushed Stone to the spring line of the pipe. (Photo 5) Material that appeared to be MEDOT 703.22 Type B Underdrain was used to backfill the 15" SD approximately 1.75' from the spring line, as seen in photo 5.

- There appears to be no rock ledge present to this point.
- Crew members with A.H. Grover, Inc. makes efforts to avoid underground utilities.
  - As can be seen in photo 5 mentioned above, a utility service to 20 Longmeadow drive was avoided by hand shoveling. Upon installation of CBs 11 and 14, the service appeared to be backfilled accordingly as can be seen in photo 6.

Photo 5 – The layers of gravel, separated by red lines are shown accordingly. Also, circled in red is a utility service avoided.

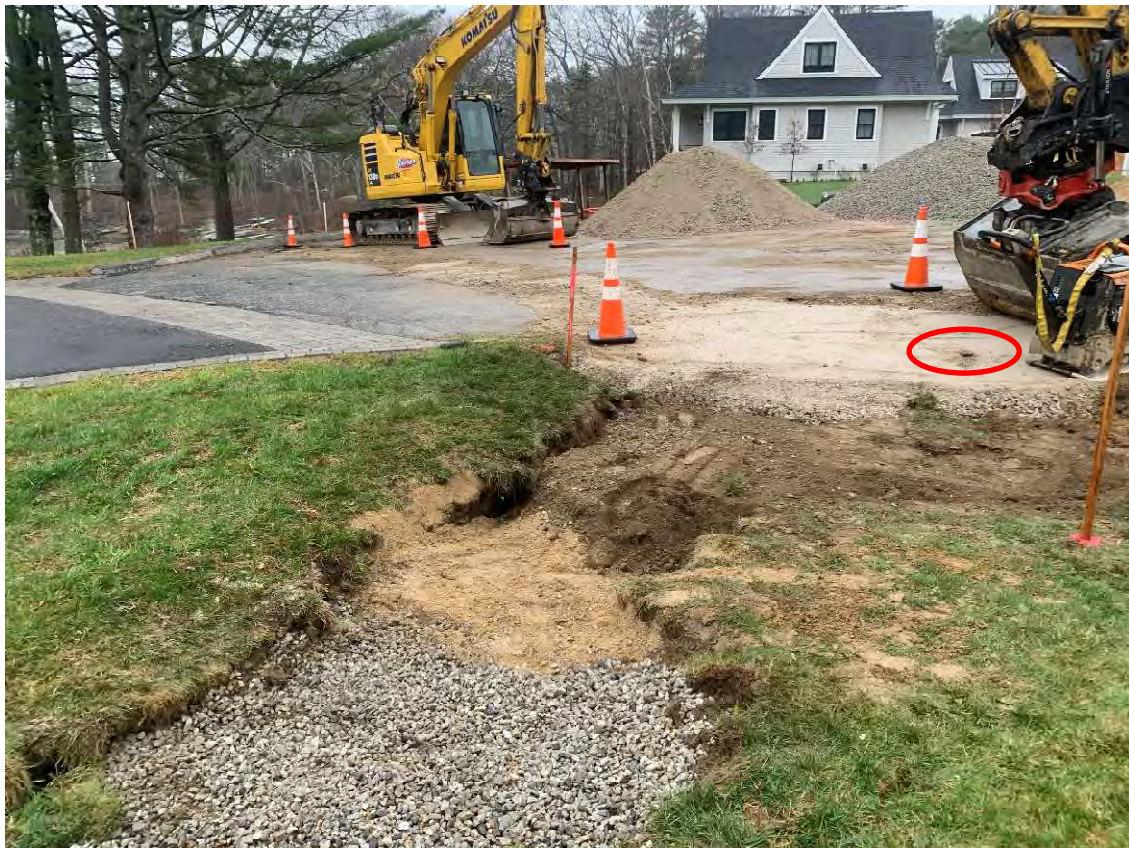
- The catch basins appeared to be embedded with ¾" crushed stone. Material consistent with MEDOT 703.22 Type B appeared to be used as backfill for installing the catch basins. Subbase material consistent with MDOT 703.07 Type D was used to temporarily cover (with a plate over the 2' opening) the catch basin until the frame and cover is installed. (Photo 6)

Photo 6 – CB 11 and CB 14 installed and temporary backfilled until frame and covers are installed. Circled in red is the same utility service circled in photo 5 backfilled accordingly.
