# FIELD OBSERVATION REPORT

Project: Longmeadow Rd & Ole Musket Rd – Drainage Improvements Client: Town of Cumberland GP Field Rep: Kassey Northrop (KN) Weather: Cloudy Time onsite: 10:30 AM – 11:30 AM Contractor: A.H. Grover, Inc. Distribution: File; Town of Cumberland GP Project No: 3656 Visit Date: May 2, 2023 Report Date: May 3, 2023 Temp. Range: 50-51°F

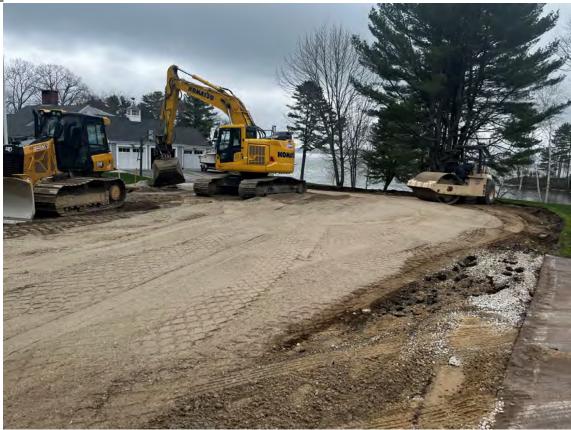
- > Upon arrival in the morning, crew had removed the existing pavement in the cul-de-sac area. (Photo I)
  - With efforts of the dozer and excavator, operated by Ben and Matt Grover, material consistent with MaineDOT Type 703.06 Type A gravel was installed, approximately 3", the area of the cul-de-sac, graded to drain towards the catch basins. (Photo 2)

Photo I – Existing pavement removed from cul-de-sac.

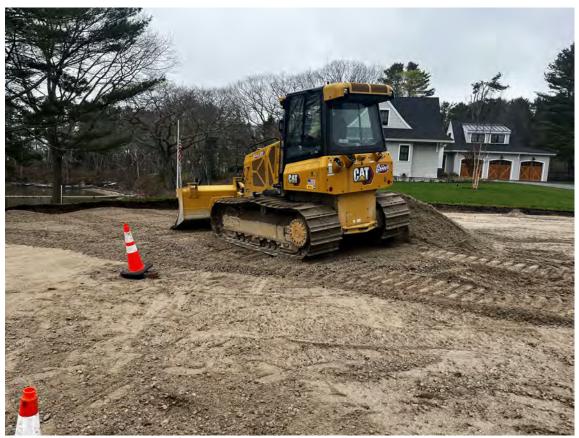
Photo 2 – Ben Grover operating dozer to push surface gravels into place.

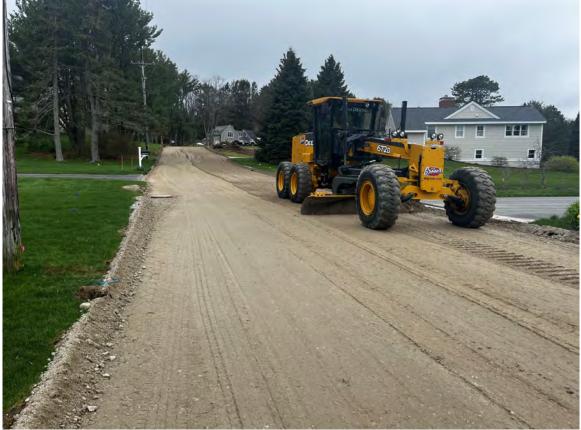
- While on site, Ben Grover operated a 627D John Deere grader to fine grade Longmeadow Road for paving. (Photo 3)
  - The grader appeared to be pitched at 2% towards the gutter line, as can be seen in photo 3.

Photo 3 – Ben Grover operating the John Deere grader at an apparent 2% pitch towards the gutter.

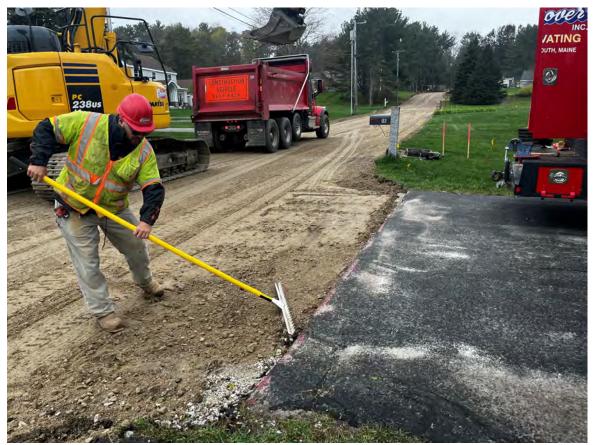
- Crew used a rake to grade the surface gravels at the driveway aprons (Photo 4)
  - A 10-ton roller was used to compact surface gravels. The 10-ton roller used can be seen in the background of photo 1.

Photo  $\overline{4 - \text{Alex Grover surfacing the driveway aprons with material consistent with MaineDOT 703.06 Type A.$
