**DAILY CONSTRUCTION REPORT**

Date: Thursday, 07-20-2017  
(Day 63)

**PROJECT:** Middle Road Improvements  
**CLIENT:** Town of Cumberland  
**CONTRACTOR:** Storey Brothers  
**PROJECT MANAGER:** Dan Diffin, P.E.

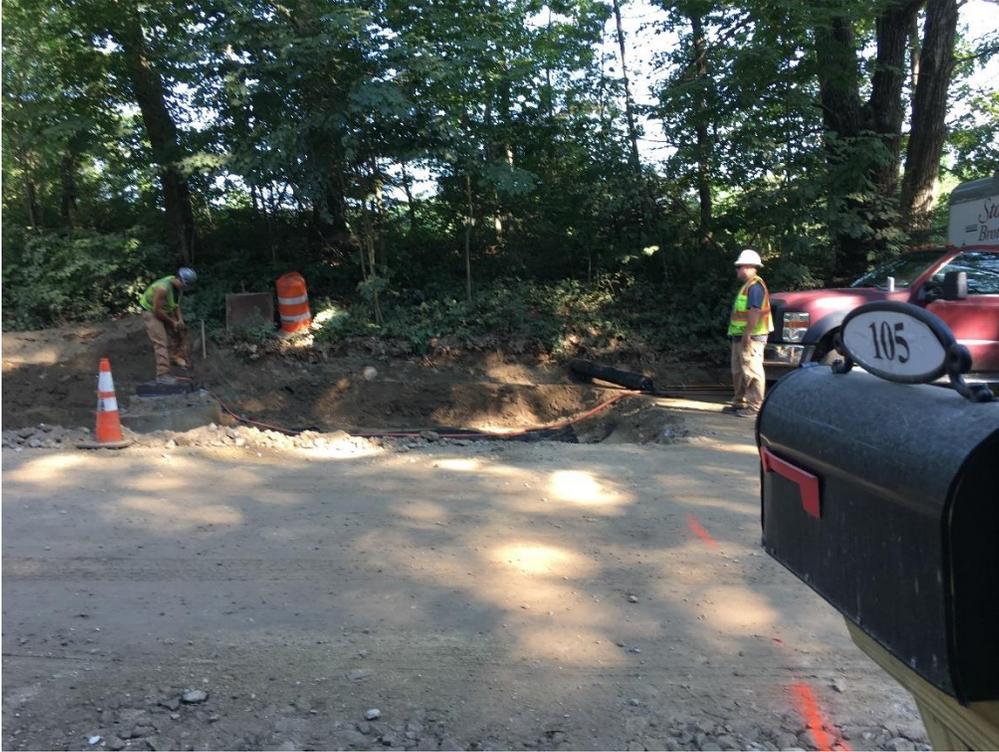
Began the day by resuming "full box cut" in southbound lane at STA 52+20 working south.

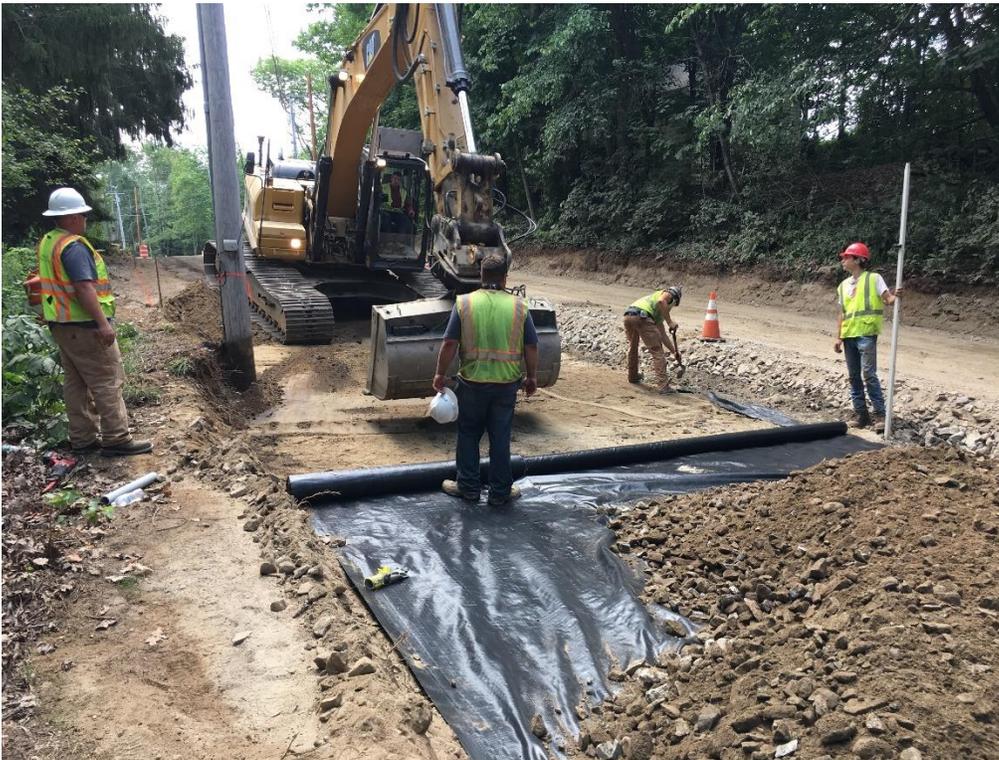
By afternoon, crew began full depth reconstruction of the northbound lane in a southerly direction starting from STA 52+20. Photo here taken near Pole 319 at STA 51+71.
