### DAILY CONSTRUCTION REPORT

Date: Friday, 09-15-2017

PROJECT: Middle Road Improvements WEATHER: Mostly cloudy, drizzle

# SEVEE & MAHER ENGINEERS, INC. CONSTRUCTION PHOTOS September 15, 2017

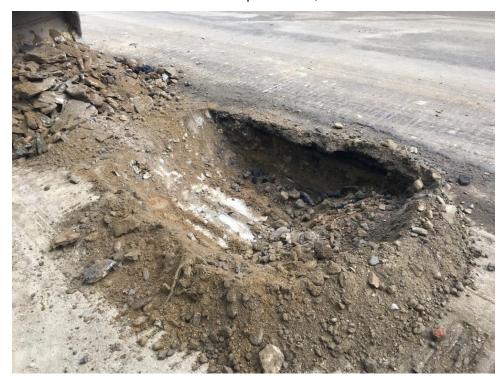
Test Pit 3C at STA 35+30, 10' Left - Encountered ledge 18-inches below the top of the milled pavement. About 4 inches of pavement had been milled off leaving about 3 inches. This area is in a "full" box cut area.

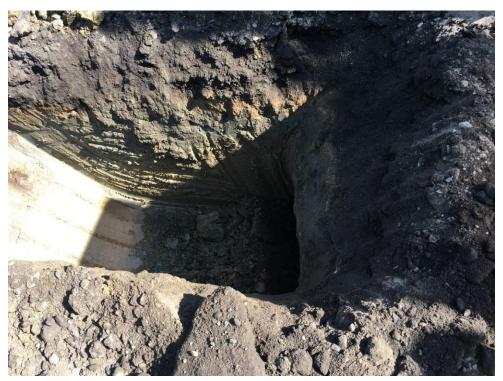
Test Pit 9 at STA 47+50 10' Left – Did not reach ledge at a depth of 45 inches below the milled pavement. Gravel/clay interface was about 18 inches below top of the 2 inches of milled pavement remaining. This area was in a "partial" box cut area.
