DAILY CONSTRUCTION REPORT

Date: Thur., 04-27-2017

PROJECT:Middle Road ImprovementsWEATHER:CloudyCLIENT:Town of CumberlandTEMP:Mid 40'sCONTRACTOR:Storey BrothersWIND:Light Breeze

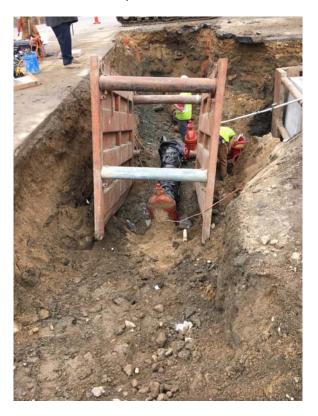
Installing 12"x8" tee on 12" line to Vault. Excavating existing 12" water main in Tuttle Road

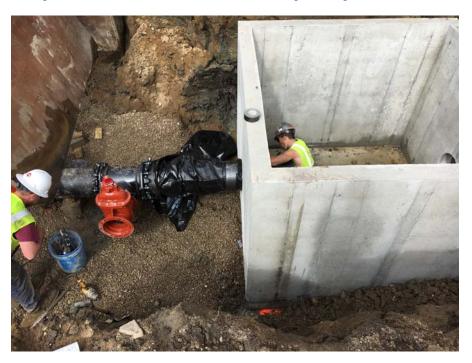
Connecting 12" water main to vault

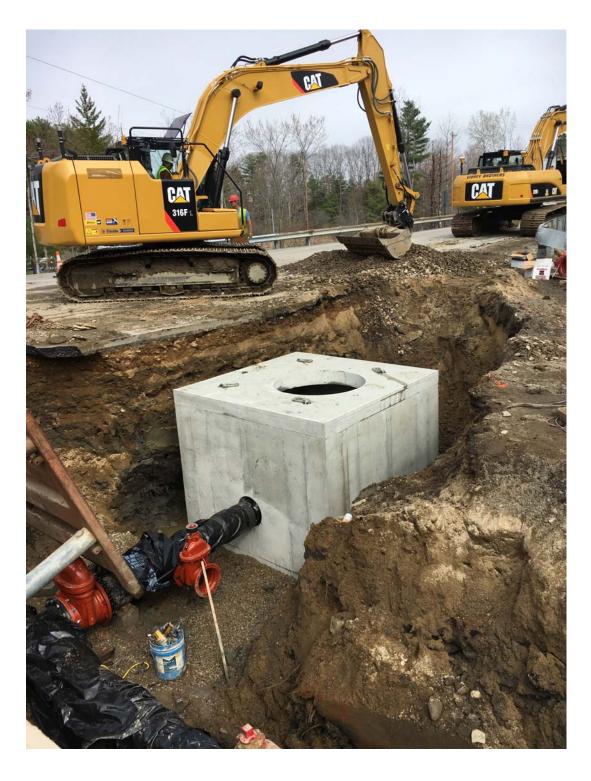
Backfill of vault underway
