**WEEKLY CONSTRUCTION REPORT**

PROJECT: MIDDLE ROAD IMPROVEMENTS

PERIOD ENDING: FRI, 9 June 2017

JOB NO.: 16047.00

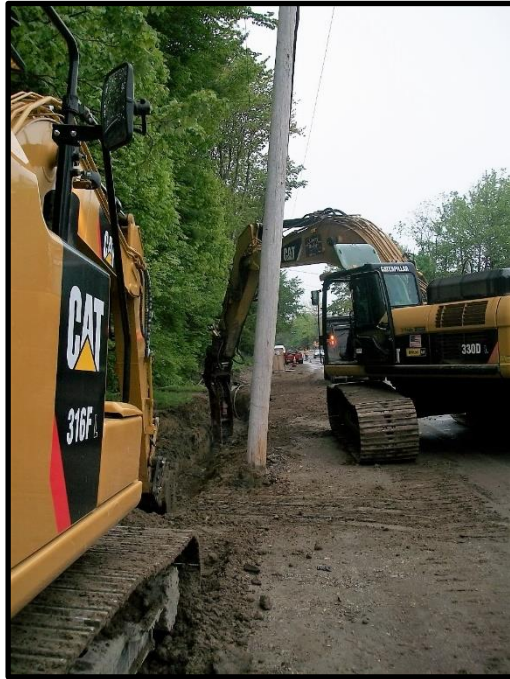
Photograph 1: Ledge removal for gas line behind Pole 337

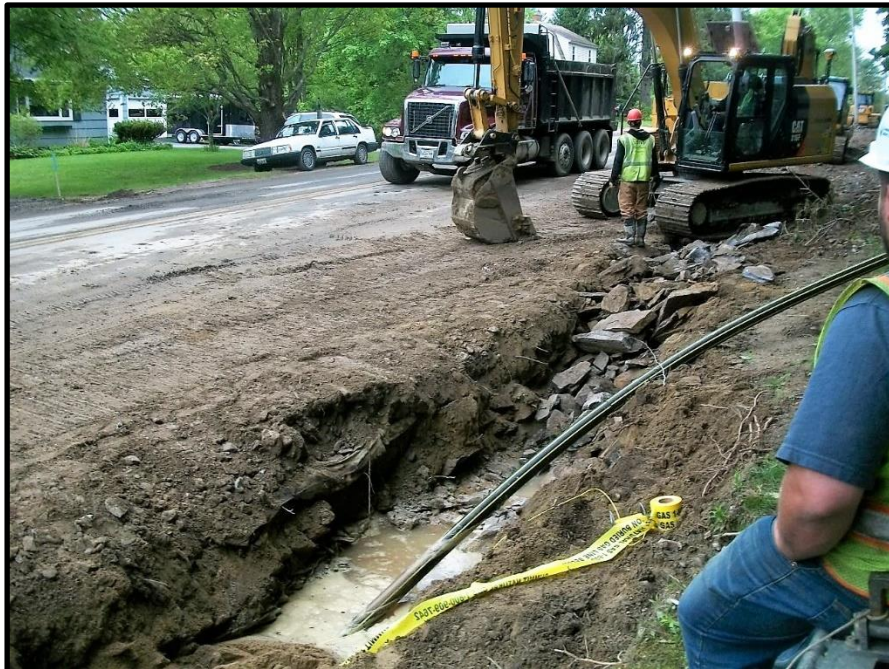
Photograph 2: Installation at the end of the day at STA 76+00 just north of Pole 336 across from 151 Middle Road.

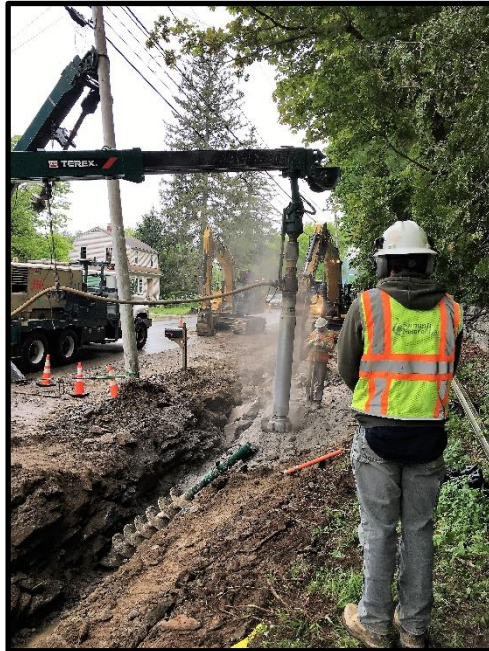
Photograph 3: Coordination of drilling hole for Pole 336 through ledge with gas line trenching and ledge removal.

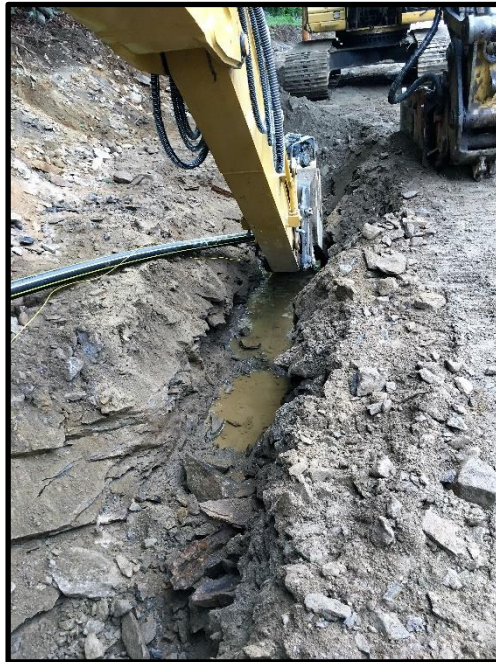
Photograph 4: Breaking up ledge with the hoe ram attachment on the excavator most of the day.

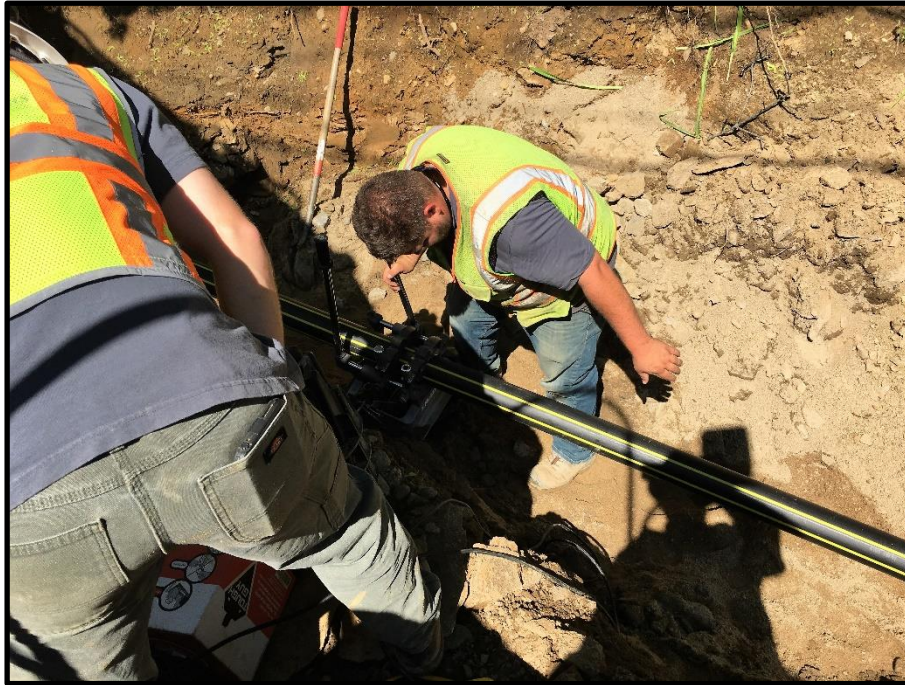
Photograph 5: Facing ends of HDPE gas line pipe prior to fusion welding.

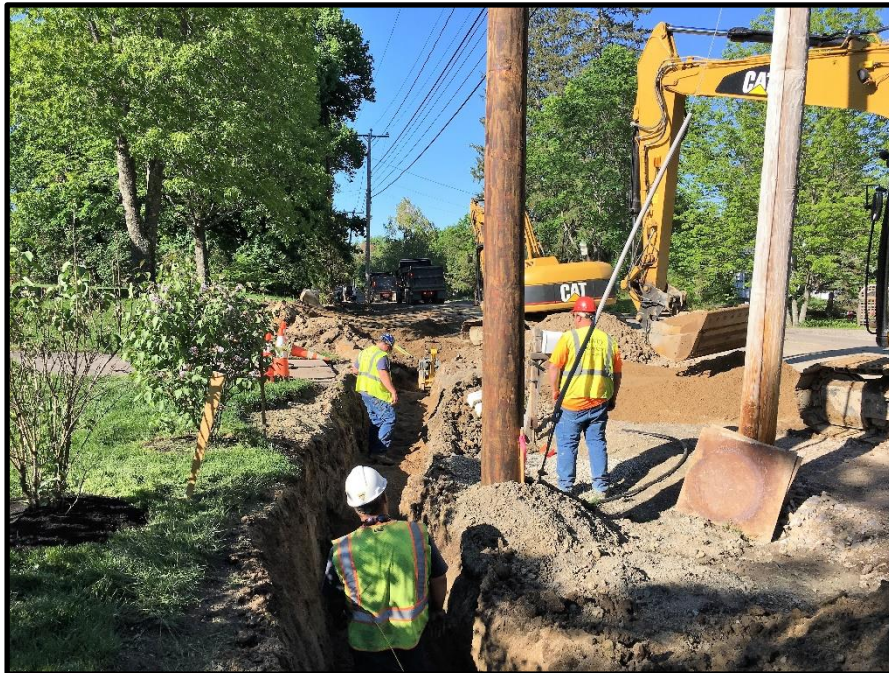
Photograph 6: Bedding gas line in sand behind new pole

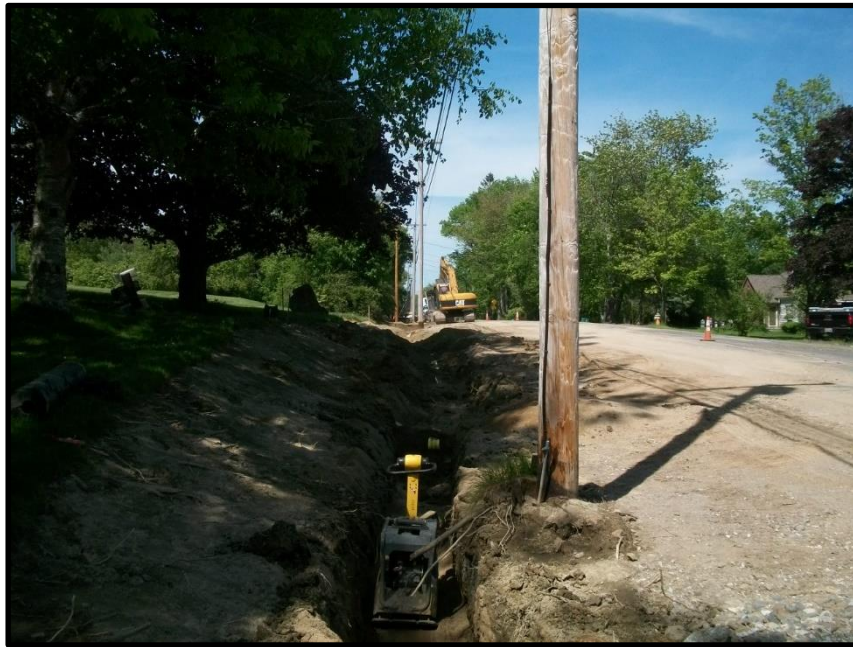
Photograph 7: Using a plate compactor on sand over the gas line prior to backfilling.

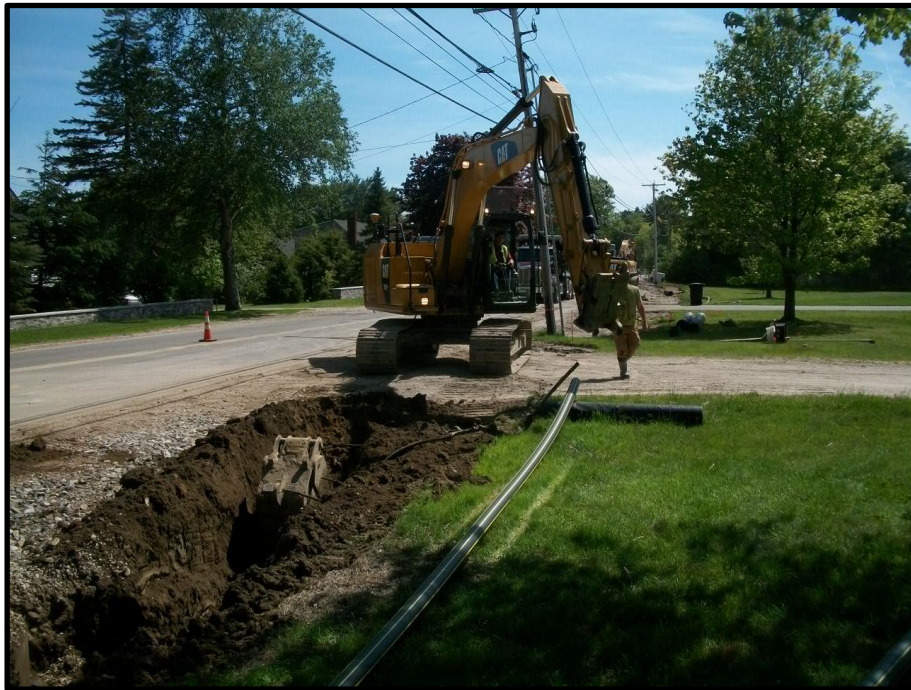
Photograph 8: Trench ahead of pipe installation just north of Butterworth Farm Road

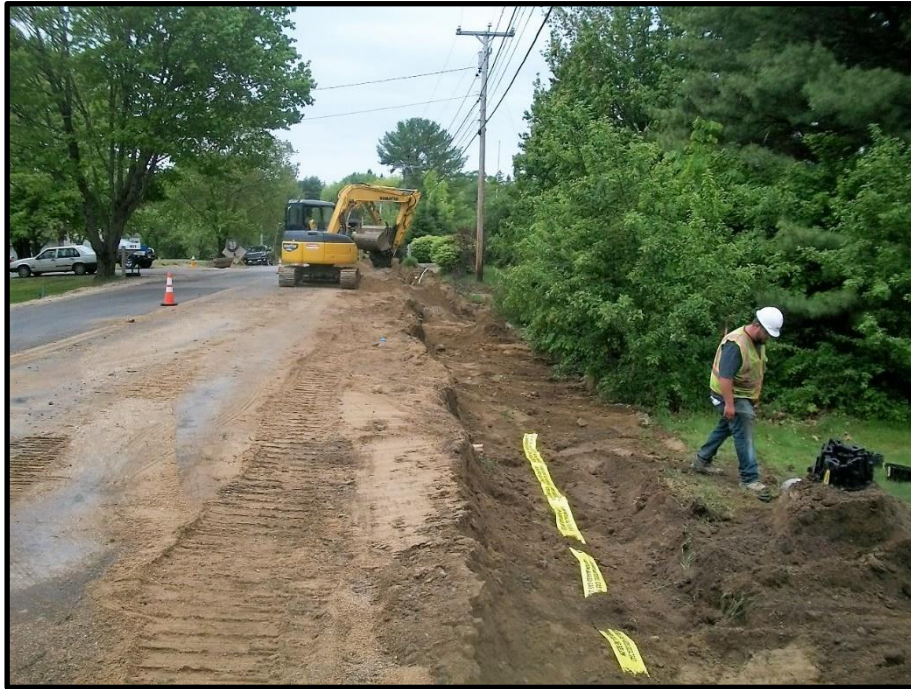
Photograph 9: Warning tape placed 24 inches above pipe and detection wire across from 125 Middle Road (Maloney).

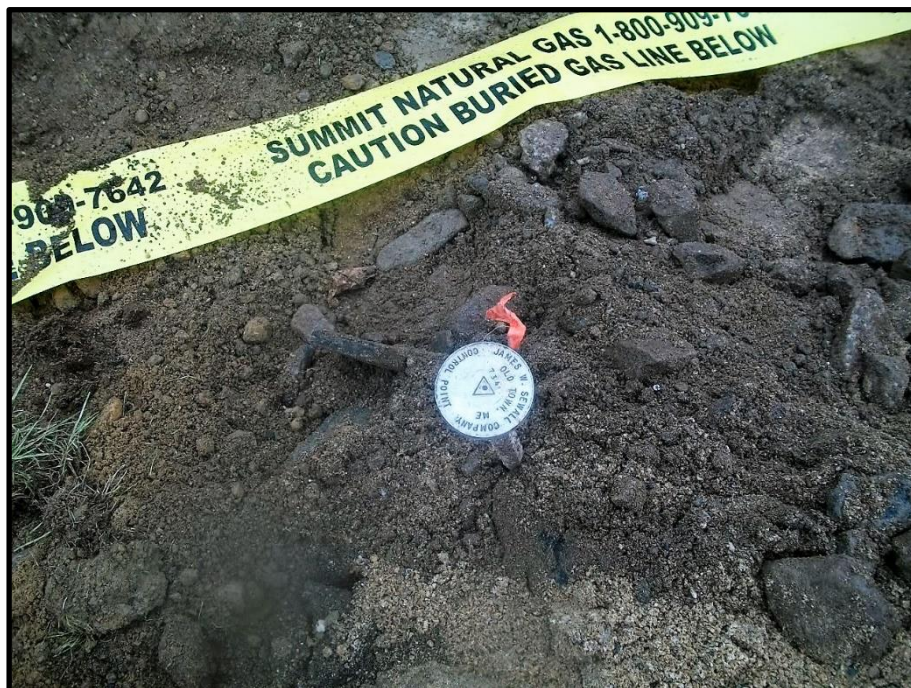
Photograph 10: Exposed but undisturbed control point survey marker near existing edge of pavement in front of 126 Middle Road. Likely from an earlier road improvement project.
