**DAILY CONSTRUCTION REPORT**

Date: Wednesday, 05-17-2017  
(Day 20)

**PROJECT:** Middle Road Improvements  
**CLIENT:** Town of Cumberland  
**CONTRACTOR:** Storey Brothers  
**PROJECT MANAGER:** Dan Diffin, P.E.

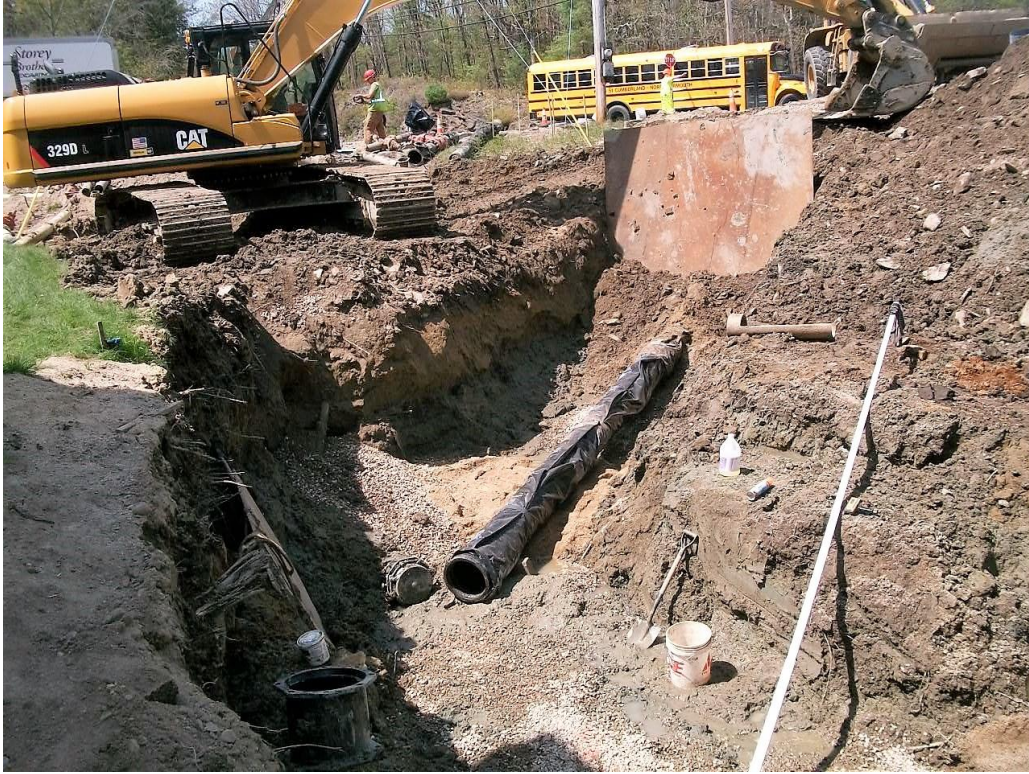
12-inch water main from new vault installed at the Tuttle Road intersection

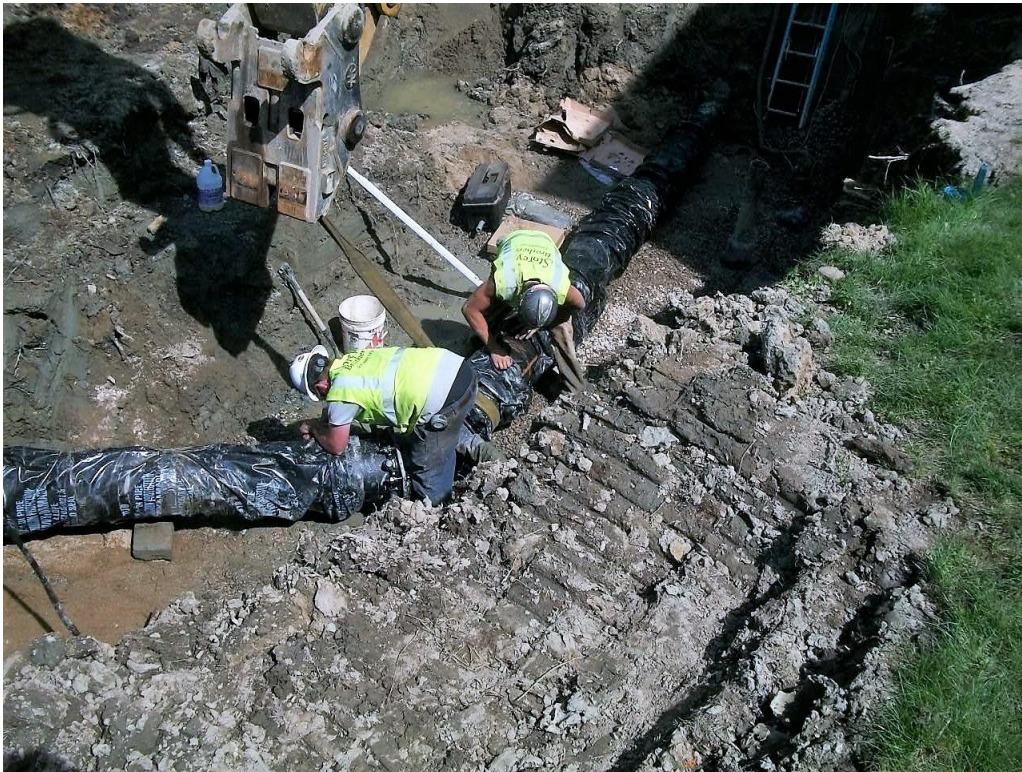
Installing elbow to connect new 12-inch main from vault to the 12-inch pipe extending from the reducer connected to the existing 10-inch main running parallel to Tuttle from the east.

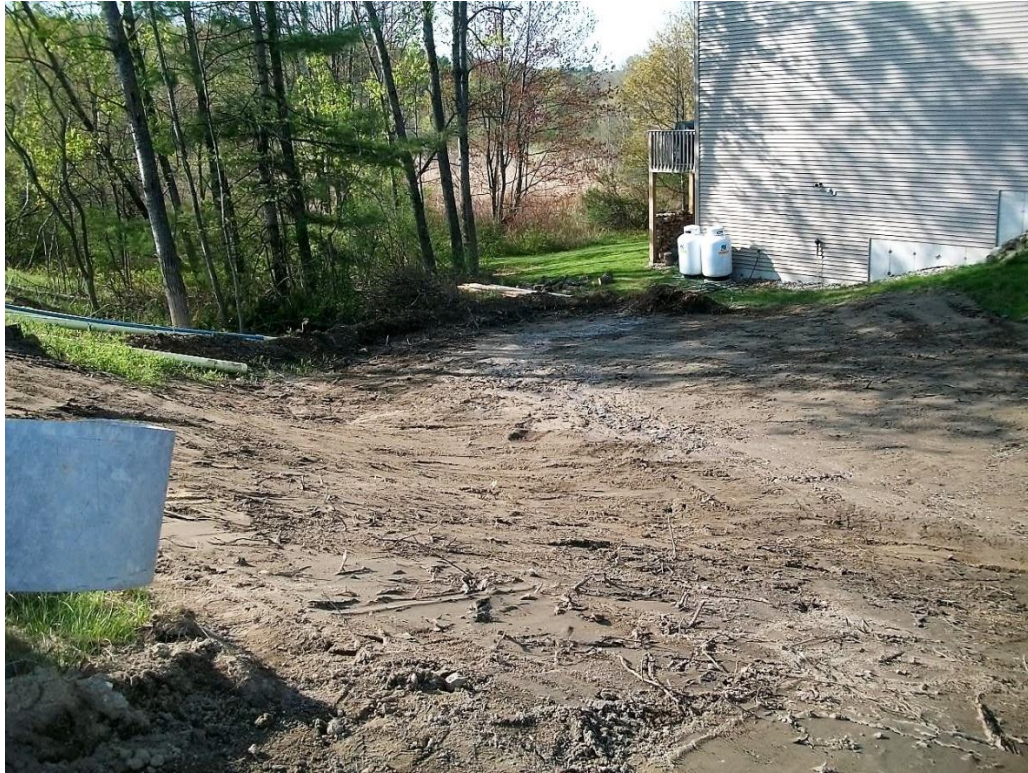
Water main connection adjacent to 163 Middle backfilled and graded late in the day.

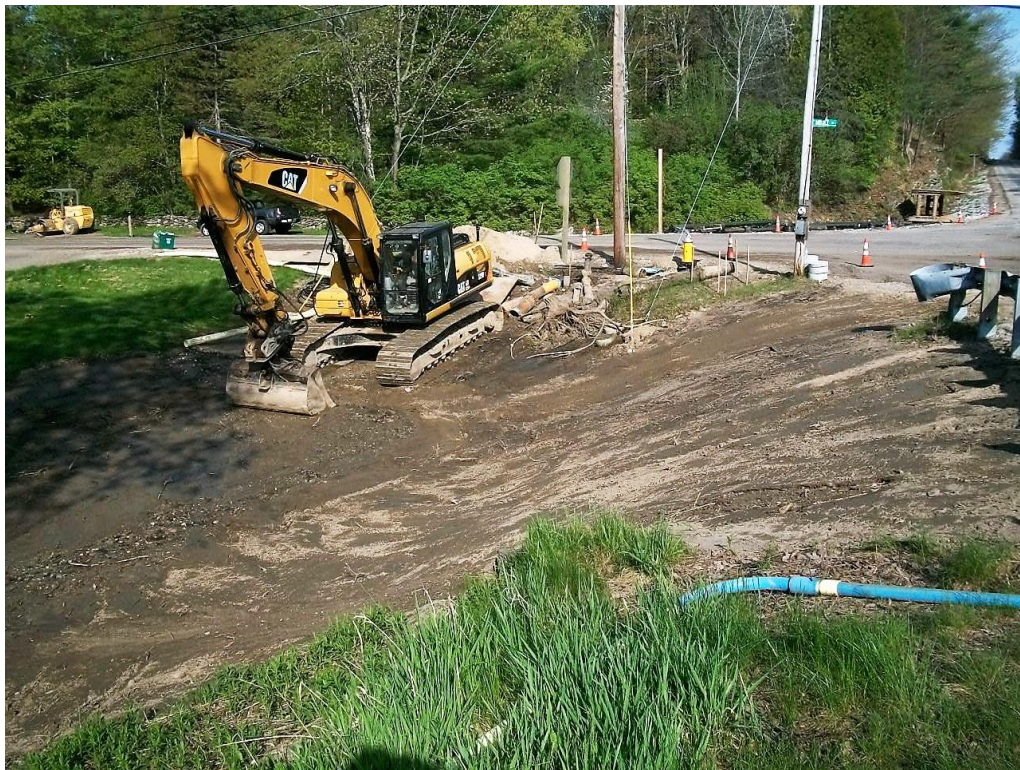
Clean-up and stabilization of water main connection site remains.
