## FIELD OBSERVATION REPORT

Project: Gas Main – Cumberland-Falmouth-Yarmouth  
Client: Towns of Cumberland, Falmouth and Yarmouth  
GP Field Rep: Benjamin Grondin (BG)  
Weather: Cloudy  
Temp. Range:70-80°F  
Time onsite: Multiple visits

GP Project No: 1636.87  
Visit Date: July 11, 2017  
Report Date: July 12, 2017

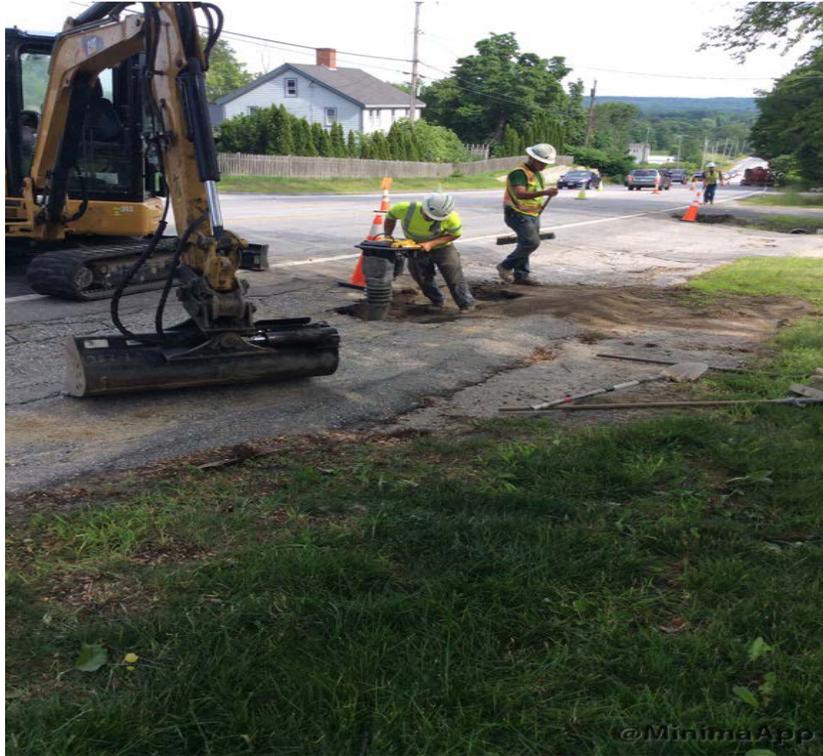
- Crew achieved >1' separation from existing utilities on all crossings. Crew also maintain >6' separation from existing parallel utilities. A rock shield was placed over the water service for #138 as a precaution as drill depth varies due to slope on roadway
- Crew backfilled trench and potholes with excavated material. Existing material was used as backfill. Backfill was compacted in lifts with a jumping jack.
- Crew clean worksite and traffic returned to normal at approximately 5:30 PM.

Compacting road near #138 water service on Rt. 100

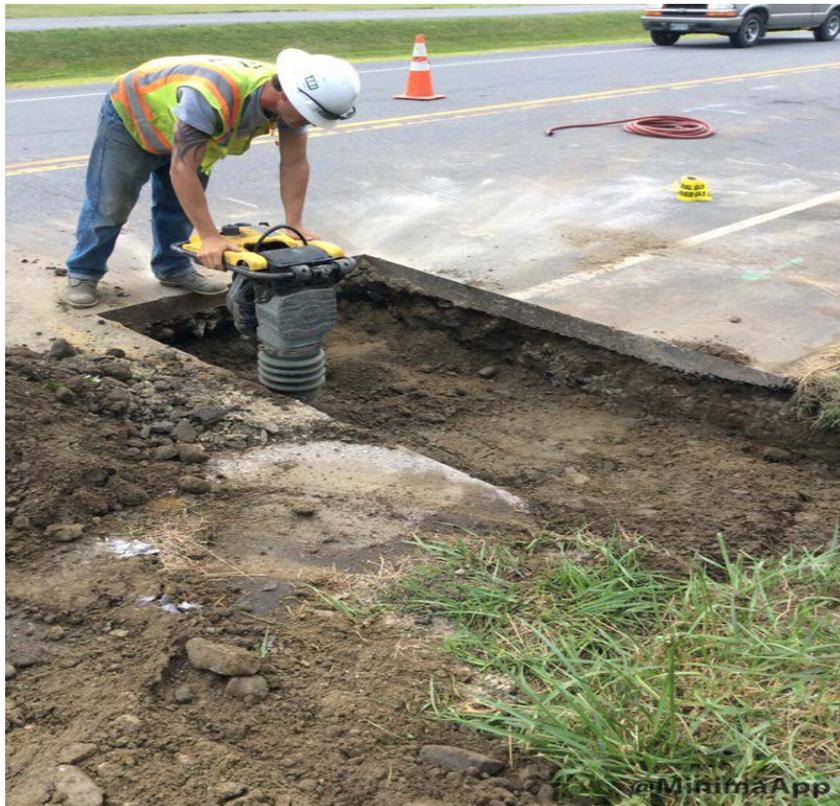
- Crew backfilled trench with sand around the gas main, with excavated material above the sand. Backfill was compacted in lifts with a jumping jack.
- Cold patch was placed in the trench and compacted with a jumping jack.
- Crew sawcut 1' setbacks from the edges of the trench.

Compacting backfill on Tuttle road

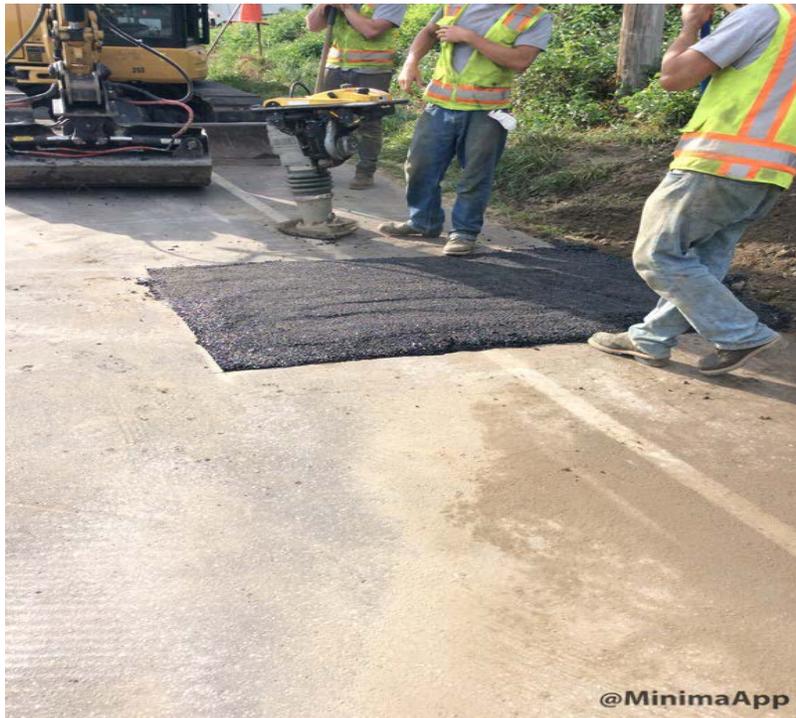
Cold patch placed at Tuttle Road

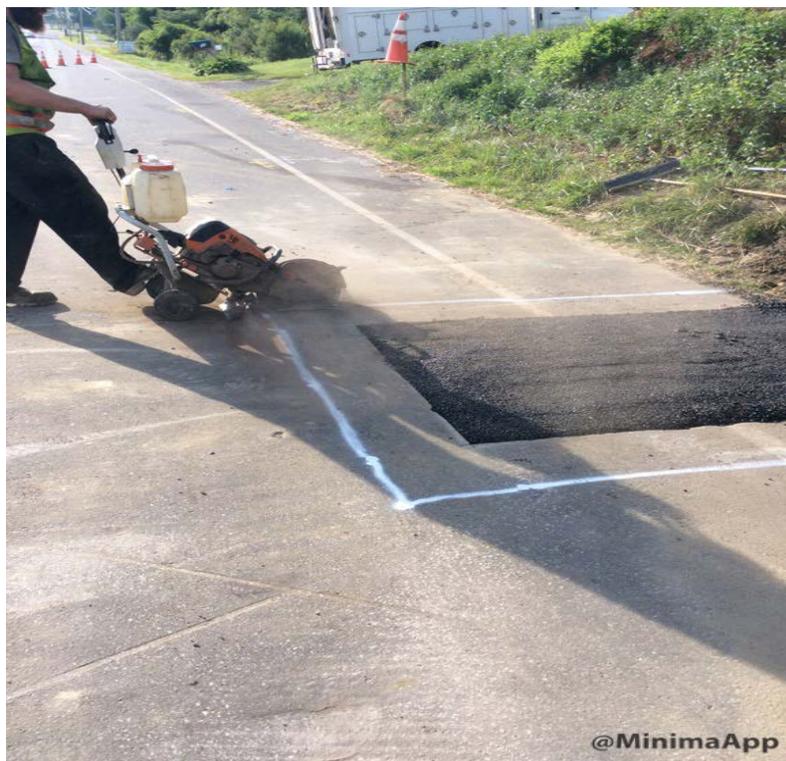
Crew sawcutting 1' setbacks at Tuttle Road
