FIELD OBSERVATION REPORT

Project: Gas Main – Cumberland-Falmouth-Yarmouth Client: Towns of Cumberland, Falmouth and Yarmouth GP Field Rep: Benjamin Grondin (BG). Weather: Cloudy Temp. Range :70-80°F Time onsite: Multiple visits GP Project No: 1636.87 Visit Date: July 12, 2017 Report Date: July 13, 2017

Work in Progress – Town of Cumberland

> Installing 4" gas main in southbound shoulder of Route 100.

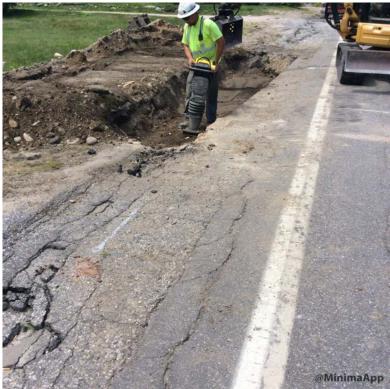
Compacting second lift of gravel near lower driveway to house #144

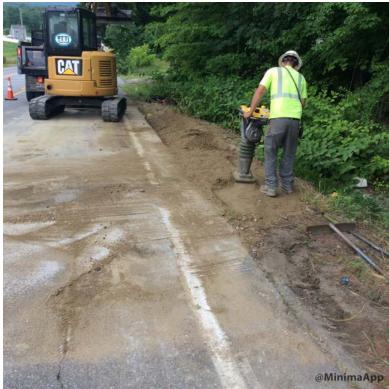
Compacting final lift of gravel near house #134

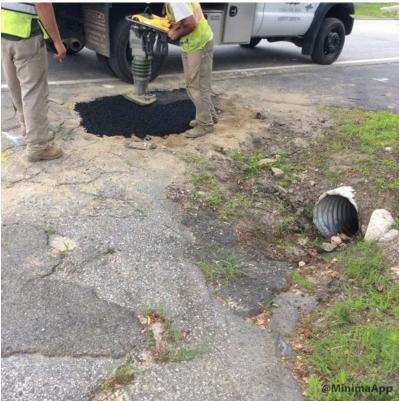
Compacting cold patch at corner of Spring Drive
