FIELD OBSERVATION REPORT

Project: Gas Main – Cumberland-Falmouth-Yarmouth Client: Towns of Cumberland, Falmouth and Yarmouth GP Field Rep: Benjamin Grondin (BG). Weather: Cloudy turning sunny Temp. Range: 70-80°F Time onsite: Multiple visits GP Project No: 1636.87 Visit Date: July 17, 2017 Report Date: July 18, 2017

> Installing 4" gas main in southbound shoulder of Route 100.

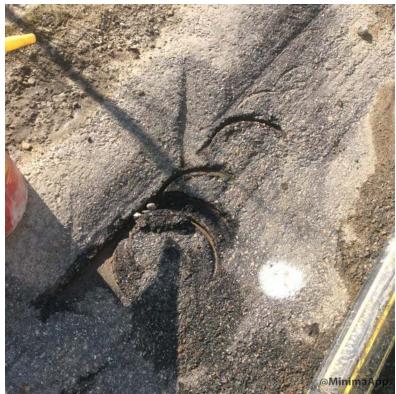
Damaged pavement in paved swale area from drill machine near CMP pole 3.1.

- Crew backfilled trench and potholes with sand around the gas main and gravel. Backfill was compacted in lifts with a jumping jack.
- BG noted some areas of pavement damaged by the drill machine. The damaged pavement in the travel way was sawcut to be replaced during paving. The damaged pavement in the paved swale shall be reviewed by GP and the town to determine if it should be replaced due to the existing condition of the paved swale.
- > Trenches and potholes were left gravel due to their size and location.
- > Crew clean worksite and traffic returned to normal at approximately 6:00 PM.

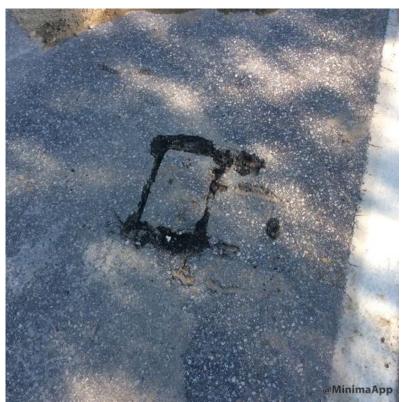
Damaged pavement in travel way from drill machine near CMP pole 3.1.

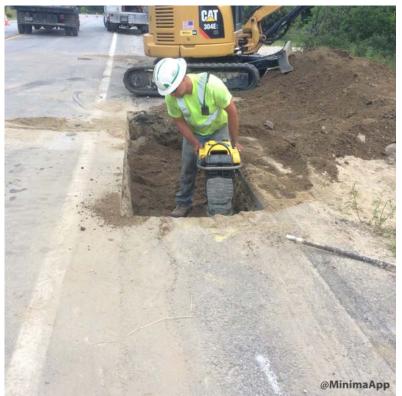
Compacting backfill with jumping jack.

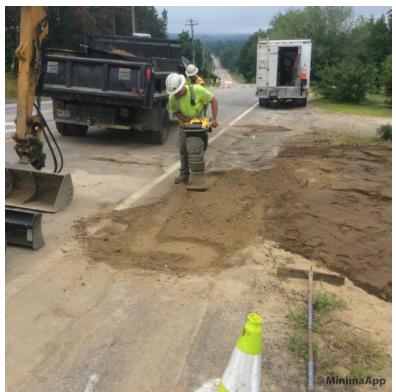
Compacting final lift of backfill with jumping jack
