FIELD OBSERVATION REPORT

Project: Gas Main – Cumberland-Falmouth-Yarmouth
Client: Towns of Cumberland, Falmouth and Yarmouth
GP Field Rep: Benjamin Grondin (BG), Drew Gagnon (DG)
Weather: Cloudy
Temp. Range: 70-80°F
Time onsite: Multiple visits

GP Project No: 1636.87
Visit Date: July 26, 2017
Report Date: July 27, 2017

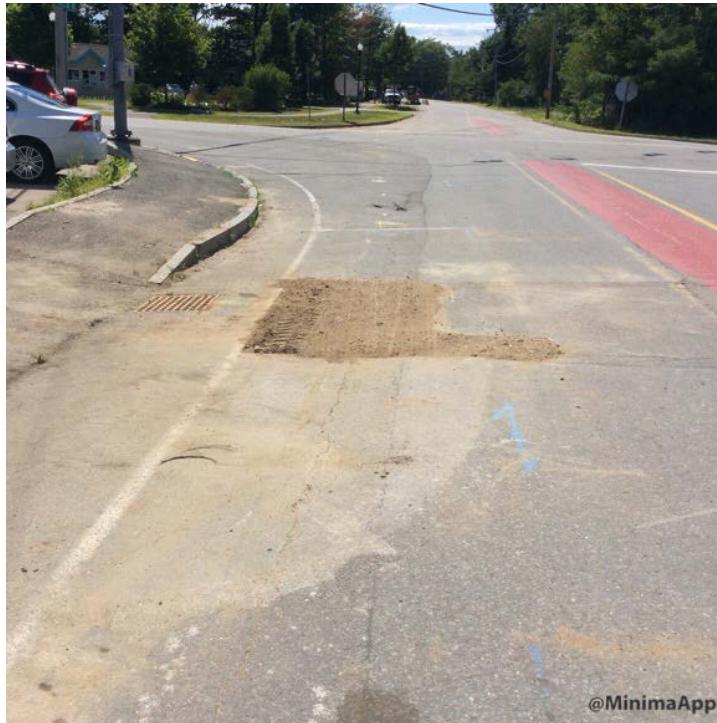
- Crew backfilled trenches and potholes with sand around the gas main and gravel. Backfill was compacted in lifts with a jumping jack.
- Trenches and potholes were left gravel due to their size and location.
- Crew clean worksite and traffic returned to normal at approximately 3:00 PM.

Trench backfilled on Skillin Road

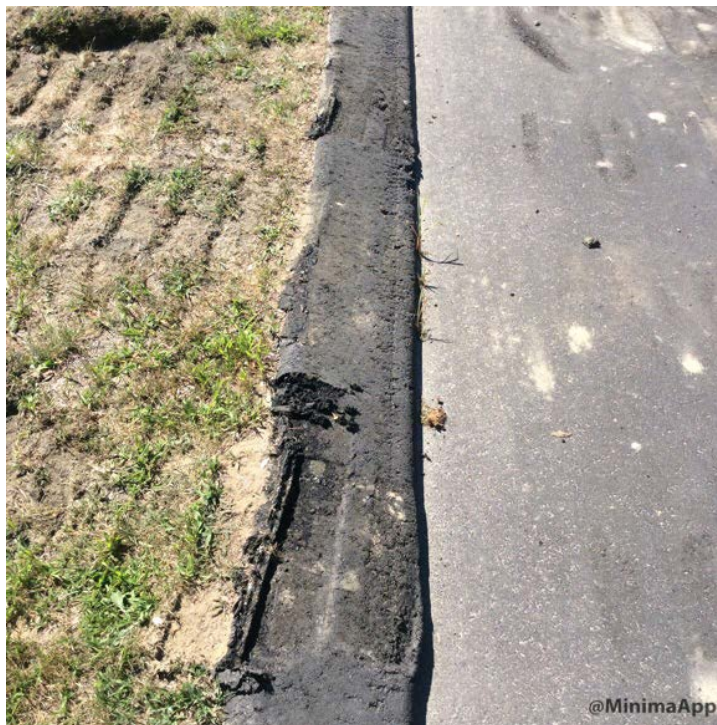
- Balsam Drive Roadway and curb was damaged by the excavator tracks. GP to review with town to determine if a corrective action should be taken.
- Crew backfilled trench with sand around the gas main and service, with excavated material above the sand. Backfill was compacted in lifts with jumping jack.
- Crew cleaned work area and traffic returned to normal by 5:00 PM

Curb damaged by excavator tracks

GP to review condition of Balsam Drive with the Town of Cumberland.

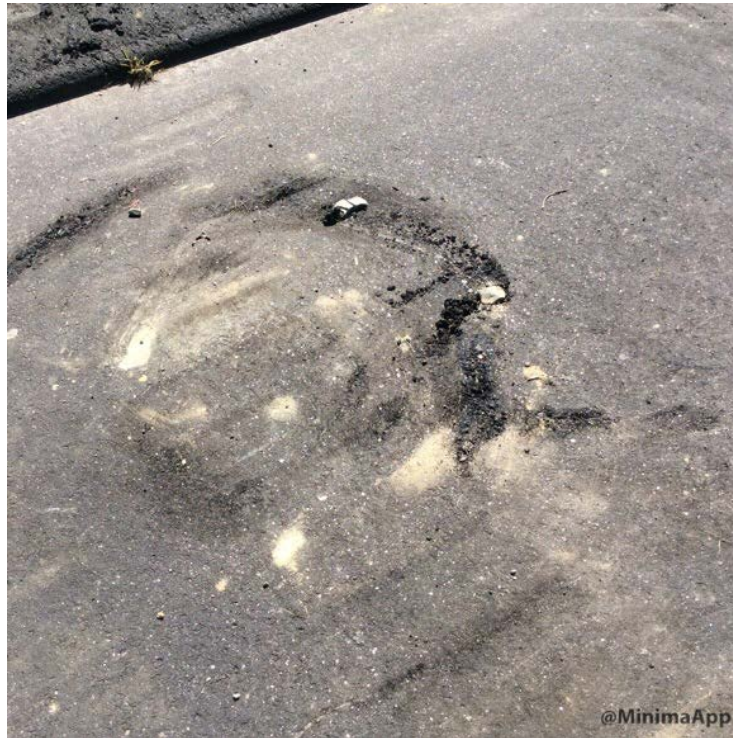
Roadway damaged by excavator tracks

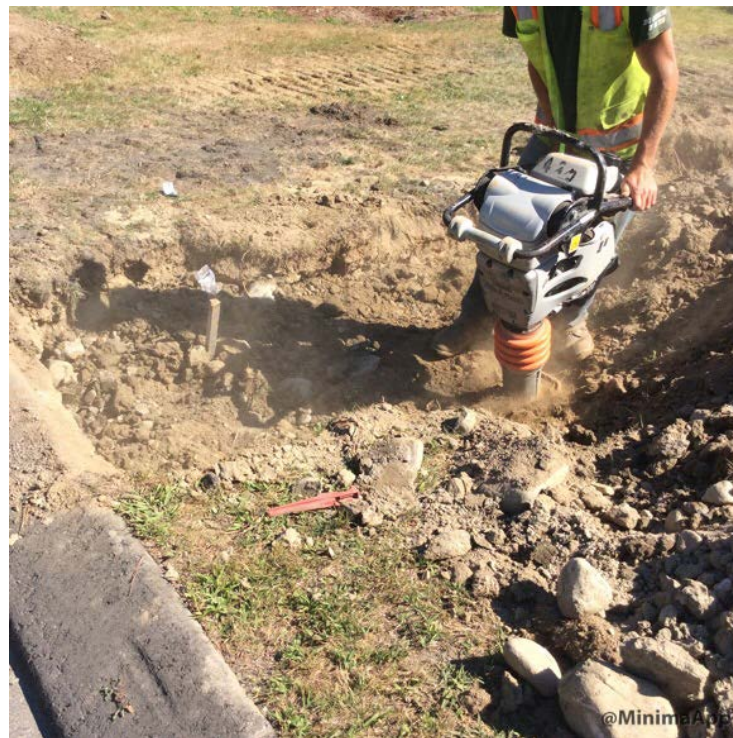
Compacting backfill with jumping jack
