GP Project No: 1636.87

Visit Date: July 31, 2017

FIELD OBSERVATION REPORT

Project: Gas Main – Cumberland-Falmouth-Yarmouth Client: Towns of Cumberland, Falmouth and Yarmouth

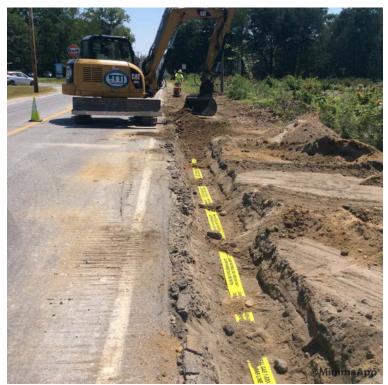
Shoulder trench on Route 100

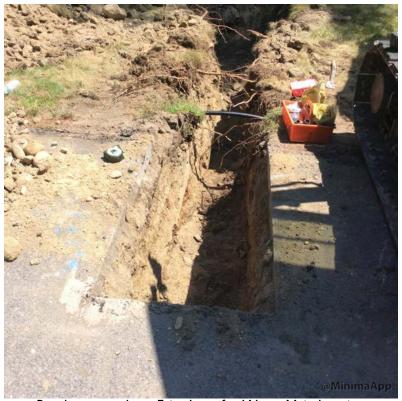
- Crew hand excavated 1' below gas service and did not located the water main or sewer main. Therefore, >1' of separation for the utility crossings was achieved. The ½" gas service is 6'+ from all existing parallel utilities.
- Crew excavated a small portion of the roadway to attempt to find the water main without undermining the road. GP will review the condition of the roadway with the town to determine if moratorium restoration is required.
- Crew backfilled trench with sand around the gas main and service, with excavated material above the sand. Backfill was compacted in lifts with jumping jack.
- Cold patch was not used for the excavated roadway trench due to the location.
- Crew cleaned work area and traffic returned to normal by 5:00 PM.

Roadway trench on Friar Lane for Water Main location

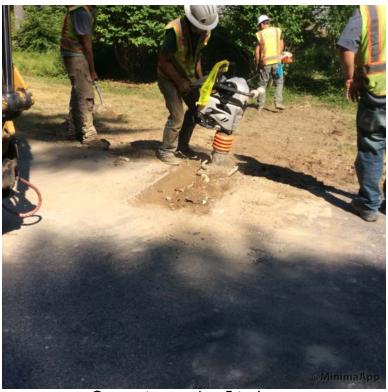
Compacting gravel on Friar Lane

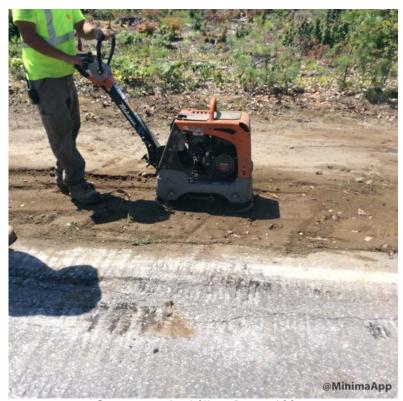
Compacting backfill on Route 100
