FIELD OBSERVATION REPORT

Project: Gas Main – Cumberland-Falmouth-Yarmouth Client: Towns of Cumberland, Falmouth and Yarmouth GP Field Rep: Benjamin Grondin (BG). Weather: Sunny Temp. Range: 70-80°F Time onsite: Multiple visits GP Project No: 1636.87 Visit Date: August 10, 2017 Report Date: August 11, 2017

Summit Natural Gas

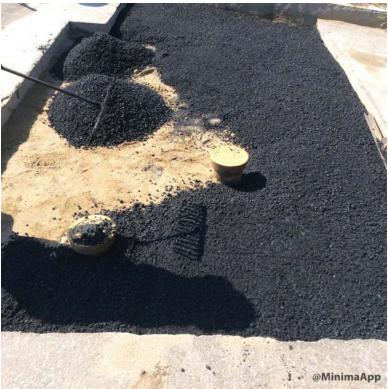
- > Edges of pavement were cleaned and tacked prior to placing 12.5mm HMA.
- Crew did not tack the edges of the trench at the corner of Blackstrap Road prior to placing the first lift of 12.5mm HMA. BG indicated to Rick all edges needed to be tacked prior to placing HMA. Crew tacked the edges of pavement before placing additional lifts.

Placing 12.5mm HMA in trench at the corner of Blackstrap Road

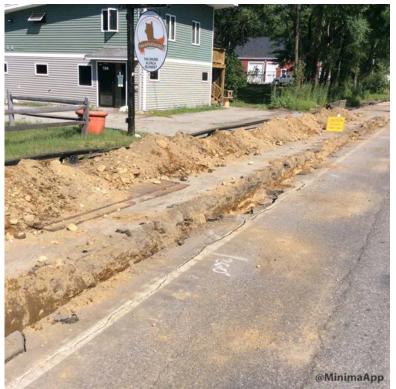
Longitudinal roadway trench for gas main install

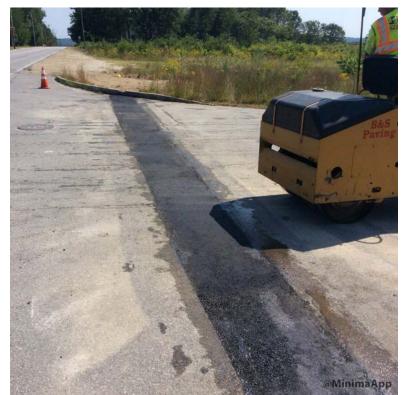
- Crew placed 12.5mm HMA in lifts with each lift compacted with a plate wacker. The final lift was compacted with a plate wacker and 3 ton vibratory roller.

Compacting 12.5mm HMA with 3 ton roller at Westside Animal Hospital
