FIELD OBSERVATION REPORT

Project: Gas Main – Cumberland-Falmouth-Yarmouth
Client: Towns of Cumberland, Falmouth and Yarmouth
GP Field Rep: Benjamin Grondin (BG)
Weather: Sunny
Temp. Range: 70-80°F
Time onsite: Multiple visits

GP Project No: 1636.87
Visit Date: August 14, 2017
Report Date: August 15, 2017

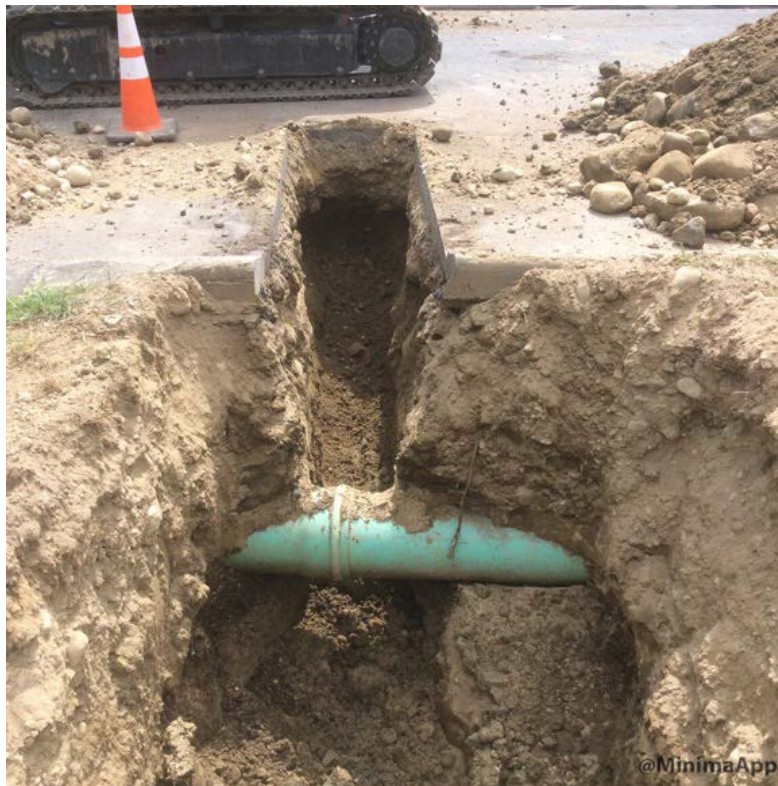
First trench opened on Balsam Drive.

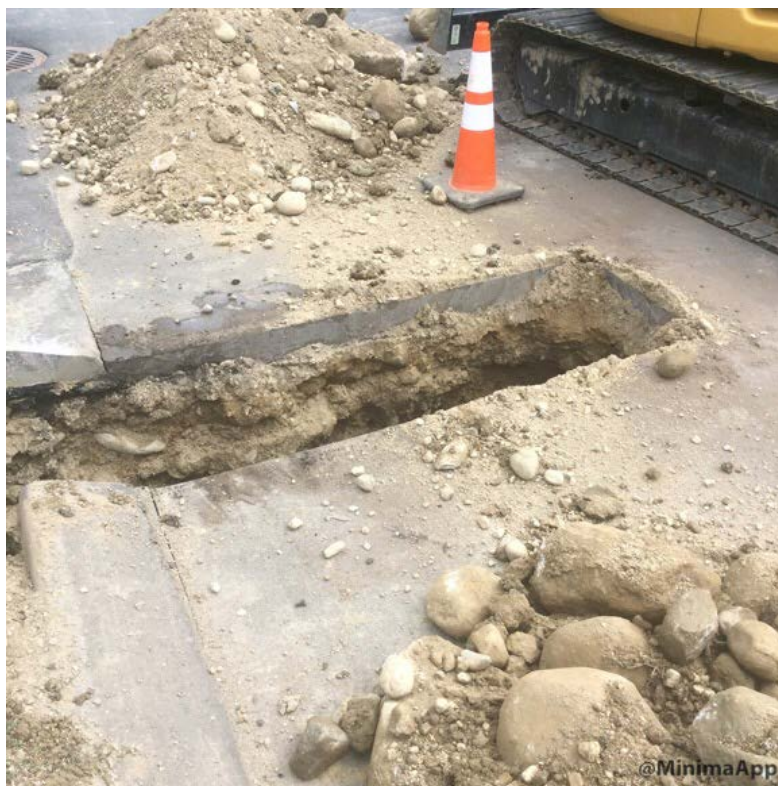
Second trench opened on 2 Balsam Dr.

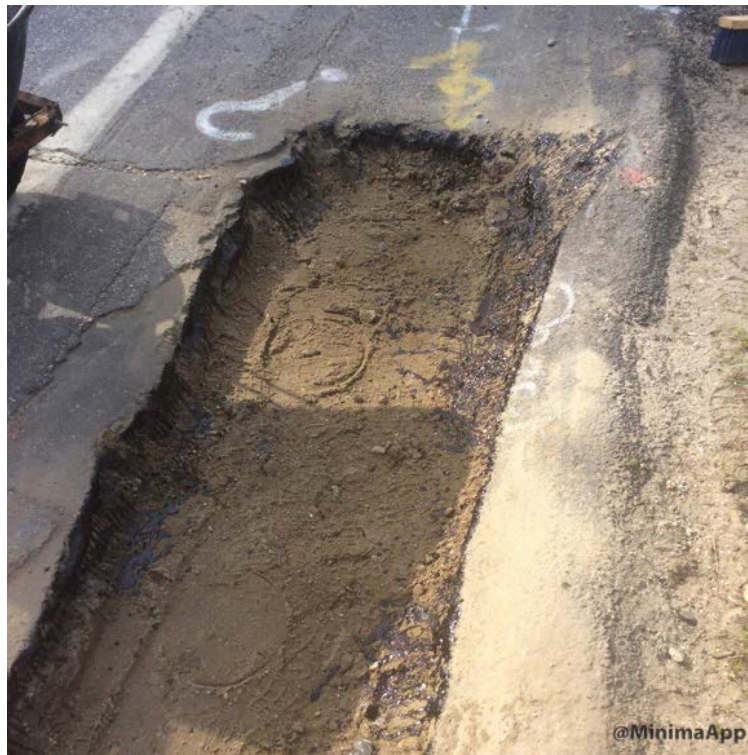
Gravel compacted and tack applied to edges of existing pavement.

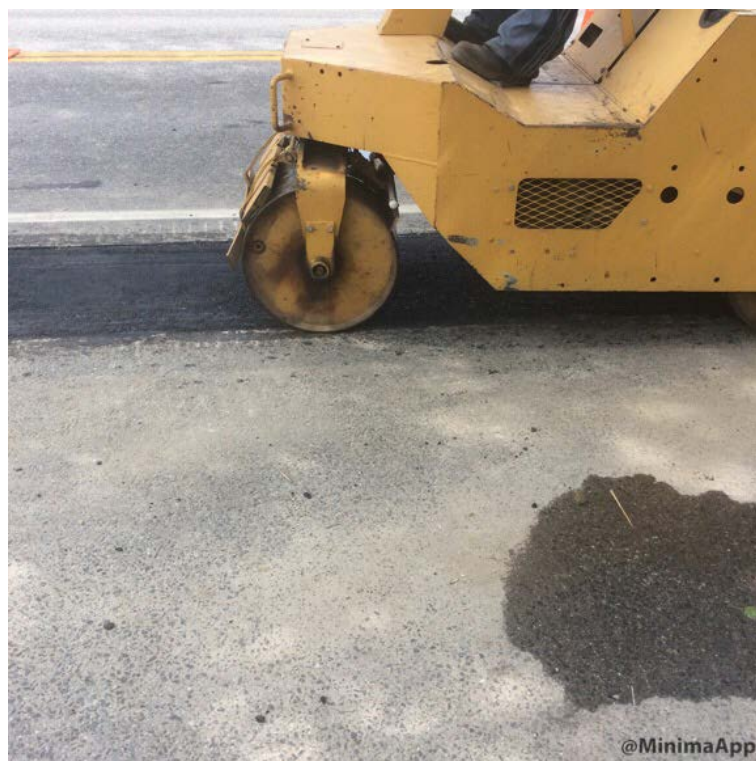
Compacting driveway crossing trench at Seymour's Bird Refuge
