FIELD OBSERVATION REPORT

Project: Gas Main – Cumberland-Falmouth-Yarmouth
Client: Towns of Cumberland, Falmouth and Yarmouth
GP Field Rep: Benjamin Grondin (BG)
Weather: Sunny
Temp. Range: 70-80°F
Time onsite: Multiple visits

GP Project No: 1636.87
Visit Date: August 15, 2017
Report Date: August 16, 2017

Summit Natural Gas

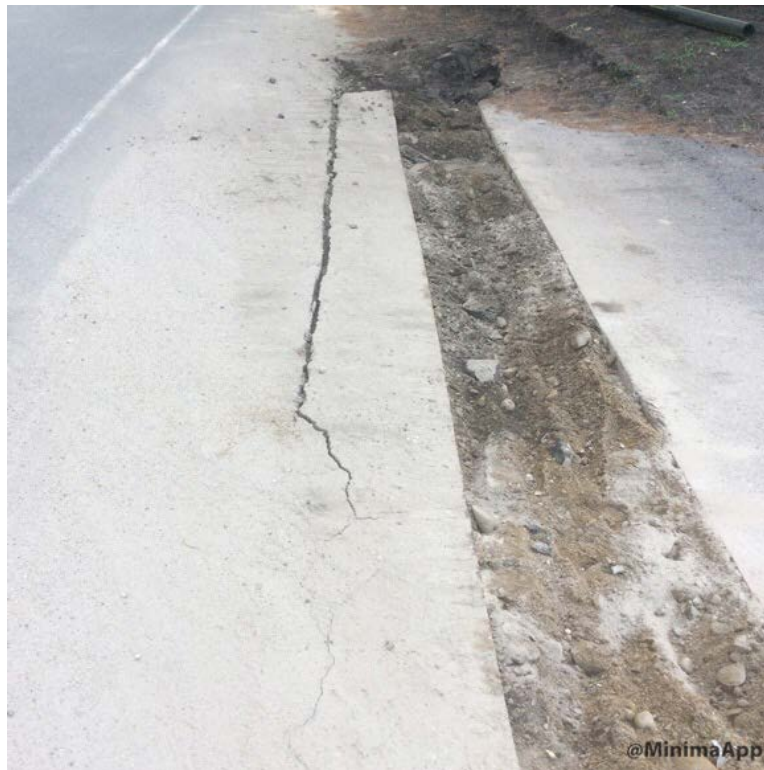
Driveway apron breaking away at roadway seam

- Cold patch was used in the section of the trench that was within the travel way on Skillin Road since this area has required frequent maintenance in the past when left gravel. The portion of the trench outside of the travel way was left gravel and shall be monitored and repaired as necessary.
- The driveway apron for the rear garage at Copp Motors appeared to be breaking away at the seam from the roadway due to trench excavation. Pavement shall be removed and replaced.
- Crew cleaned worksite and traffic returned to normal by 4:00 PM.

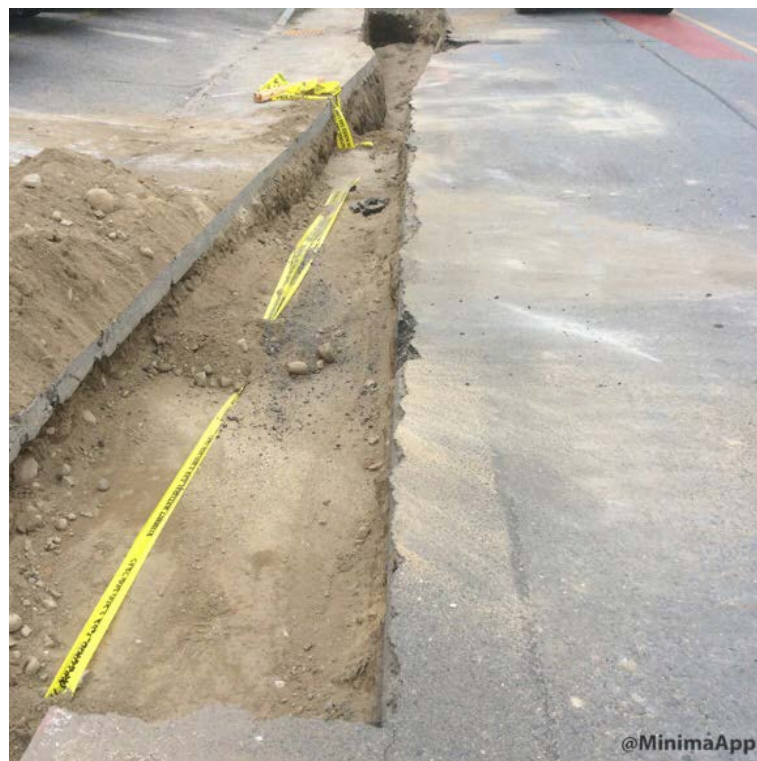
Backfill compacted and warning tape placed

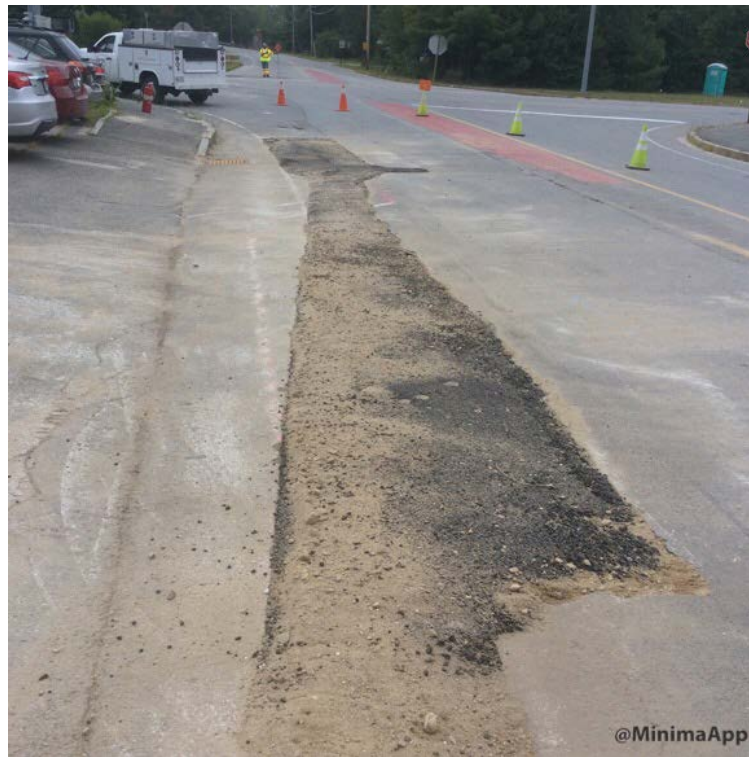
Cold patch in roadway portion of trench
