FIELD OBSERVATION REPORT

Project: Gas Main – Cumberland-Falmouth-Yarmouth
Client: Towns of Cumberland, Falmouth and Yarmouth
GP Field Rep: Benjamin Grondin (BG)
Weather: Sunny
Temp. Range: 70-80°F
Time onsite: Multiple visits

GP Project No: 1636.87
Visit Date: August 16, 2017
Report Date: August 17, 2017

Summit Natural Gas

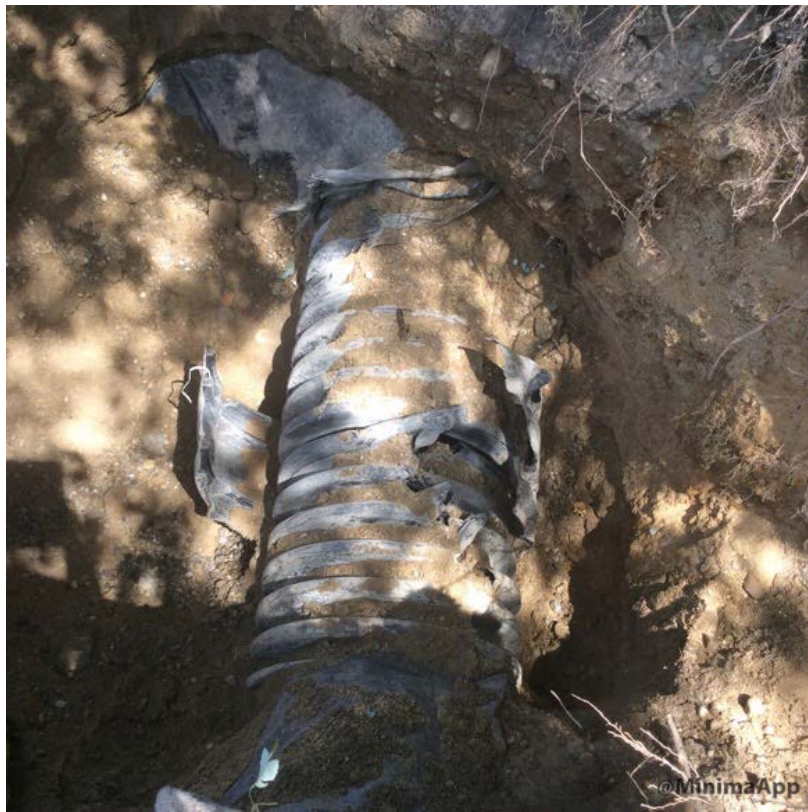
- Crew planned to continue the run line for the gas main in the east bound shoulder beyond Kathy Lane. Due to a narrowing Right-Of-Way across from Tammy Lane, the run line was adjusted to cross Skillin Road to the west bound shoulder at the western side of Tammy Lane. During excavation it was found that the 24" Stormdrain in the east bound shoulder was inside of the curb line instead of outside of the curb line. Jeff indicated to BG the run line will be adjusted again to cross Skillin Road near the eastern side of Kathy Lane to move away from existing utilities.
- During excavation behind the catch basin on the eastern side of Kathy Lane, the crew damaged a 24" Stormdrain. Damage was limited to the top of the Stormdrain. Crew repaired the Stormdrain with a

Damaged 24" stormdrain.

collar as the location was at the joining of two pipes. Crew used spray foam around the edges of the collar to fill any voids. Crushed stone was placed around the Stormdrain with fabric over the stone.

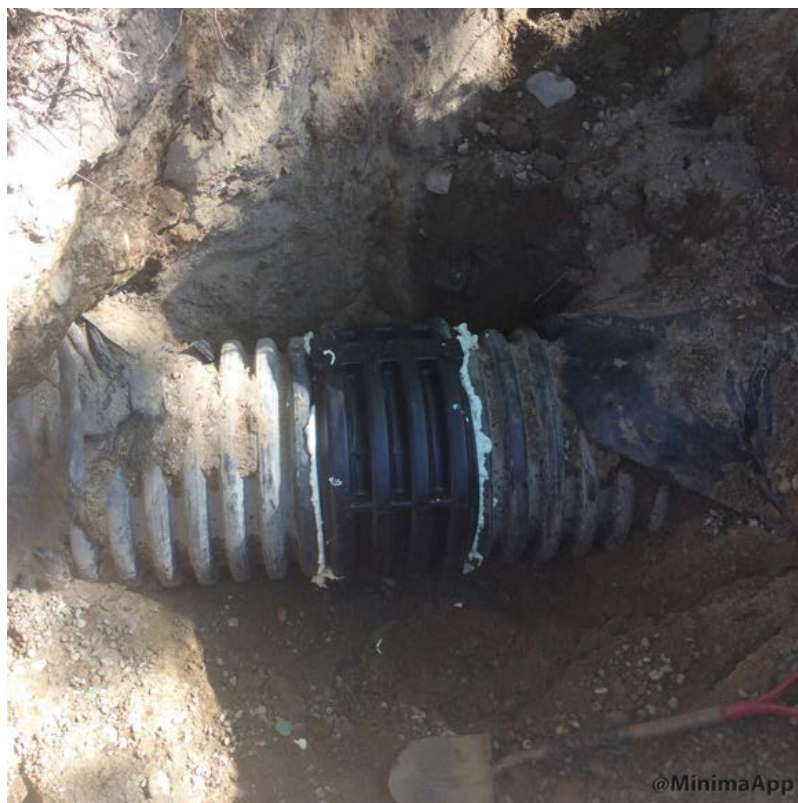
Stormdrain repaired with collar

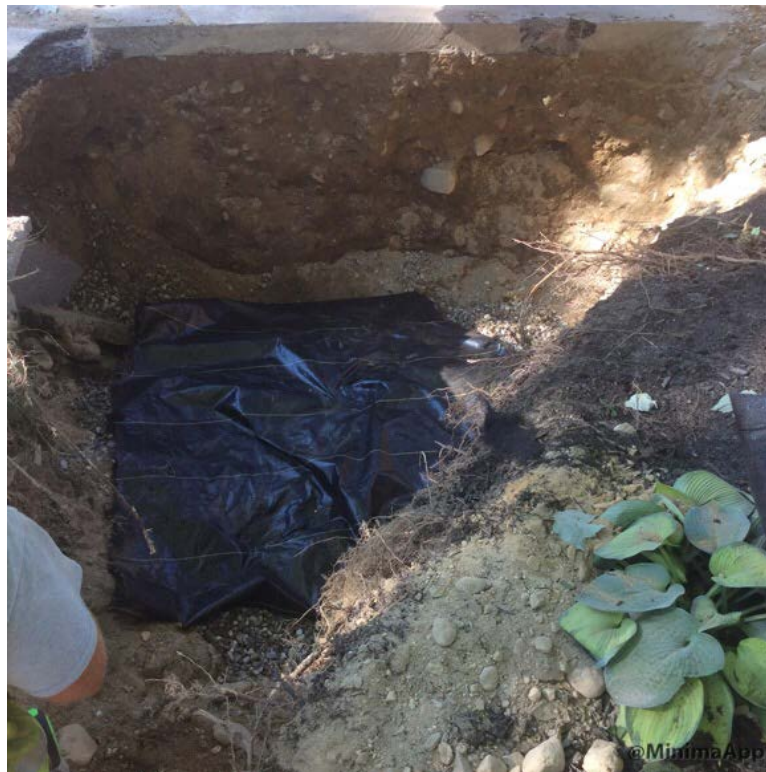
Fabric placed over crushed stone

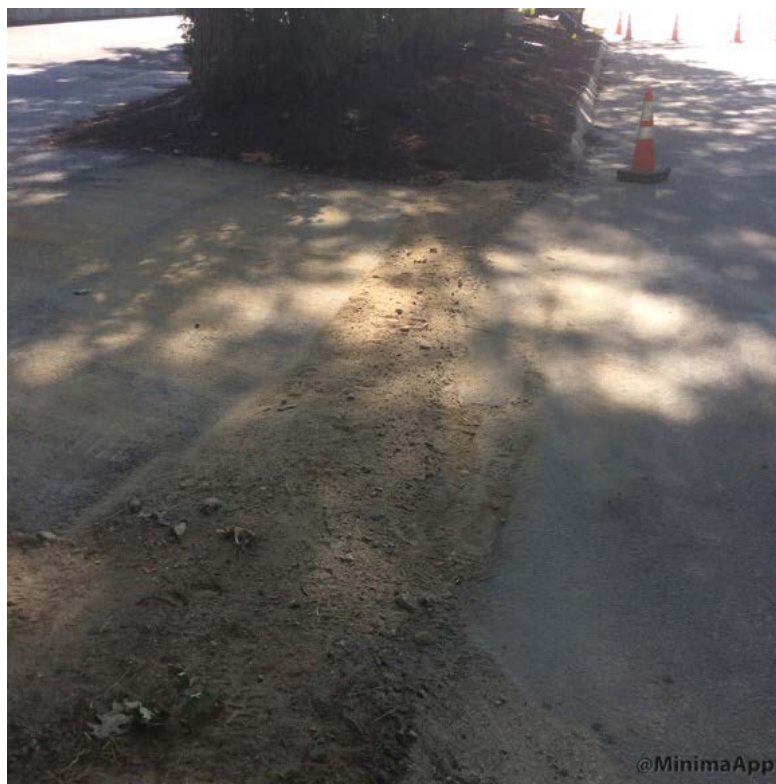
- Crew backfilled trench with sand around the gas main and service, with excavated material above the sand. Backfill was compacted in lifts with a plate wacker.

Backfill compacted at #5 driveway crossing
