# FIELD OBSERVATION REPORT

Project: Gas Main – Cumberland-Falmouth-Yarmouth Client: Towns of Cumberland, Falmouth and Yarmouth GP Field Rep: Benjamin Grondin (BG). Weather: Sunny Temp. Range: 70-80°F Time onsite: Multiple visits GP Project No: 1636.87 Visit Date: August 17, 2017 Report Date: August 18, 2017

#### Summit Natural Gas

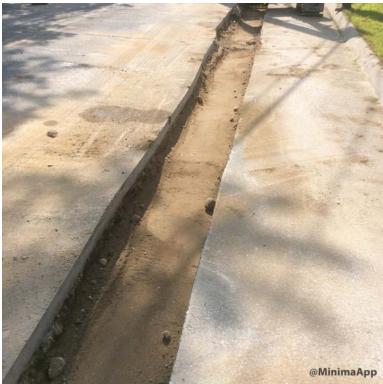
Backfill compacted in gas main trench

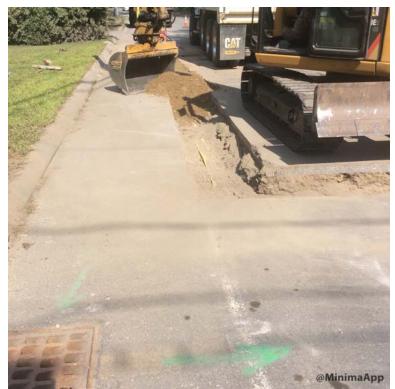
Crew placing backfill in roadway trench

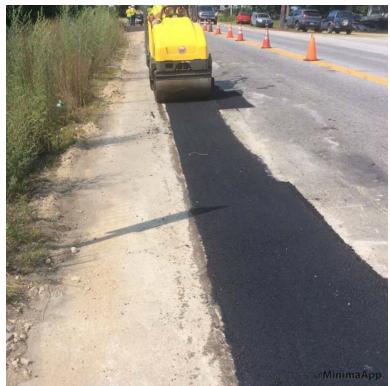
Compacting 12.5mm HMA with 3 ton roller

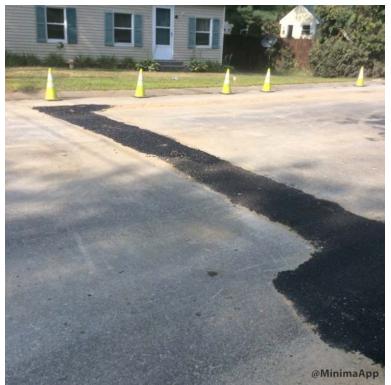
Cold patch in roadway crossing trench
