FIELD OBSERVATION REPORT

Project: Gas Main – Cumberland-Falmouth-Yarmouth
Client: Towns of Cumberland, Falmouth and Yarmouth
GP Field Rep: Benjamin Grondin (BG)
Weather: Cloudy
Temp. Range: 70-80°F
Time onsite: Multiple visits

GP Project No: 1636.87
Visit Date: August 2, 2017
Report Date: August 3, 2017

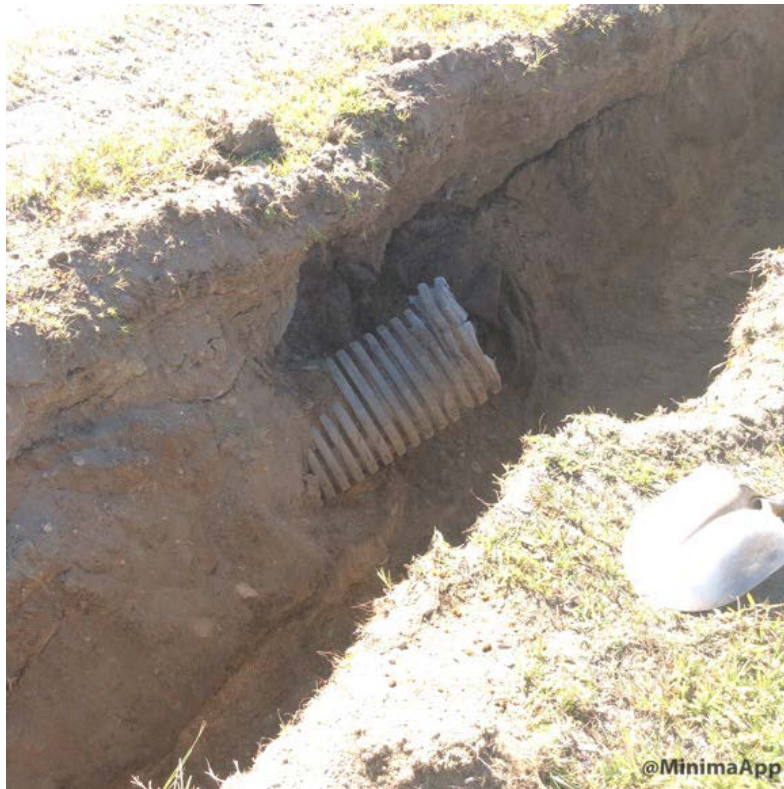
- Crew damaged an unmarked stormdrain in the esplanade near the Bru-Thru Coffee Shack on Route 100.
- The stormdrain in the esplanade near the Bru-Thru Coffee Shack on Route 100 appeared to be abandoned since stormdrain was plugged with brick and mortar. Crew sawcut the stormdrain back to remove the damage portion. Crew then repaired the plug with spray-foam and tape.
- Crew backfilled trench with sand around the gas main and existing material. Backfill was compacted in lifts with a plate wacker.
- Crew placed cold patch in the gravel trench in Skillin Road as the gravel trench has require frequent maintenance.
- Crew placed loam, seed, and hay mulch on the disturbed vegetated area in the esplanade on Route 100.
- Crew clean worksite and traffic returned to normal at approximately 3:30 PM.

Damaged abandoned storm drain

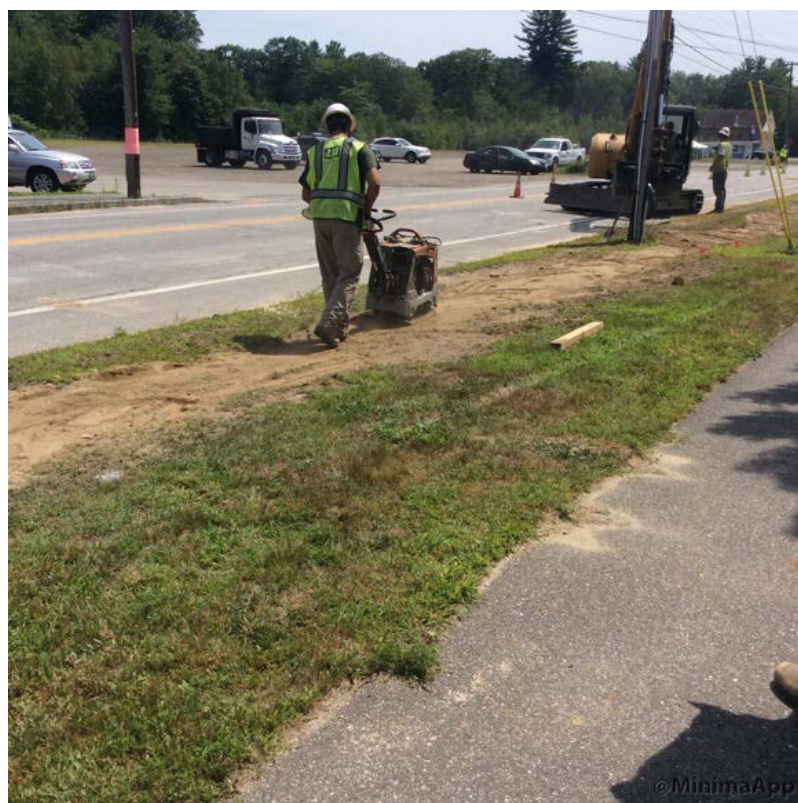
Compacting backfill with plate wacker

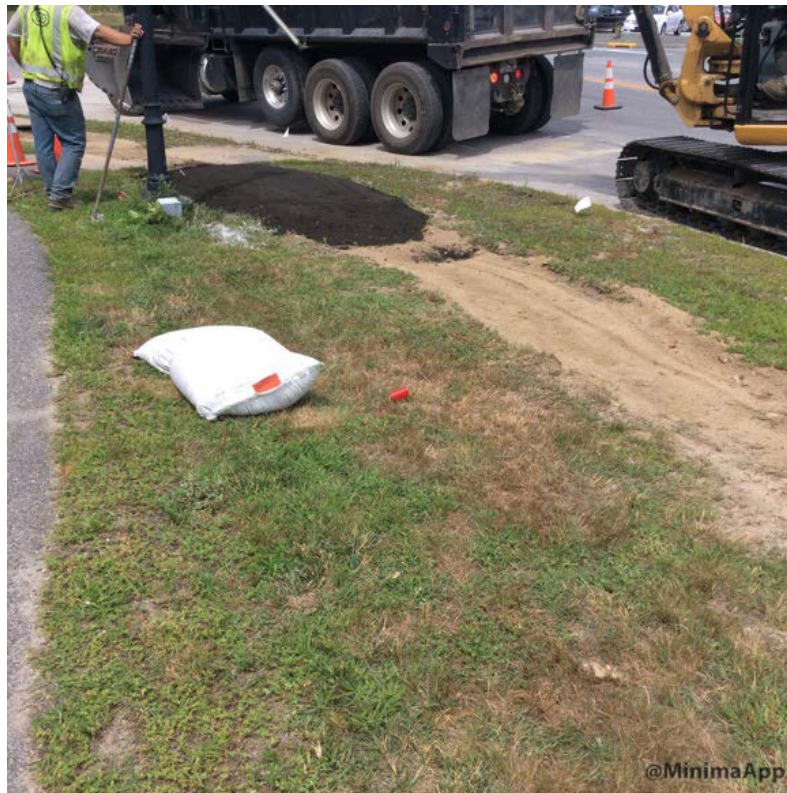
Placing loam in esplanade
