FIELD OBSERVATION REPORT

Project: Gas Main – Cumberland-Falmouth-Yarmouth
Client: Towns of Cumberland, Falmouth and Yarmouth
GP Field Rep: Benjamin Grondin (BG)
Weather: Sunny
Temp. Range: 70-80°F
Time onsite: Multiple visits

GP Project No: 1636.87
Visit Date: August 3, 2017
Report Date: August 4, 2017

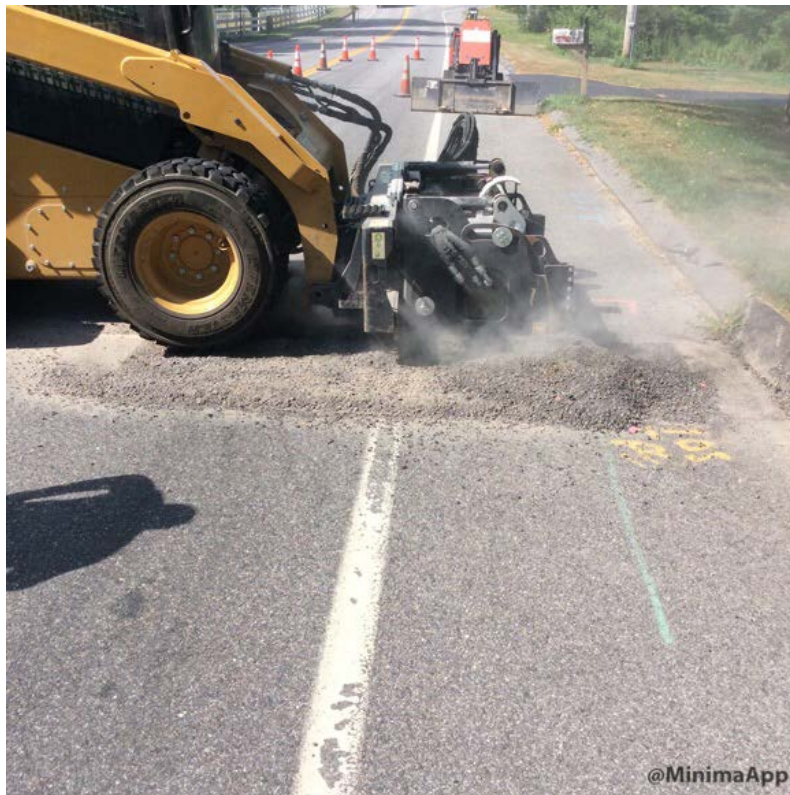
- Work Zone Closure: 1 lane closed on roads with flaggers maintaining alternating one way traffic.
- Crew milled trenches on Route 88 and Casco Bay Drive to approximately 1" depth.

- Trench edges that were rounded from the mill machine were sawcut to provide a staigt square edge.
- Ambient air temperature at start of paving was approximately 82°F.

Milling trench patch on Route 88

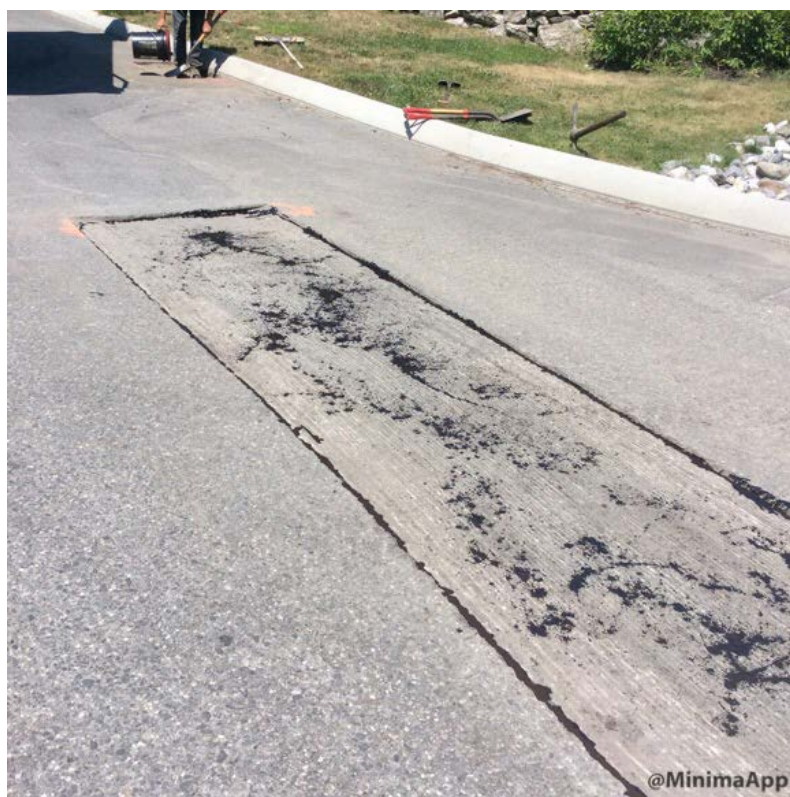
- Crew cleaned and tacked the milled areas prior to placing 9.5mm HMA.
- Crew hand placed 9.5mm HMA in the milled areas.
- 9.5mm HMA was measured to be 301°F which conforms to the MaineDOT standard specifications.

Milled area cleaned and tacked on Casco Bay Drive
