## FIELD OBSERVATION REPORT

Project: Gas Main – Cumberland-Falmouth-Yarmouth  
Client: Towns of Cumberland, Falmouth and Yarmouth  
GP Field Rep: Benjamin Grondin (BG)  
Weather: Sunny  
Temp. Range: 70-80°F  
Time onsite: Multiple visits

GP Project No: 1636.87  
Visit Date: August 7, 2017  
Report Date: August 8, 2017

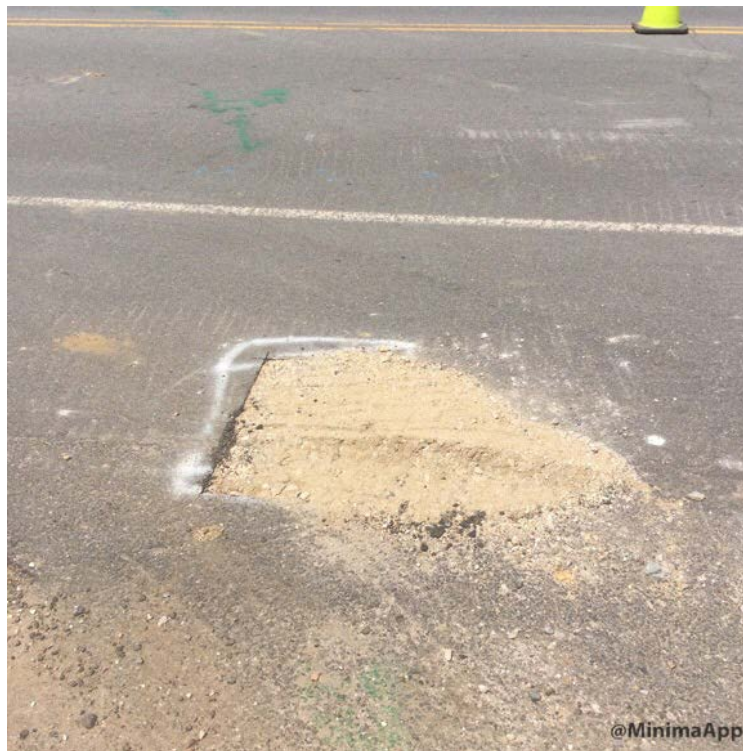
Pothole at seam of Blackstrap Road and West Cumberland Fire Station driveway

- Crew backfilled trench with sand around the gas main and existing material. Backfill was compacted in lifts with a jumping jack.
- Cold patch was not placed in the trench at the westerly driveway crossing for the West Cumberland Fire Station due to the size and location of the trench. The gravel trench shall be monitored and repaired as necessary.
- Crew clean worksite and traffic returned to normal at approximately 4:00 PM.
- Crew had previously potholed to locate the depth of a water service when installing main via directional drill method. The pothole is on the seam of the westerly driveway entrance to the West Cumberland Fire Station and Blackstrap Road. Blackstrap Road is under moratorium. GP shall review the pothole with the Town of Cumberland to determine the restoration required.

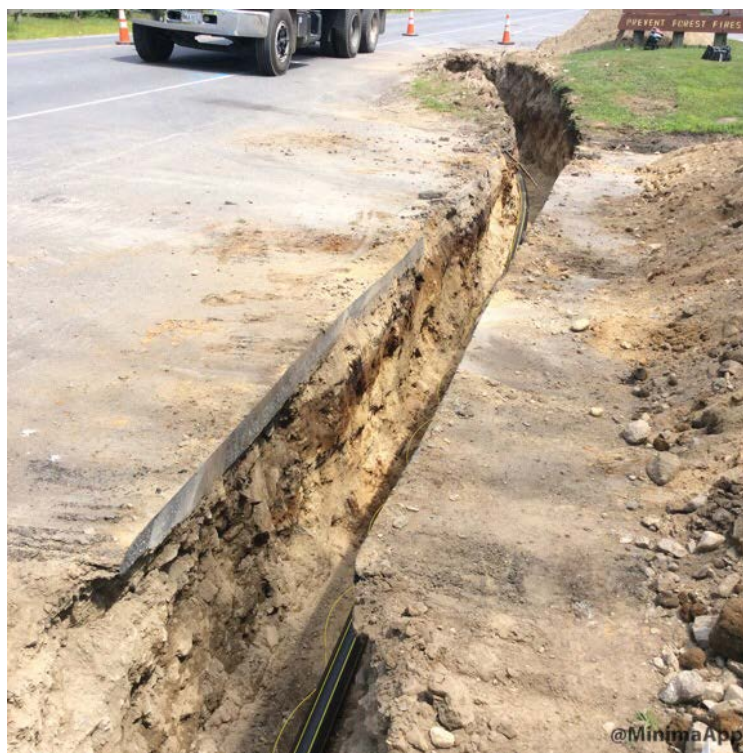
Trench across the westerly driveway to the West Cumberland Fire Station

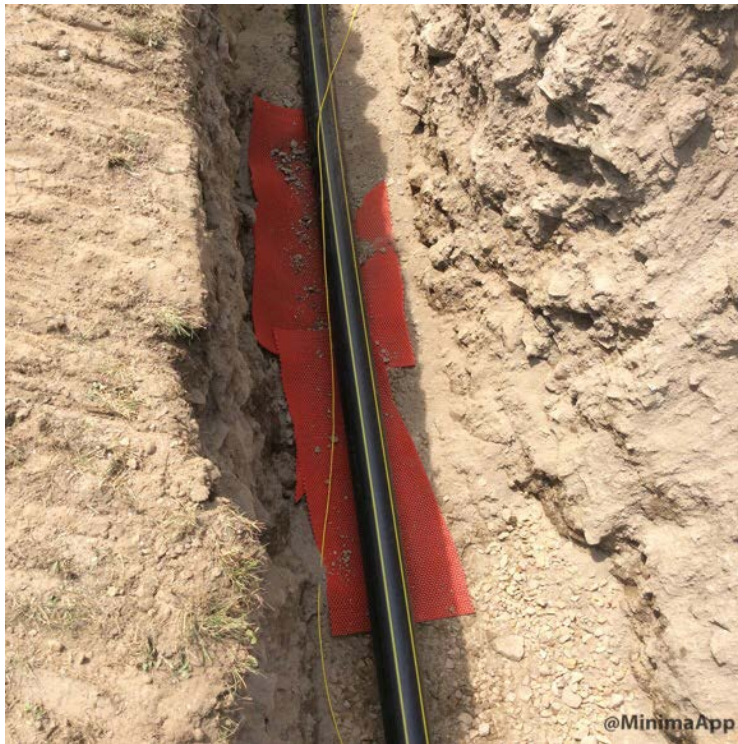
- Crew hand excavated 1' below the gas main and did not locate the water service therefore >1' separation was achieved.
- Crew indicated they were unable to achieve >1' of separation at the stormdrain crossings due to the depth of the previously installed gas main. Deflection to acquire the separation would put the depth of the gas main at a greater depth than the previously installed gas main at the connection. A rock shield was placed between the gas main and stormdrain crossings.

Rock shield placed at stormdrain crossing

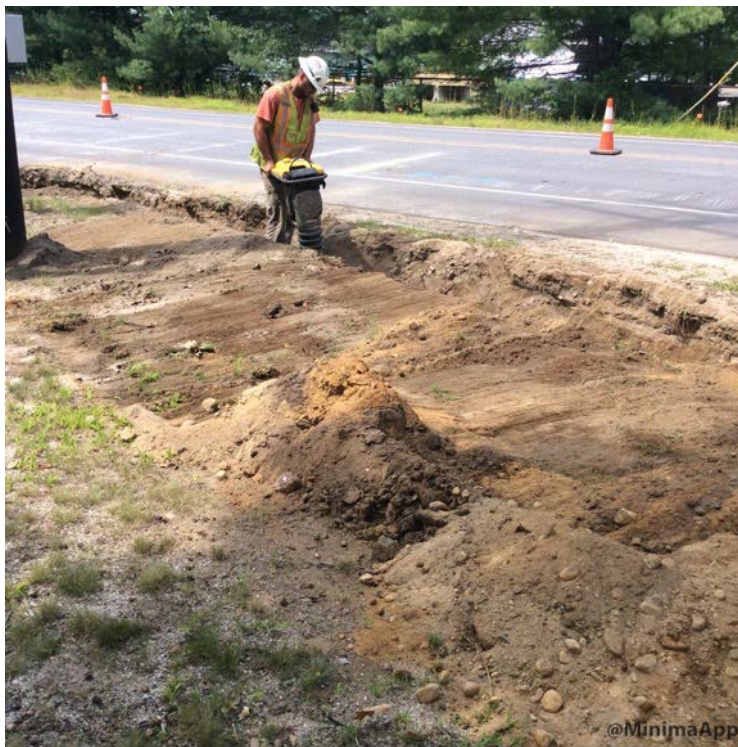
Compacting backfill with jumping jack
