GP Project No: 1636.87

Visit Date: August 9, 2017

FIELD OBSERVATION REPORT

Project: Gas Main – Cumberland-Falmouth-Yarmouth Client: Towns of Cumberland, Falmouth and Yarmouth

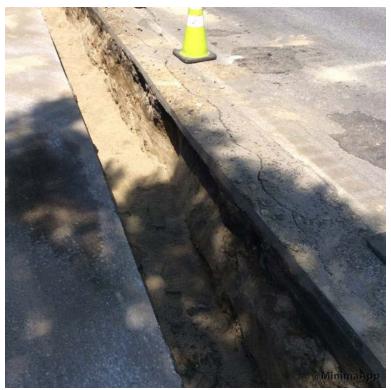
Undermining at driveway crossing trench
