FIELD OBSERVATION REPORT

Project: Gas Main – Cumberland-Falmouth-Yarmouth
Client: Towns of Cumberland, Falmouth and Yarmouth
GP Field Rep: Benjamin Grondin (BG)
Weather: Cloudy
Temp. Range: 63-75°F
Time onsite: Multiple visits

GP Project No: 1636.87
Visit Date: September 5, 2017
Report Date: September 6, 2017

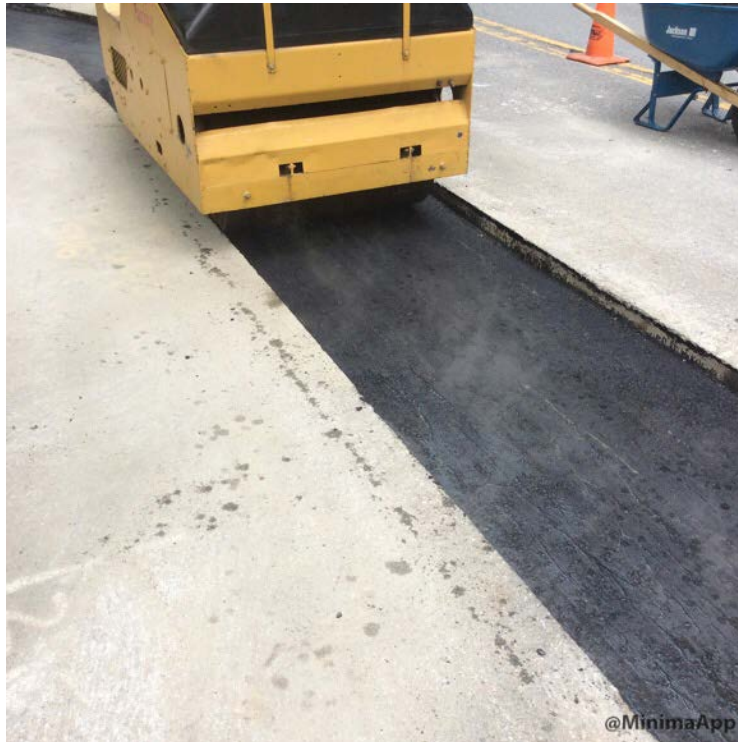
Compacting the first lift of 12.5mm HMA with 3 ton vibratory roller.

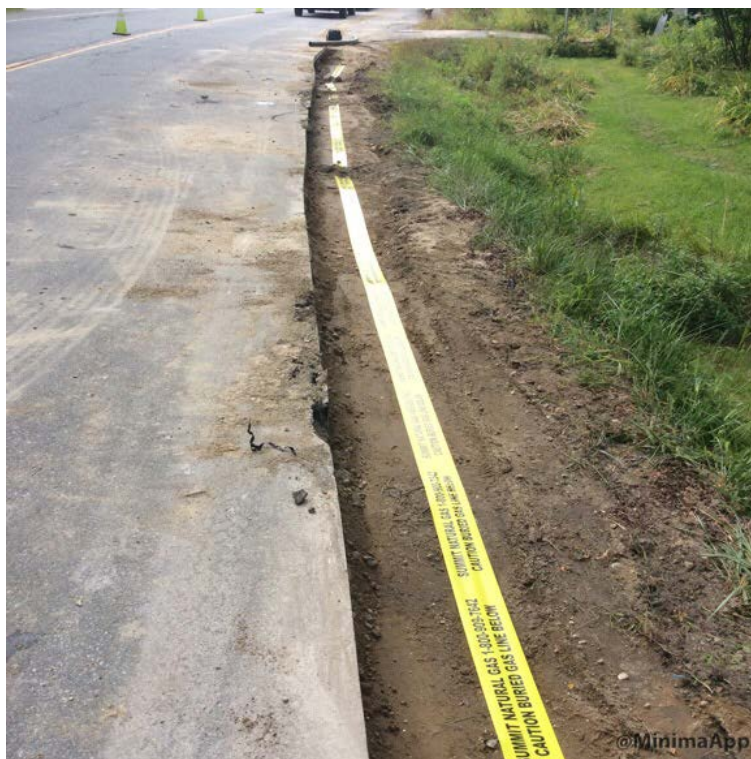
Backfill compacted and warning tape placed in gas main trench.

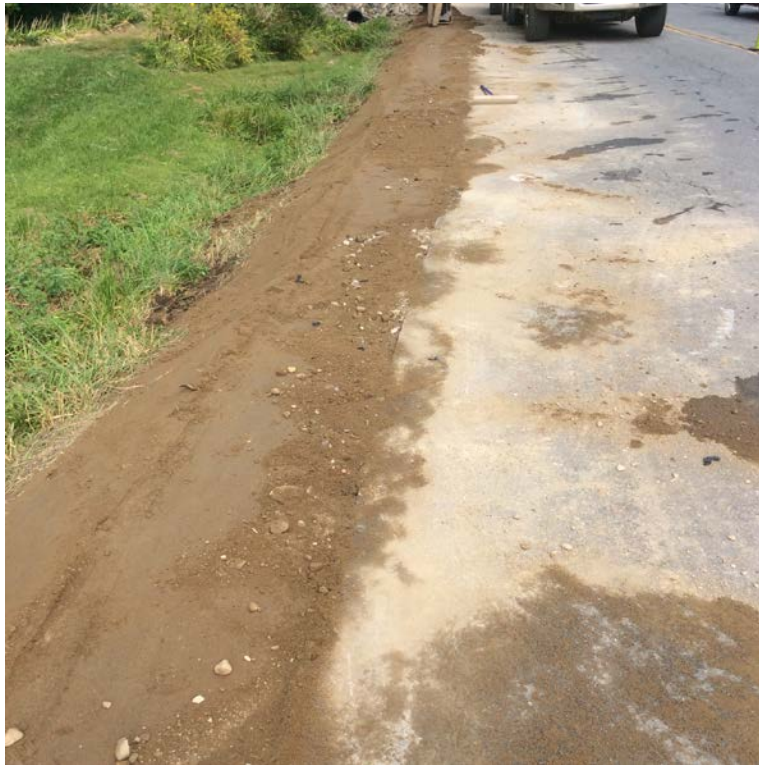
Final lift of backfill compacted.
