# FIELD OBSERVATION REPORT

Project: Gas Main – Cumberland-Falmouth-Yarmouth Client: Towns of Cumberland, Falmouth and Yarmouth GP Field Rep: Drew Gagnon (DG), David Vitali (DV) Weather: Sunny Temp. Range:70-80°F Time onsite: Multiple visits GP Project No: 1636.87 Visit Date: July 7, 2017 Report Date: July 7, 2017

> Installing 4" gas main in southbound shoulder on Route 100 north of Castlerock Drive.

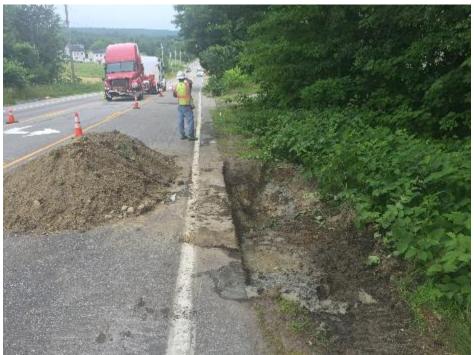
Trench excavated off roadway of Route 100

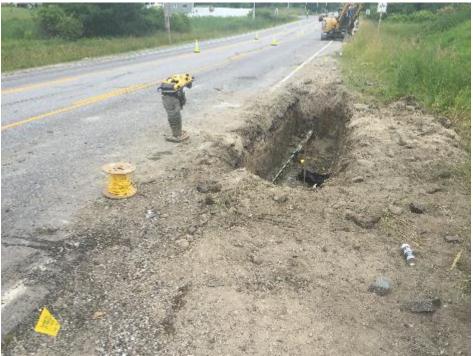
Trench and compactor awaiting backfill off Route 100
