FIELD OBSERVATION REPORT

Project: Gas Main – Cumberland-Falmouth-Yarmouth Client: Towns of Cumberland, Falmouth and Yarmouth GP Field Rep: Benjamin Grondin (BG). Weather: Sunny Temp. Range: 55-70°F Time onsite: Multiple visits GP Project No: 1636.87 Visit Date: October 10, 2017 Report Date: October 11, 2017

Work in Progress – Town of Cumberland

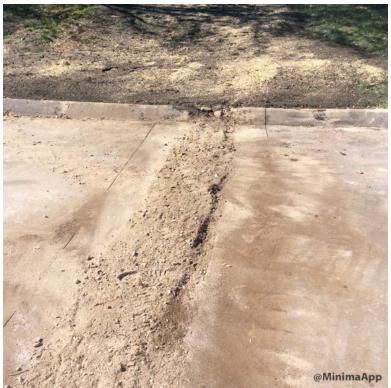
Backfill compacted and 1' cutbacks.

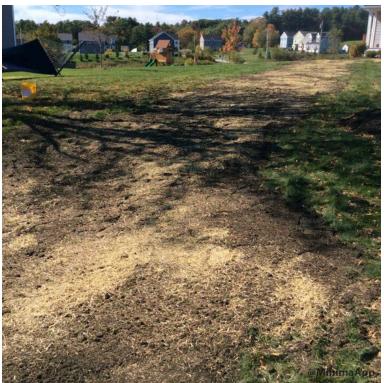
Loam, seed, and mulch placed in the disturbed vegetated area.
