## FIELD OBSERVATION REPORT

Project: Gas Main – Cumberland-Falmouth-Yarmouth  
Client: Towns of Cumberland, Falmouth and Yarmouth  
GP Field Rep: Benjamin Grondin (BG)  
Weather: Sunny  
Temp. Range: 55-70°F  
Time onsite: Multiple visits

GP Project No: 1636.87  
Visit Date: October 11, 2017  
Report Date: October 12, 2017

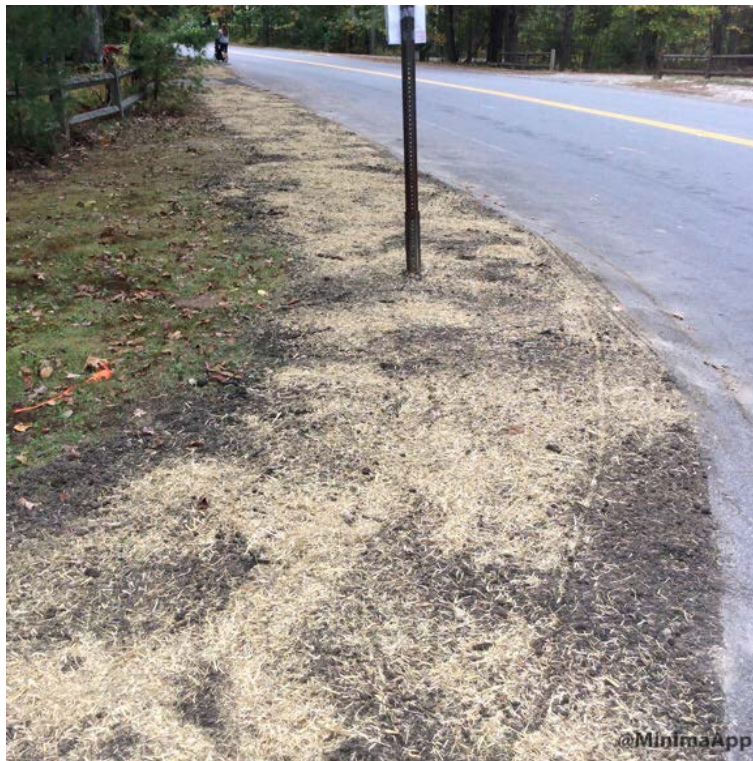
Loam, seed, and mulch placed at intersection of Skillin and Blanchard.

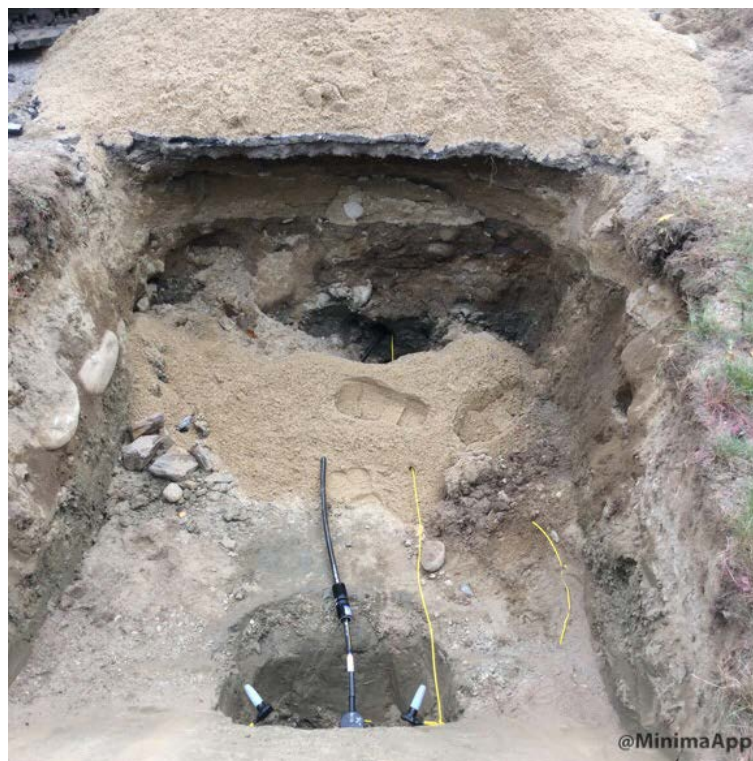
Undermining of Meadow Lane for gas service

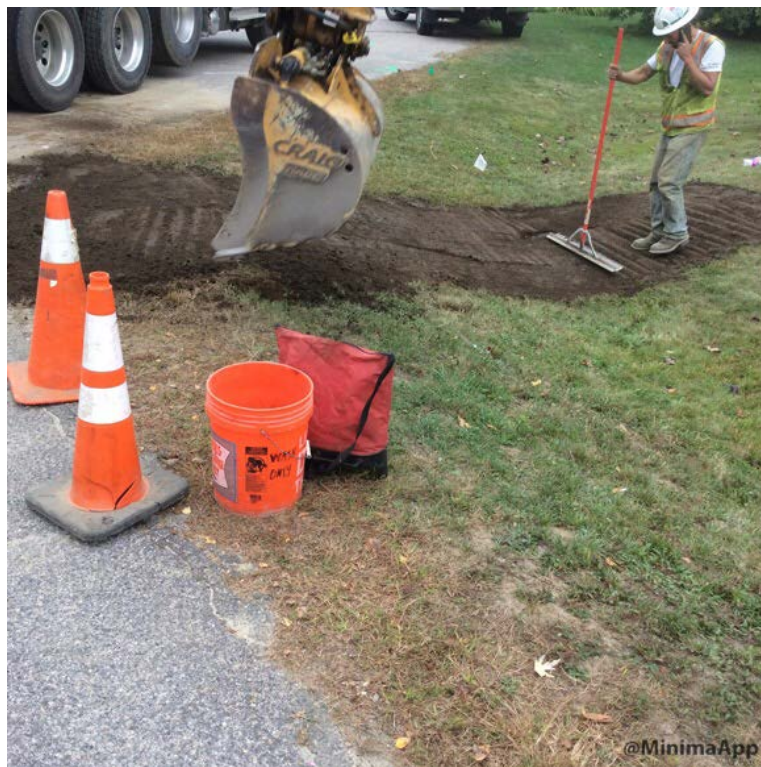
Placing loam in disturbed vegetated area on Meadow Lane
