GP Project No: 1636.87

Visit Date: October 16, 2017

FIELD OBSERVATION REPORT

Project: Gas Main – Cumberland-Falmouth-Yarmouth Client: Towns of Cumberland, Falmouth and Yarmouth

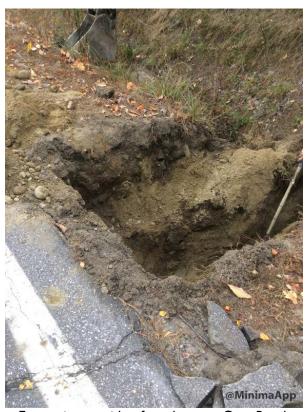
Excavating outside of roadway on Gray Road.

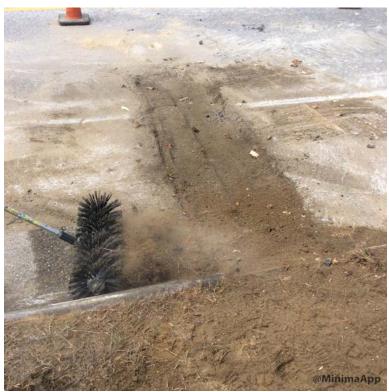
Compacted backfill in shoulder trench on Main Street.

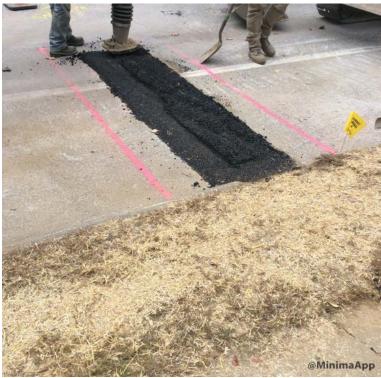
Compacting cold patch in roadway shoulder on Main Street

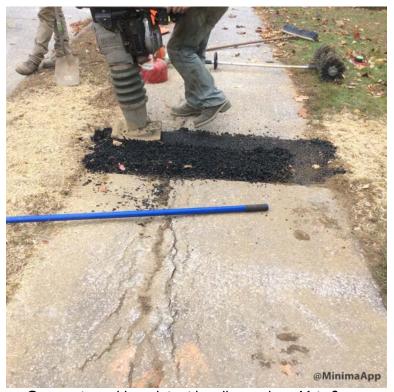
Compacting cold patch in sidewalk trench on Main Street
