## FIELD OBSERVATION REPORT

Project: Gas Main – Cumberland-Falmouth-Yarmouth  
Client: Towns of Cumberland, Falmouth and Yarmouth  
GP Field Rep: Benjamin Grondin (BG)  
Weather: Sunny  
Temp. Range: 55-70°F  
Time onsite: Multiple visits

GP Project No: 1636.87  
Visit Date: October 17, 2017  
Report Date: October 18, 2017

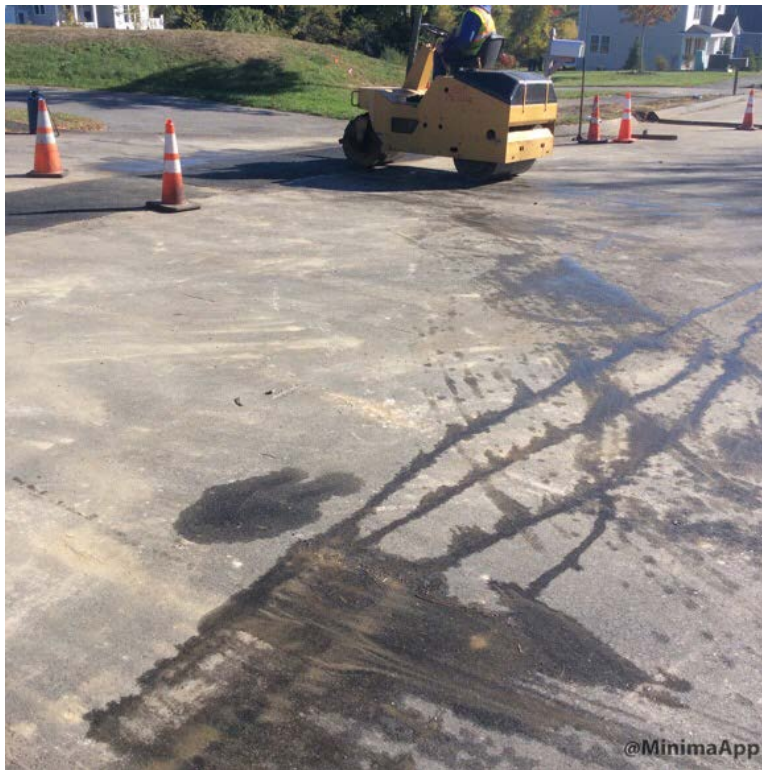
- All loads of 12.5mm HMA conformed the the MaineDOT Standard Specification temperature range.
- 12.5 HMA was placed in lifts with each lift being compacted with a plate wacker and 3-ton vibratory roller on roadway crossings.

Compacting final lift of roadway crossing trench with 3 ton roller.

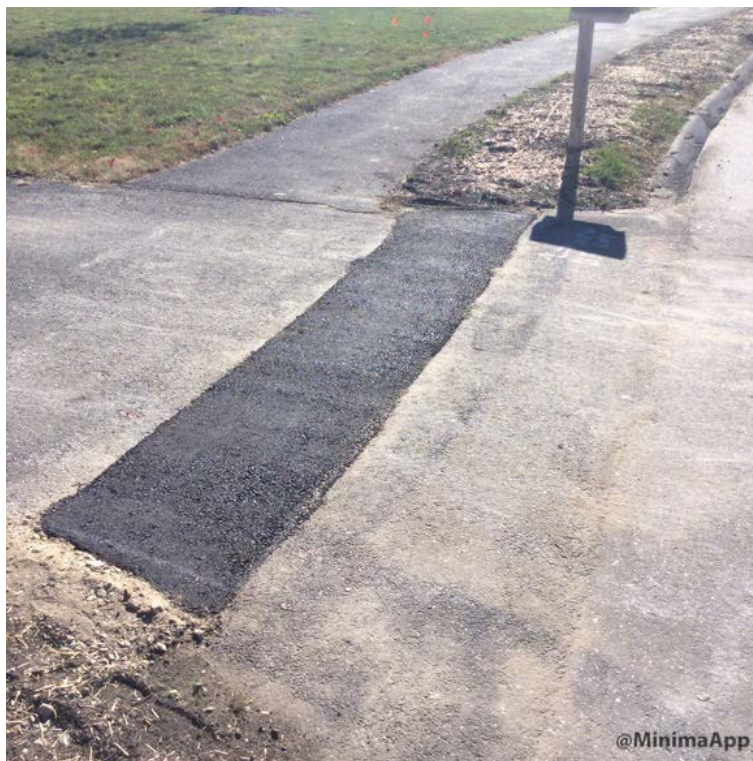
- On driveway crossings the first two lifts was compacted with a plate wacker only. The final lift was compacted with a plate wacker and 3 ton vibratory roller.

Completed driveway crossing trench.

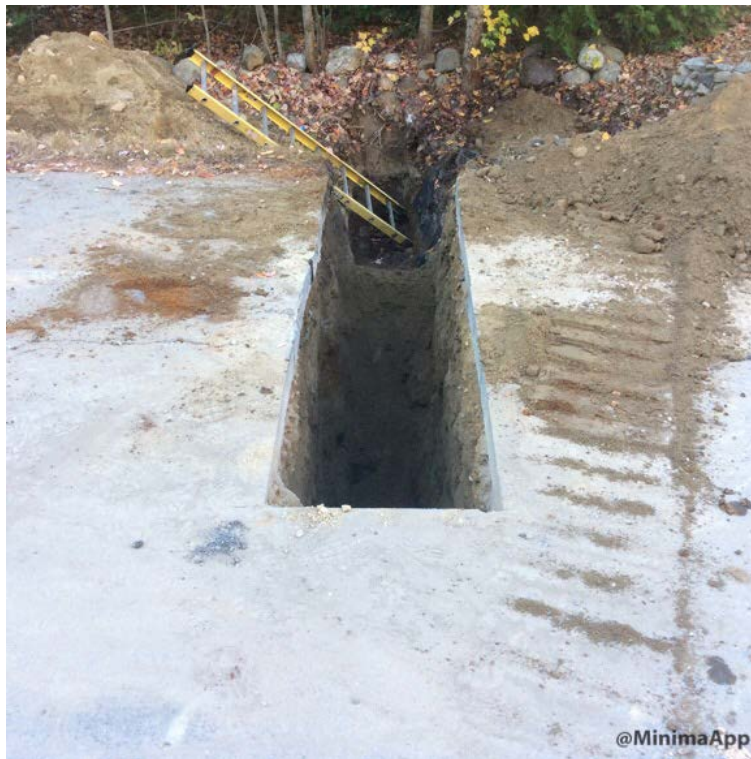
- Automatic punch was not located at the exit pit in the vegetated area off the westbound lane shoulder.
- Crew sawcut and excavated in the westbound lane. Automatic punch was located at approximately 7' depth. Crew removed punch and air tube from the trench.
- Matt indicated they would not be installing pipe and would return to the site tomorrow to install pipe via open trench method.
- Crew backfilled trench with excavated material and gravel. Backfill was compacted in lifts with a jumping jack.
- Cold patch was not used as crew is returning to the site tomorrow (10/18).

Trench open on westbound lane to locate automatic punch.

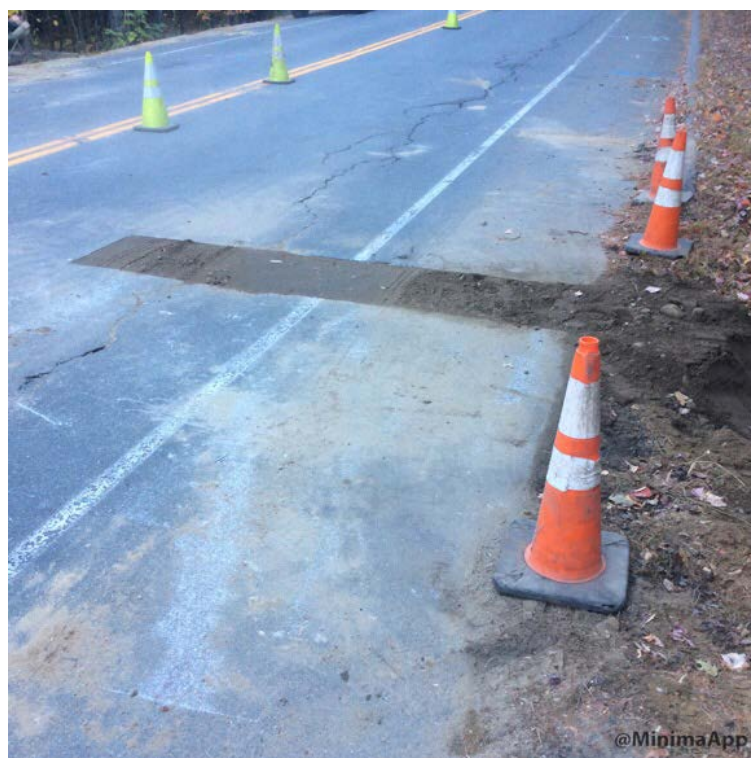
Westbound lane trench backfilled and compacted.
