## FIELD OBSERVATION REPORT

Project: Gas Main – Cumberland-Falmouth-Yarmouth  
Client: Towns of Cumberland, Falmouth and Yarmouth  
GP Field Rep: Benjamin Grondin (BG)  
Weather: Sunny  
Temp. Range: 50-65°F  
Time onsite: Multiple visits

GP Project No: 1636.87  
Visit Date: October 2, 2017  
Report Date: October 3, 2017

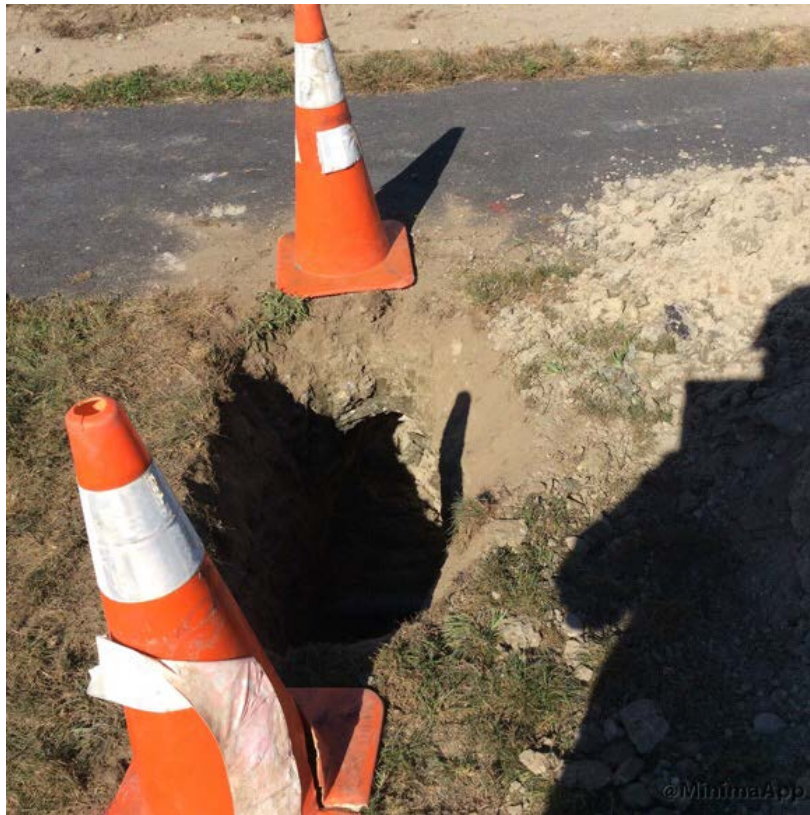
Excavated area near sidewalk.

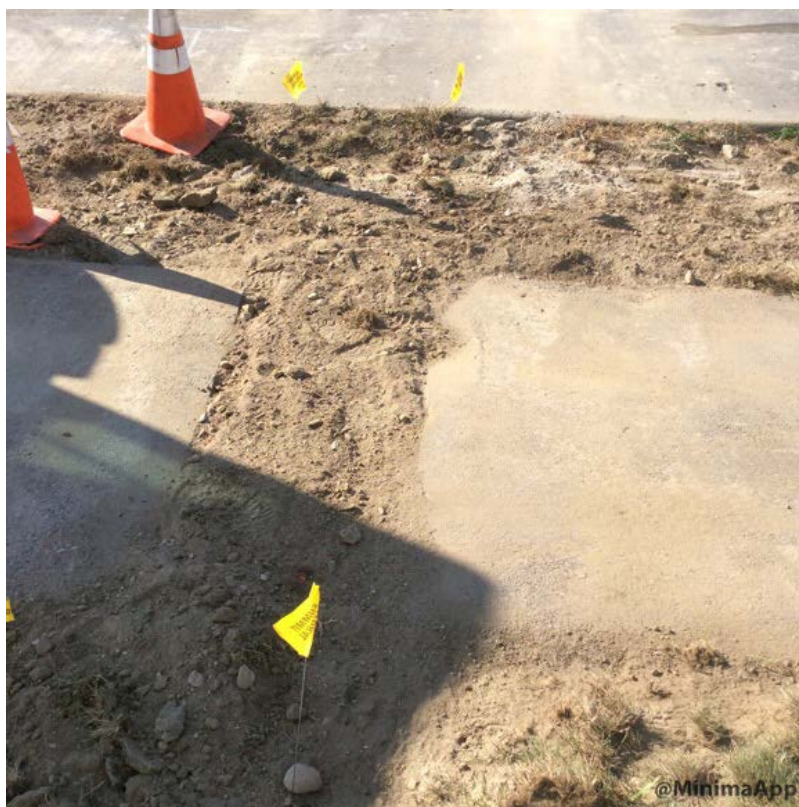
Sidewalk crossing trench backfilled.
