FIELD OBSERVATION REPORT

Project: Gas Main – Cumberland-Falmouth-Yarmouth
Client: Towns of Cumberland, Falmouth and Yarmouth
GP Field Rep: Benjamin Grondin (BG)
Weather: Sunny
Temp. Range: 55-70°F
Time onsite: Multiple visits

GP Project No: 1636.87
Visit Date: October 20, 2017
Report Date: October 23, 2017

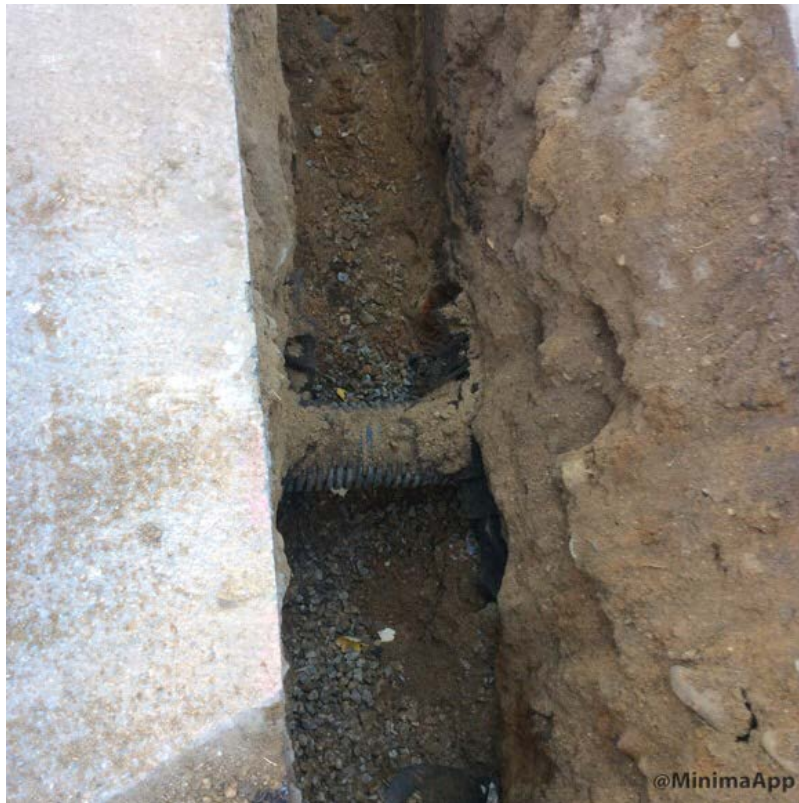
Utility	Depth
16" water main	48"+
6" underdrain	33"

Underdrain in trench on Skillin road.

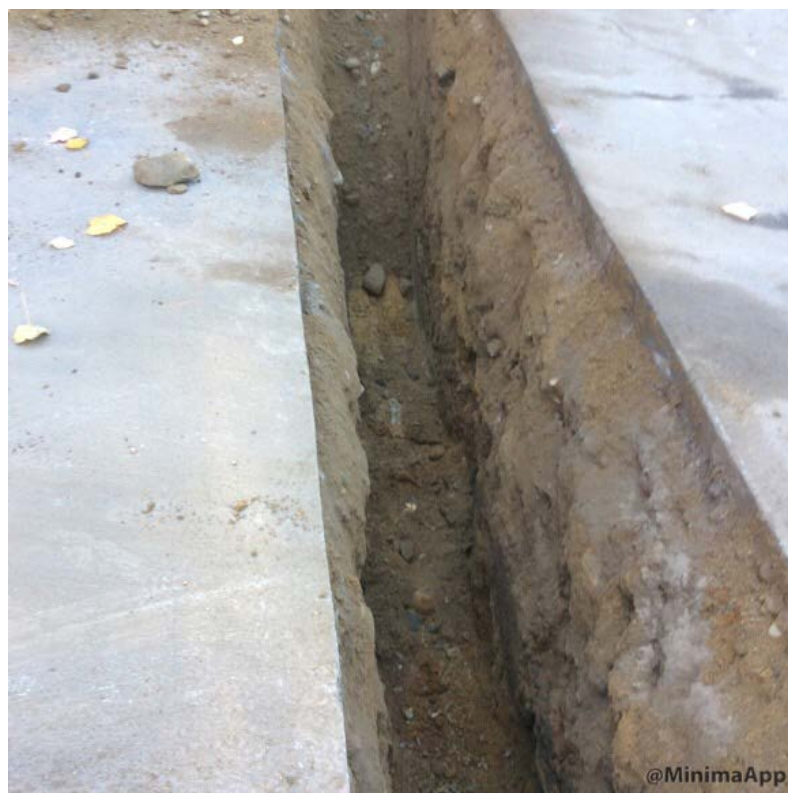
- Work Zone Closure: Skillin Road reduced to one lane with flaggers maintaining alternating one way traffic.
- Crew sawcut and removed pavement for 1/2" gas service install via open trench method. Service was installed at approximately 36" depth.
- All utilities located via manhole inverts, camera, electronic locator, or hand excavated.
- Depth of utilities is to top of pipe unless noted in the table below:

Roadway crossing trench for 88 Skillin

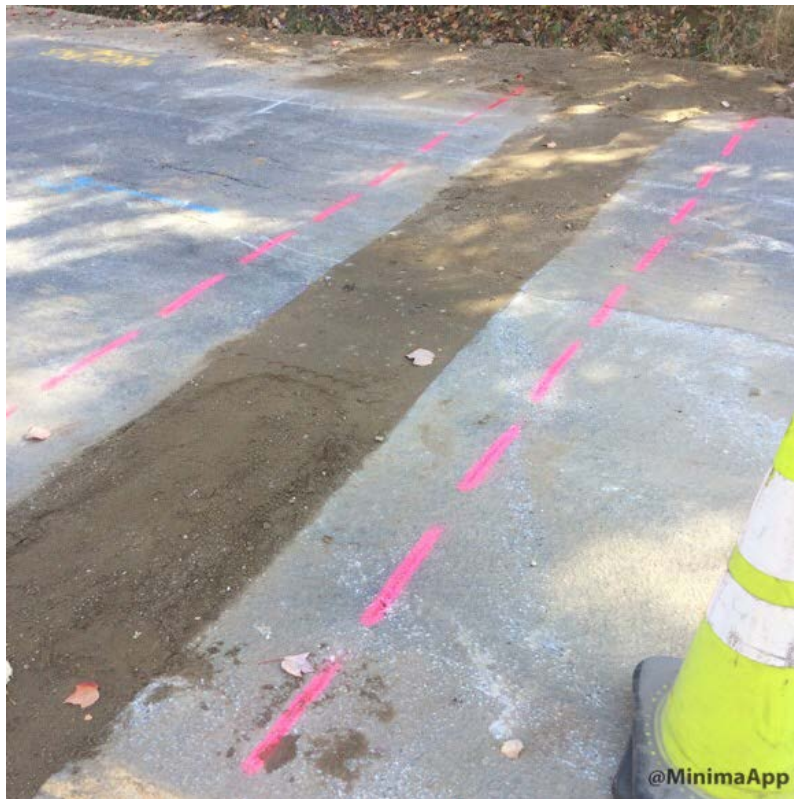
- Crew hand excavated 1' below the elevation of the gas service and did not locate the water main therefore >1' of separation would be achieved.
- Gas service is not parallel to any utilities therefore >6' of separation was achieved.
- Crew backfilled trench with excavated material and gravel. Backfill was compacted in lifts with a jumping jack.
- Cold patch was not used due to the size of the crossing trench. Gravel in trench shall be monitored and repaired as necessary.
- Crew cleaned worksite and traffic returned to normal by 12:00PM.

Trench backfilled, compacted, and marked for cutbacks.

- All gravel trenches within the roadway shall be monitored and repaired or treated for dust control as necessary.
- Ditch side slopes on Skillin Road require soft restoration as they were vegetated prior to gas main install.
- Notify GP when moratorium restoration at Balsam Drive will occur.
