## FIELD OBSERVATION REPORT

Project: Gas Main – Cumberland-Falmouth-Yarmouth  
Client: Towns of Cumberland, Falmouth and Yarmouth  
GP Field Rep: Benjamin Grondin (BG)  
Weather: Sunny  
Temp. Range: 55-70°F  
Time onsite: Multiple visits

GP Project No: 1636.87  
Visit Date: October 23, 2017  
Report Date: October 24, 2017

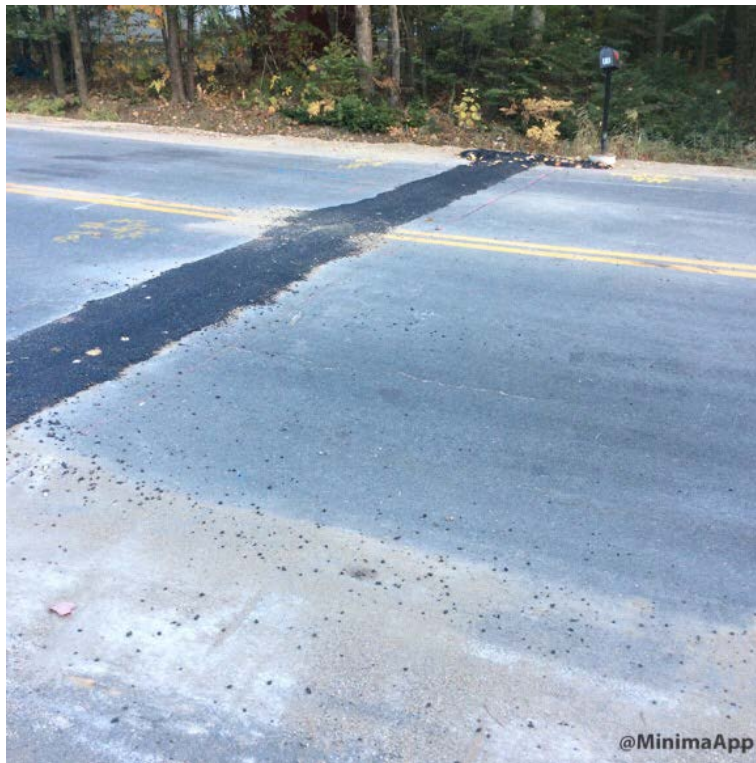
Cold patch in roadway crossing at 88 Skillin.

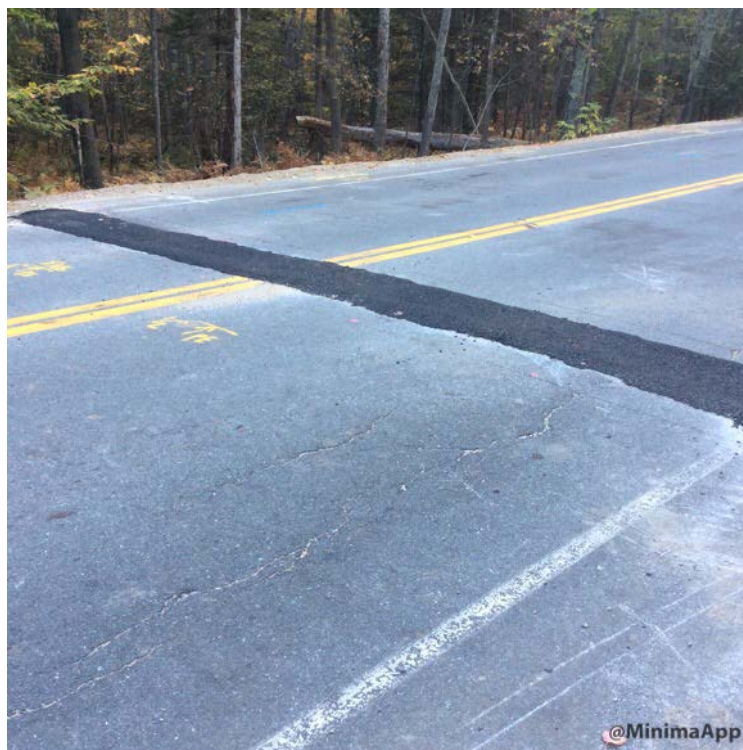
Cold patch in roadway crossing at 80 Skillin
