FIELD OBSERVATION REPORT

Project: Gas Main – Cumberland-Falmouth-Yarmouth Client: Towns of Cumberland, Falmouth and Yarmouth GP Field Rep: Benjamin Grondin (BG). Weather: overcast/rain showers Temp. Range: 50-65°F Time onsite: Multiple visits GP Project No: 1636.87 Visit Date: October 24, 2017 Report Date: October 25, 2017

Summit Natural Gas

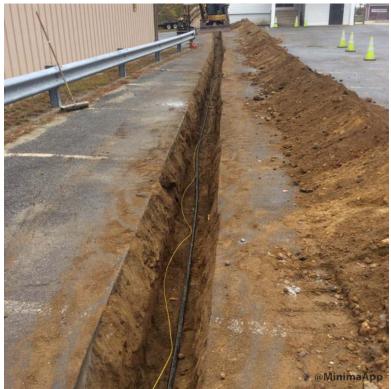
Open trench in parking area adjacent to the Fire Station.

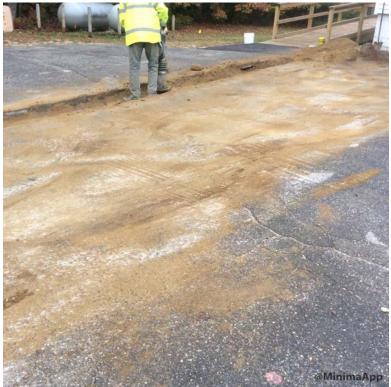
Comparing backfill with jumping jack.

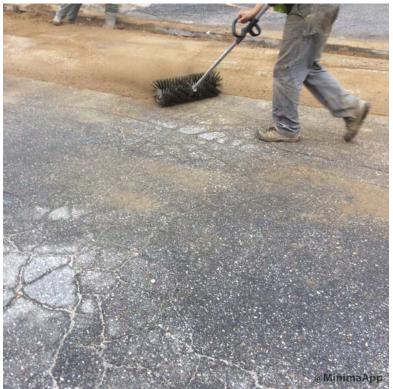
Sweeping pavement.
