FIELD OBSERVATION REPORT

Project: Gas Main – Cumberland-Falmouth-Yarmouth
Client: Towns of Cumberland, Falmouth and Yarmouth
GP Field Rep: Benjamin Grondin (BG)
Weather: Sunny
Temp. Range: 55-70°F
Time onsite: Multiple visits

GP Project No: 1636.87
Visit Date: October 3, 2017
Report Date: October 4, 2017

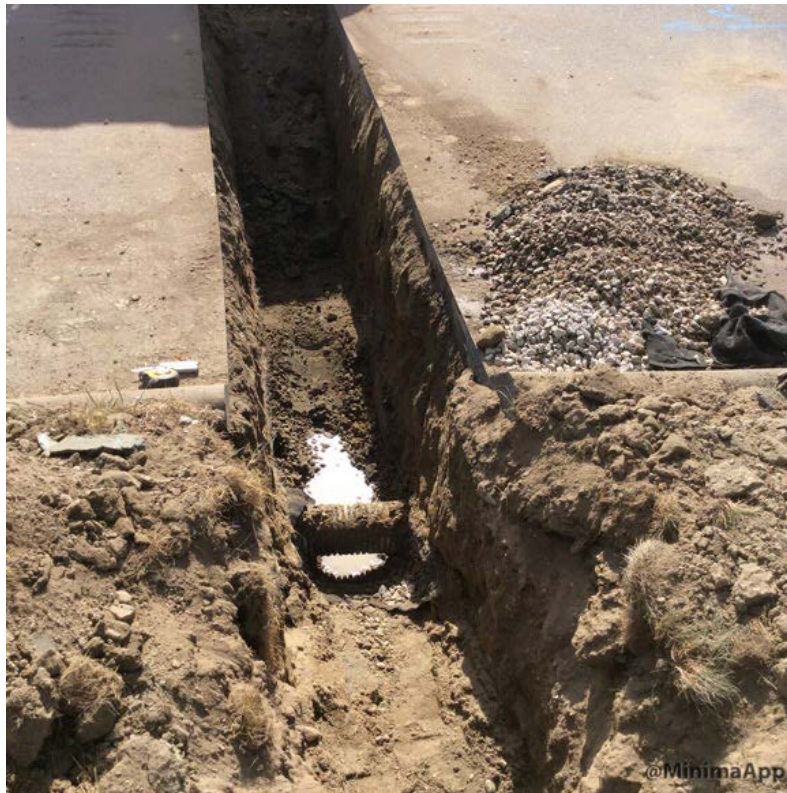
- Crew did not achieve >1' of separation at the underdrain and stormdrain crossings due to the pipe size and proximity to each other and the 2" gas main. Approximately 3" of separation was achieved at the crossings. A rock shield was placed between the 1/2" gas service and the underdrain and stormdrain.

- It appears there is fabric under the entire width of the roadway on Castlerock Drive. Fabric was removed during trench excavation. BG indicated to Jeff and Matt fabric should be replaced within the trench area.
- Crew backfilled trench with sand around the gas main, with excavated material above the sand. Backfill was compacted in lifts with a jumping jack.
- Crew cleaned worksite and traffic returned to normal by 4:30PM.

Trench on Castlerock Drive.

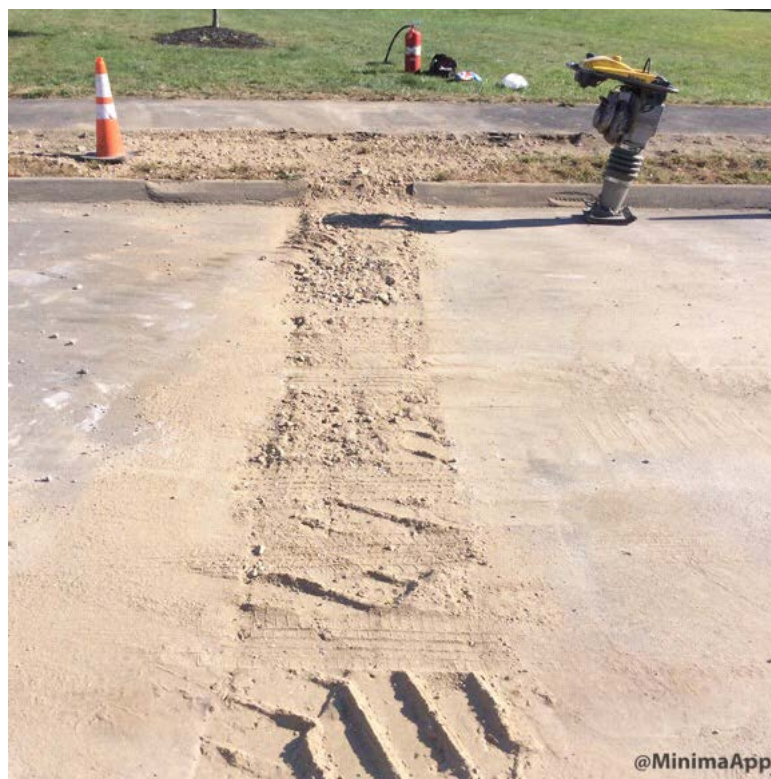
Trench backfilled and compacted on Castlerock Drive.

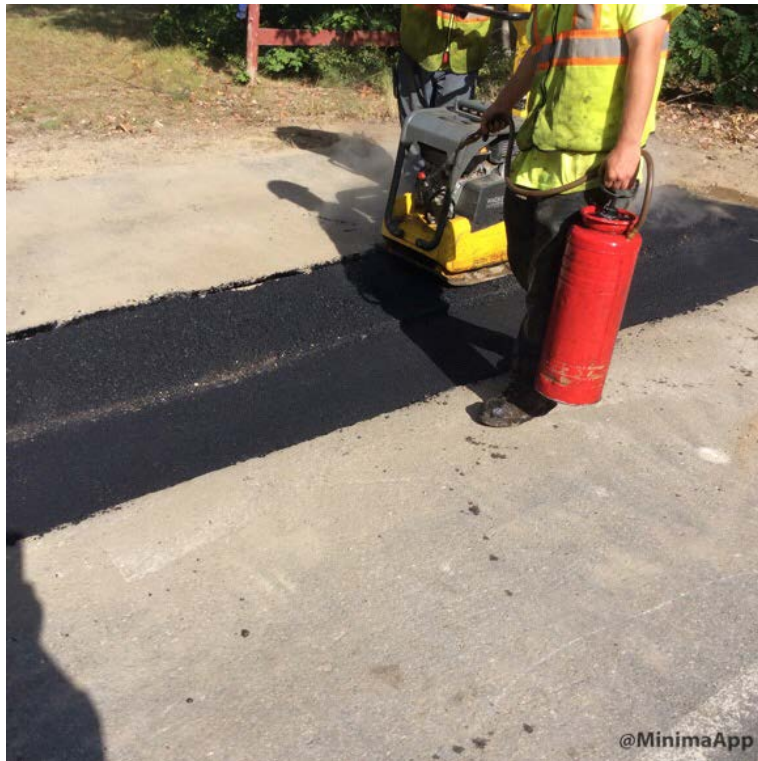
- Work Zone Closure: 1 lane closed on Skillin Road with flaggers maintaining alternating one way traffic.
- Crew removed saw cut pavement on the shoulder of Skillin Road. Gravel on the shoulder of Skillin road was compacted with a plate wacker only.
- Edges of pavement were cleaned and tacked prior to placing 12.5mm HMA.
- Ambient air temperature at start of paving was approximately 56°F.
- Crew hand placed 12.5mm HMA in trench area.
- All loads of 12.5mm HMA conformed the the MaineDOT Standard Specification temperature range.
- The roadway shoulder trench was placed in 3 lifts with the first 2 lifts being compacted with a plate wacker only. The final lift was compacted with both a plate wacker and 3 ton vibratory roller.
- Crew completed trench paving on Skillin Road.
- Crew cleaned worksite and traffic returned to normal at approximately 3:30 PM.

Crew compacting first lift of 12.5mm HMA.

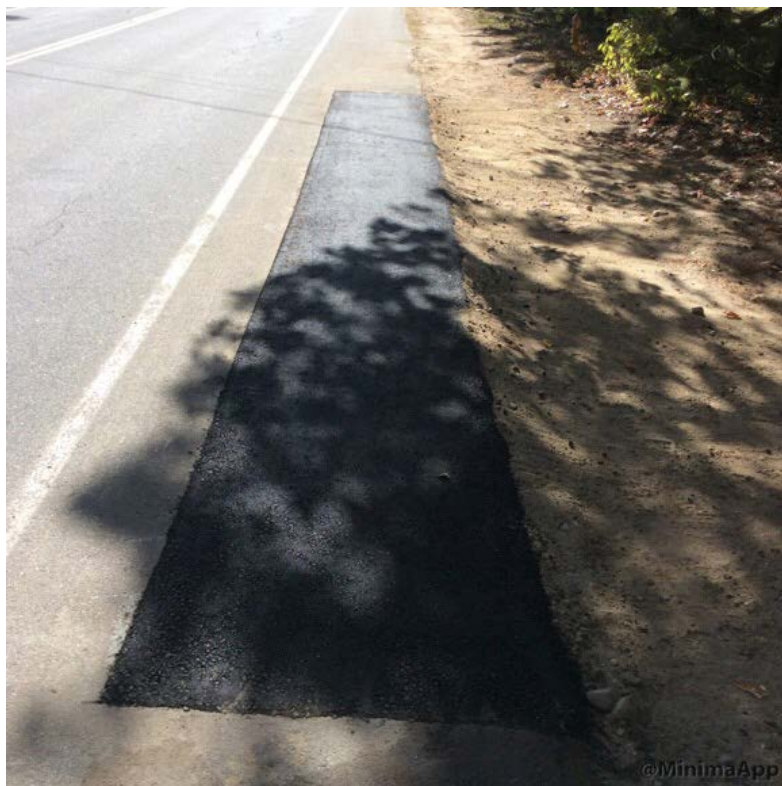
Completed roadway shoulder trench patch on Skillin Road.
