FIELD OBSERVATION REPORT

Project: Gas Main – Cumberland-Falmouth-Yarmouth Client: Towns of Cumberland, Falmouth and Yarmouth GP Field Rep: Benjamin Grondin (BG). Weather: Sunny Temp. Range: 55-70°F Time onsite: Multiple visits GP Project No: 1636.87 Visit Date: October 4, 2017 Report Date: October 5, 2017

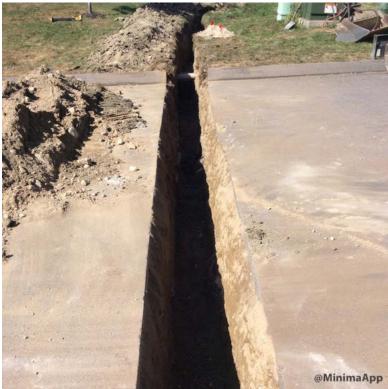
Trench on Castlerock drive.

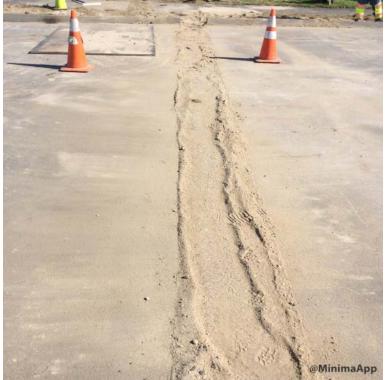
Trench backfilled and gravel compacted on Castlerock.

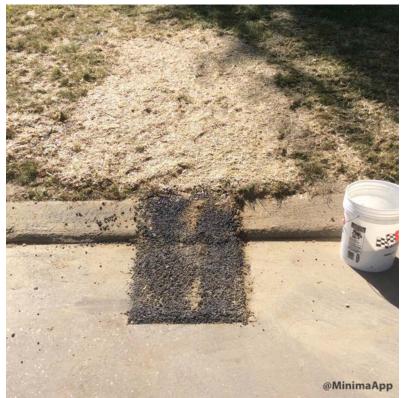
Cold patch placed on Pinewood.
