# FIELD OBSERVATION REPORT

Project: Gas Main – Cumberland-Falmouth-Yarmouth Client: Towns of Cumberland, Falmouth and Yarmouth GP Field Rep: Benjamin Grondin (BG). Weather: Sunny Temp. Range: 55-70°F Time onsite: Multiple visits GP Project No: 1636.87 Visit Date: October 5, 2017 Report Date: October 6, 2017

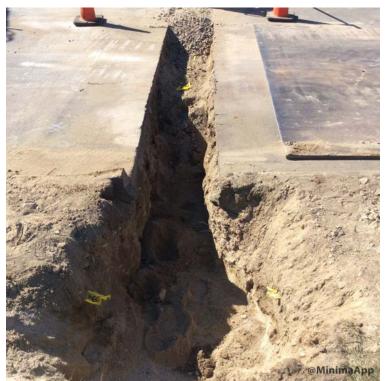
Trench on Castlerock drive.

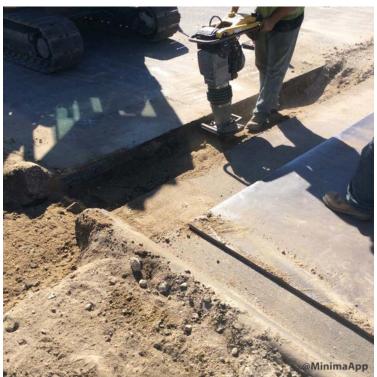
Compacting backfill on Castlerock.

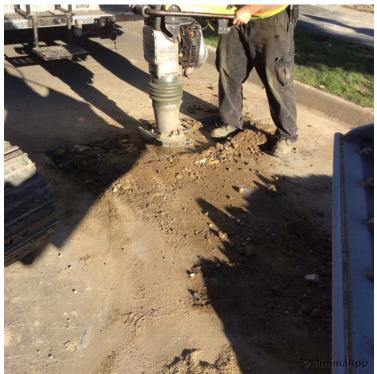
Compacting backfill in roadway on Wyman Way

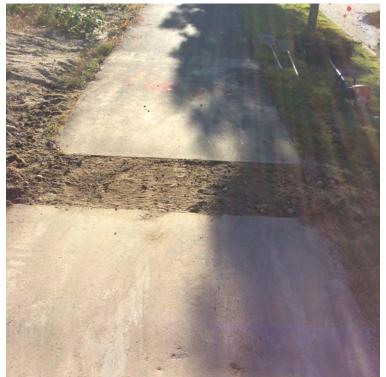
Sidewalk trench on Wyman Way
