FIELD OBSERVATION REPORT

Project: Gas Main – Cumberland-Falmouth-Yarmouth
Client: Towns of Cumberland, Falmouth and Yarmouth
GP Field Rep: Benjamin Grondin (BG)
Weather: Cloudy/rain
Temp. Range: 55-70°F
Time onsite: Multiple visits

GP Project No: 1636.87
Visit Date: October 9, 2017
Report Date: October 10, 2017

Summit Natural Gas

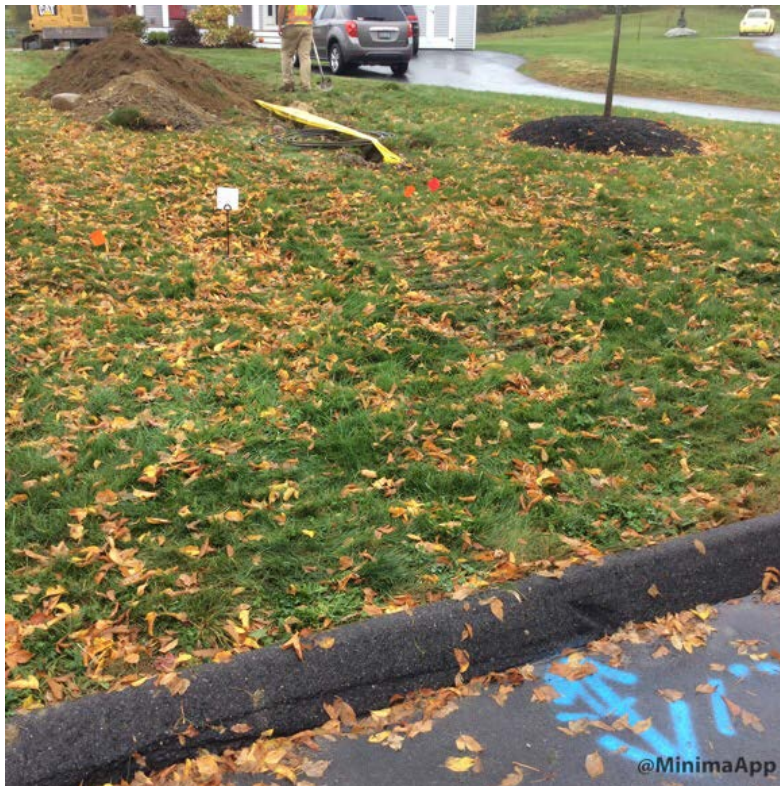
Installing gas service from #14 to roadway.

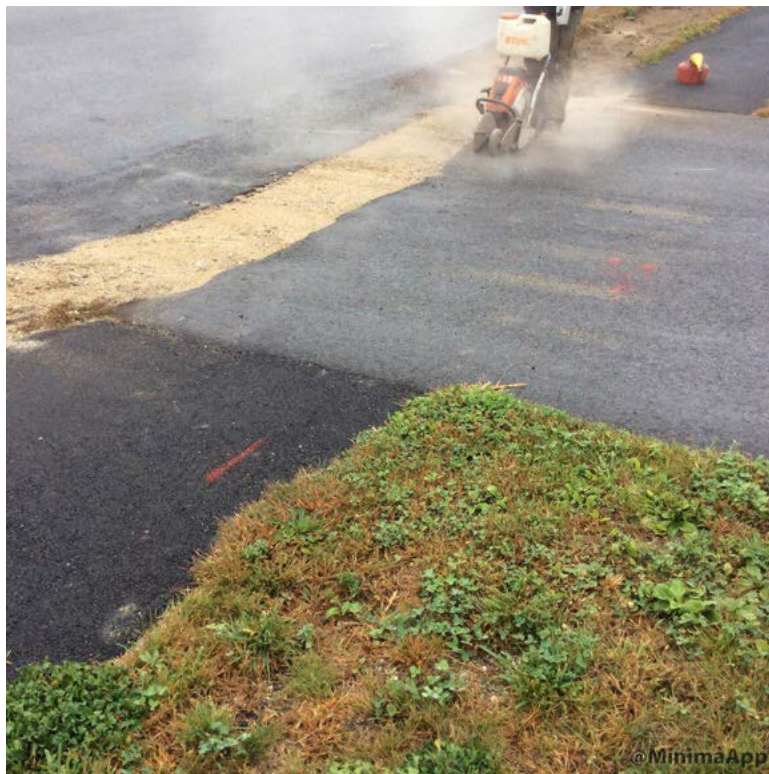
Saw cutting driveway crossing trench.

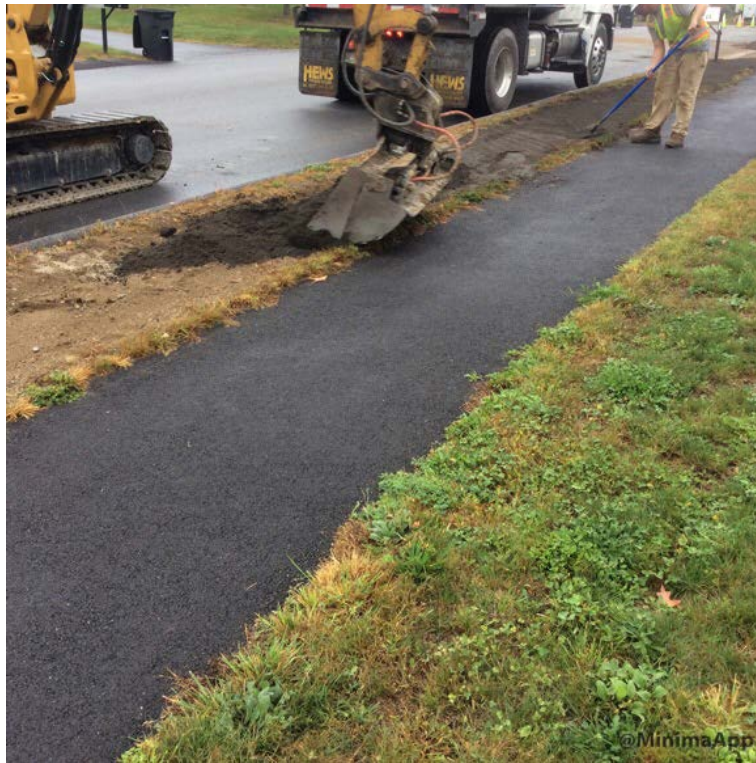
Placing loam in esplanade.
