GP Project No: 1636.87

Visit Date: November 6, 2017

# FIELD OBSERVATION REPORT

Project: Gas Main – Cumberland-Falmouth-Yarmouth Client: Towns of Cumberland, Falmouth and Yarmouth

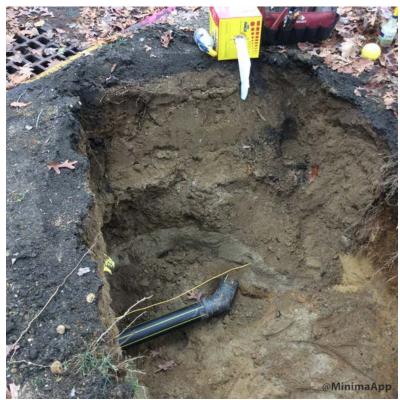
Open trench to access main at 11 Skillin Road.

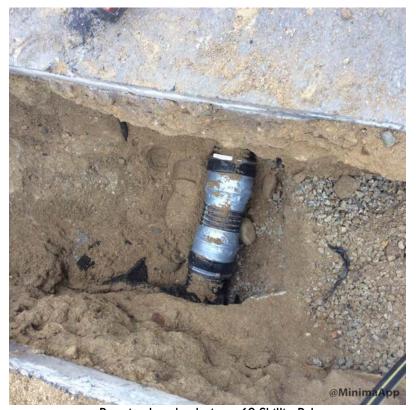
- Crew damaged a 6" underdrain on the west bound lane side of Skillin Road. The underdrain was repaired with a new piece of 6" underdrain and 2 Fernco's.
- All utilities located via manhole inverts, camera, electronic locator, or hand excavated.
- Pepth of utilities is to top of pipe unless noted in the table below

Repaired underdrain at 69 Skillin Rd.

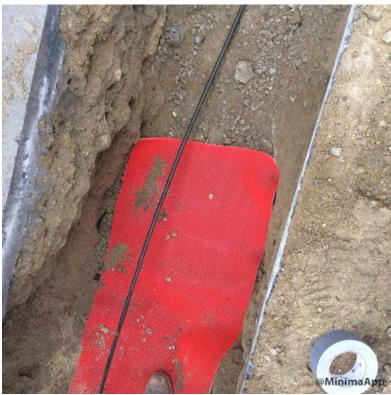
- Crew hand excavated I' below the gas service at the marked location for the water main. Crew did not locate the water main. Therefore, > I' of separation was achieved.
- Crew did not achieve >1' of separation from the 6" underdrain do to the proximity of the underdrain to the gas main. Rock shield was placed between the 6" underdrain and the gas service.
- Gas service is not parallel to any utilities therefore >6' of separation was achieved.
- Crew backfilled trench with sand around the gas main and excavated material. Backfill was compacted in lifts with a jumping jack.
- > Crew cleaned worksite and traffic returned to normal by 2:30PM.

Rock shield placed between gas service and underdrain

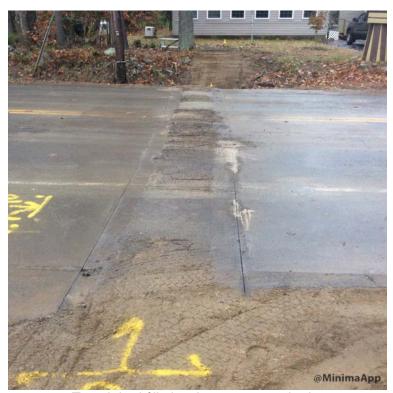
Trench backfilled with pavement cutbacks.
