FIELD OBSERVATION REPORT

Project: Gas Main – Cumberland-Falmouth-Yarmouth
Client: Towns of Cumberland, Falmouth and Yarmouth
GP Field Rep: Benjamin Grondin (BG)
Weather: Sunny
Temp. Range: 35-45°F
Time onsite: Multiple visits

GP Project No: 1636.87
Visit Date: November 8, 2017
Report Date: November 9, 2017

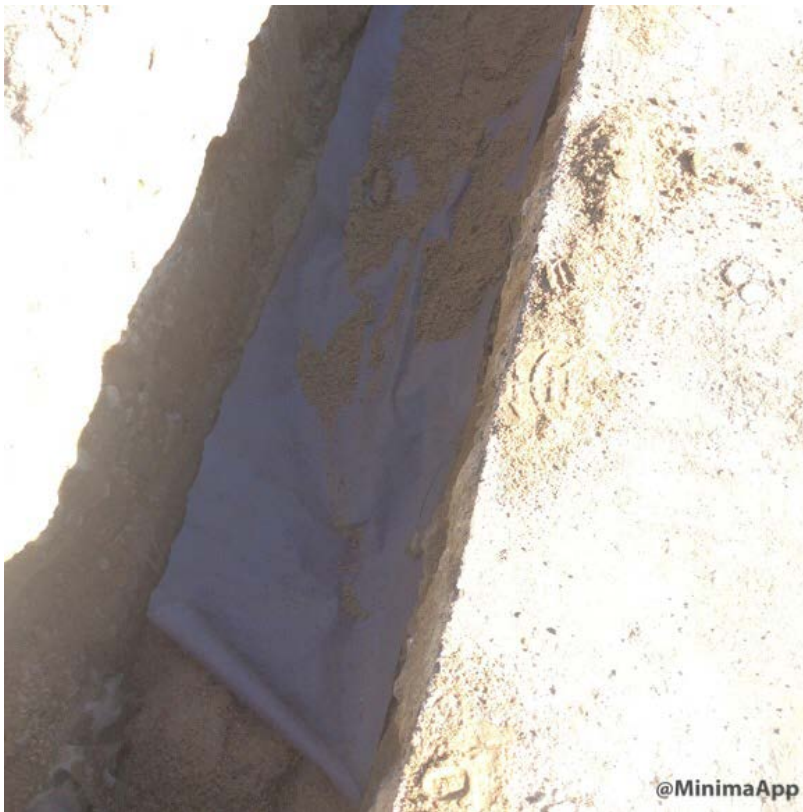
- Crew backfilled trench with sand around the gas main and excavated material. Backfill was compacted in lifts with a jumping jack.
- Crew placed a filter fabric material in trench to replace the fabric removed during excavation.

Fabric placed in trench.

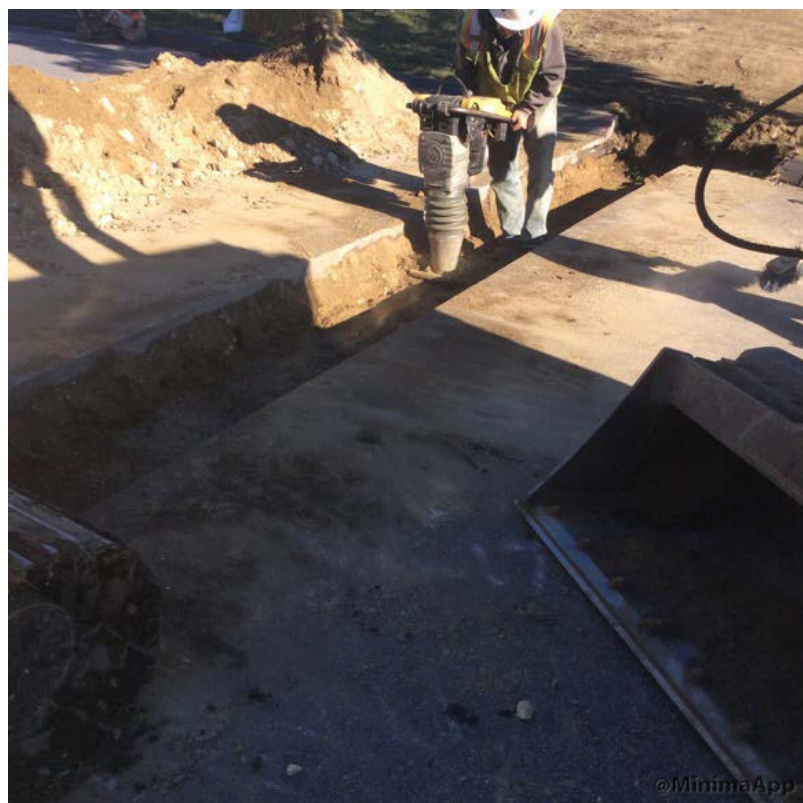
Compacting backfill with jumping jack.

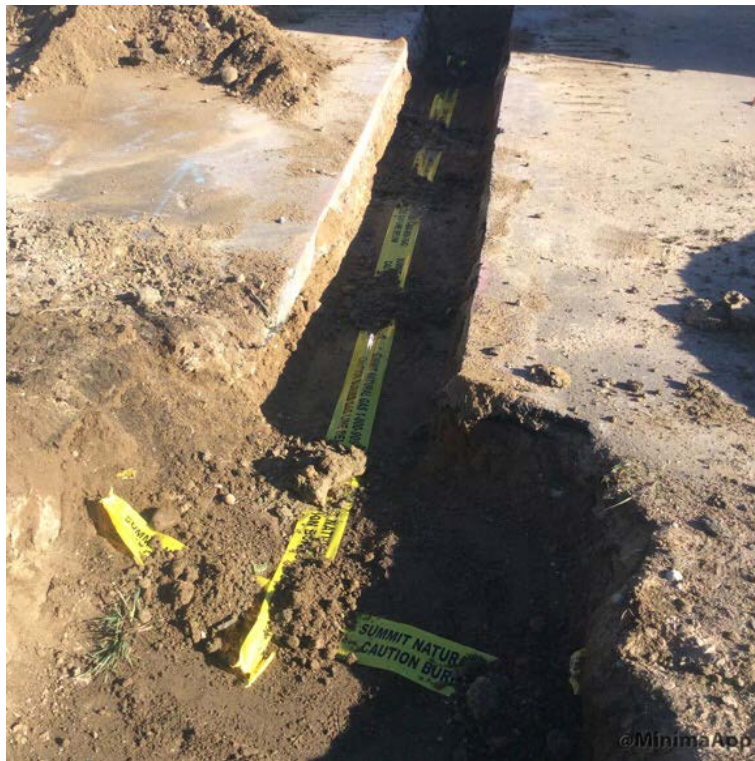
Warning tape placed in trench.

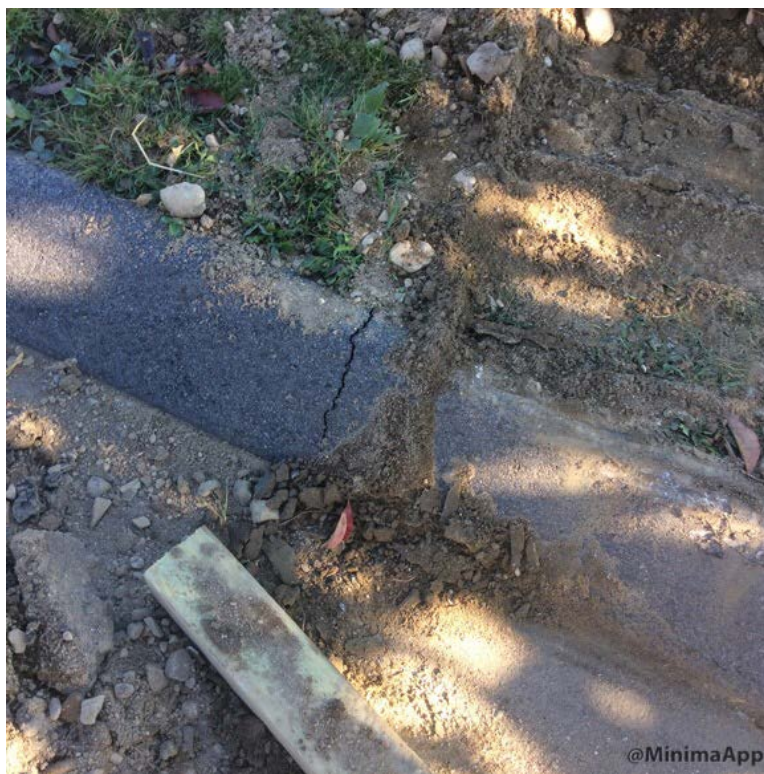
- Crew sawcut and removed pavement for roadway crossing trench and curb for the gas service installation.
- Curb beyond the trench limits was damaged during excavation. Curb will require replacement.

Damaged curb.
