## FIELD OBSERVATION REPORT

Project: Gas Main – Cumberland-Falmouth-Yarmouth  
Client: Towns of Cumberland, Falmouth and Yarmouth  
GP Field Rep: Benjamin Grondin (BG)  
Weather: Sunny  
Temp. Range: 30-40°F  
Time onsite: Multiple visits

GP Project No: 1636.87  
Visit Date: November 9, 2017  
Report Date: November 10, 2017

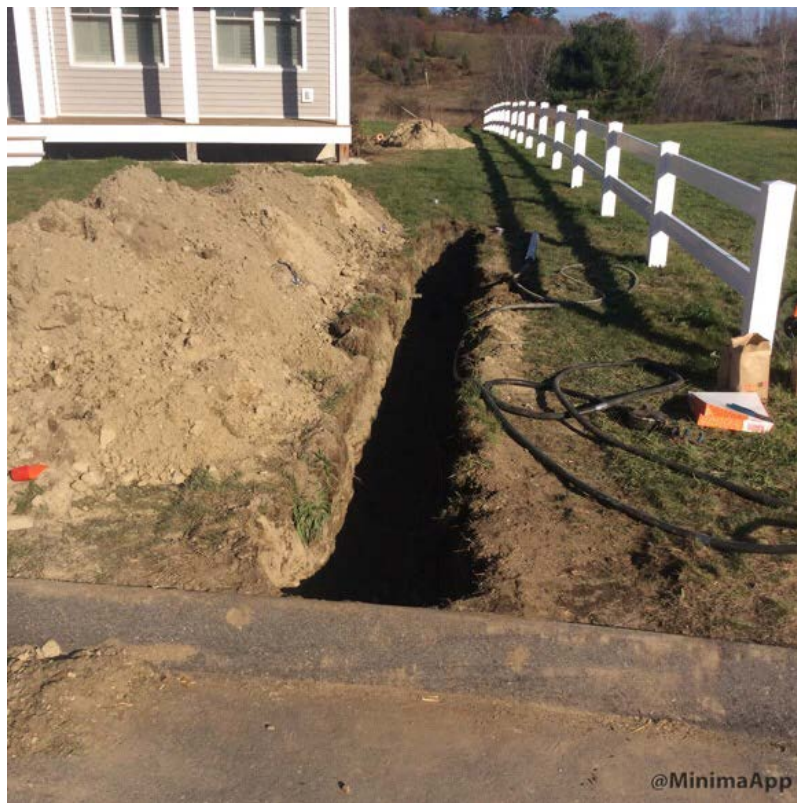
Open trench on house side.

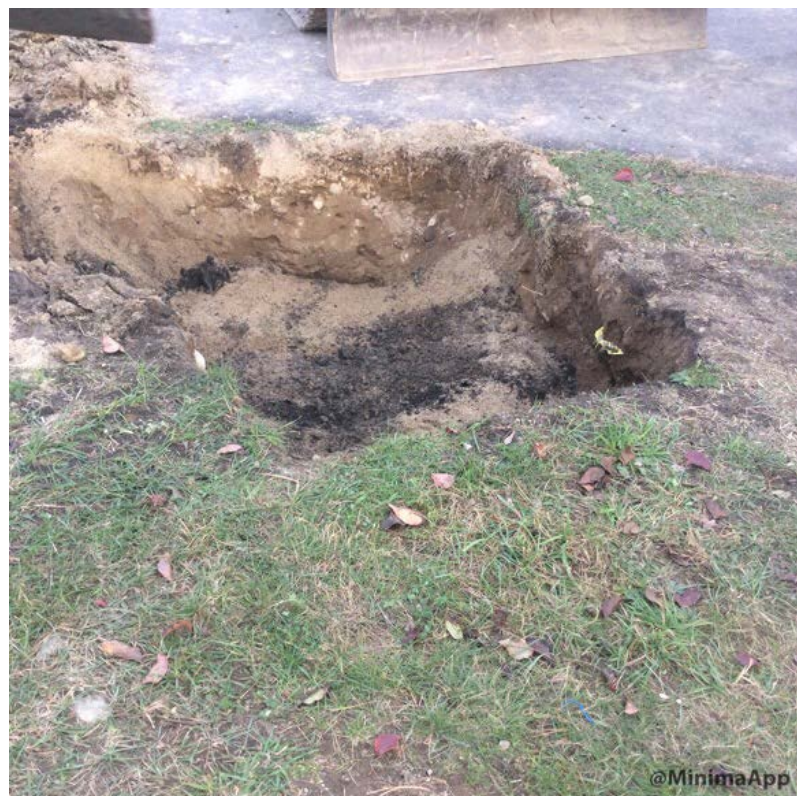
Open trench in vegetated island.

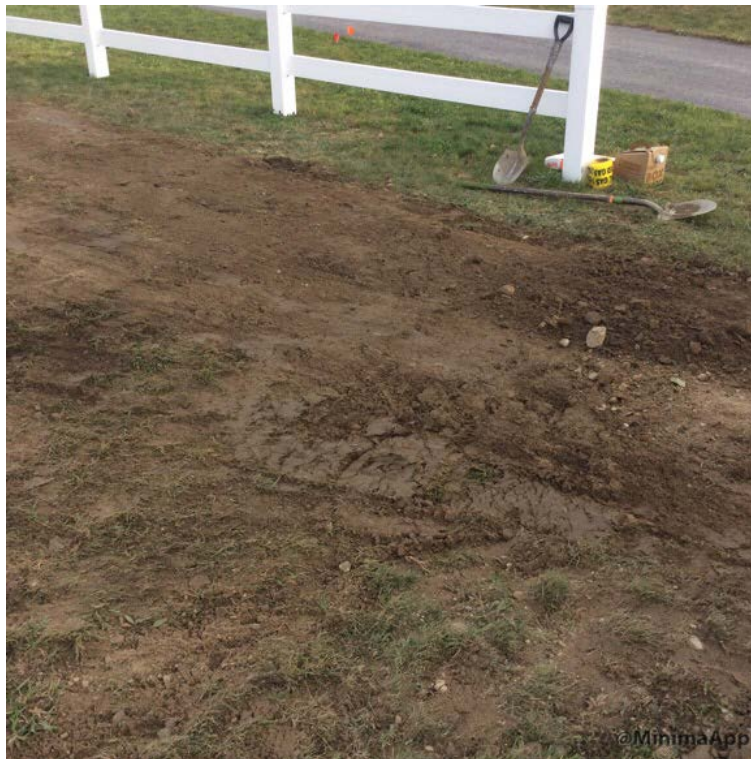
Trench on house side backfilled.

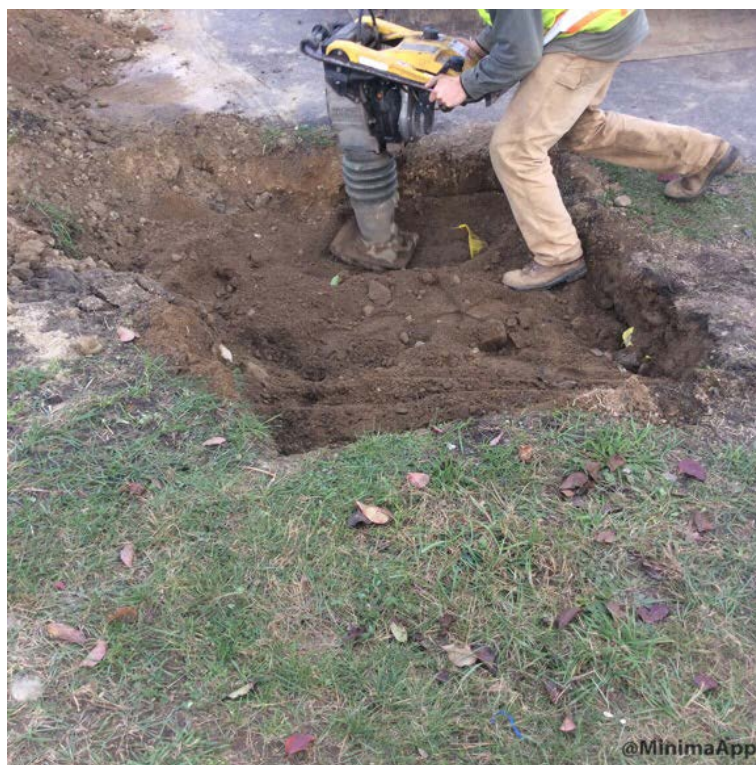
Compacting backfill in trench at vegetated island.
