FIELD OBSERVATION REPORT

Project: Gas Main – Cumberland-Falmouth-Yarmouth
Client: Towns of Cumberland, Falmouth and Yarmouth
GP Field Rep: Benjamin Grondin (BG)
Weather: Fog
Temp. Range: 60-70°F
Time onsite: Multiple visits

GP Project No: 1636.87
Visit Date: September 18, 2017
Report Date: September 19, 2017

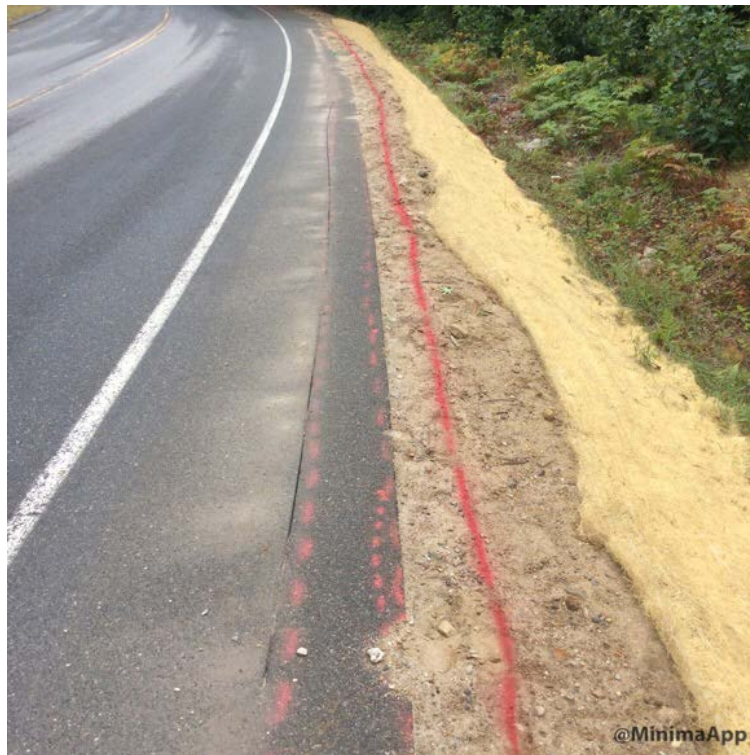
- The shoulder section trench near the large culvert was placed in 3 lifts with the first two lifts compacted with a plate wacker only. The final lift was compacted with both a plate wacker and 3 ton vibratory roller.

Layout of shoulder trench near large culvert.

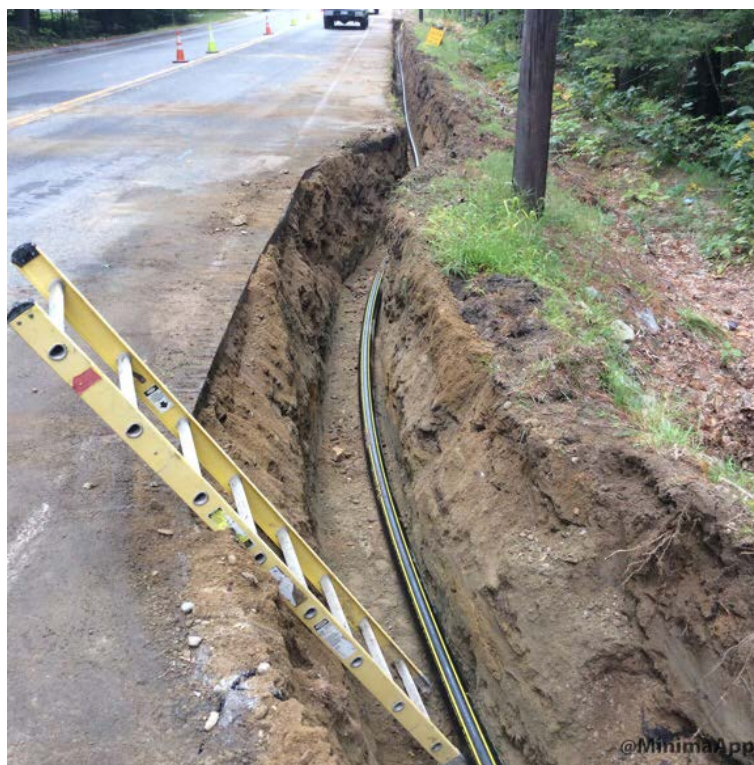
Removed pavement section near utility pole 27

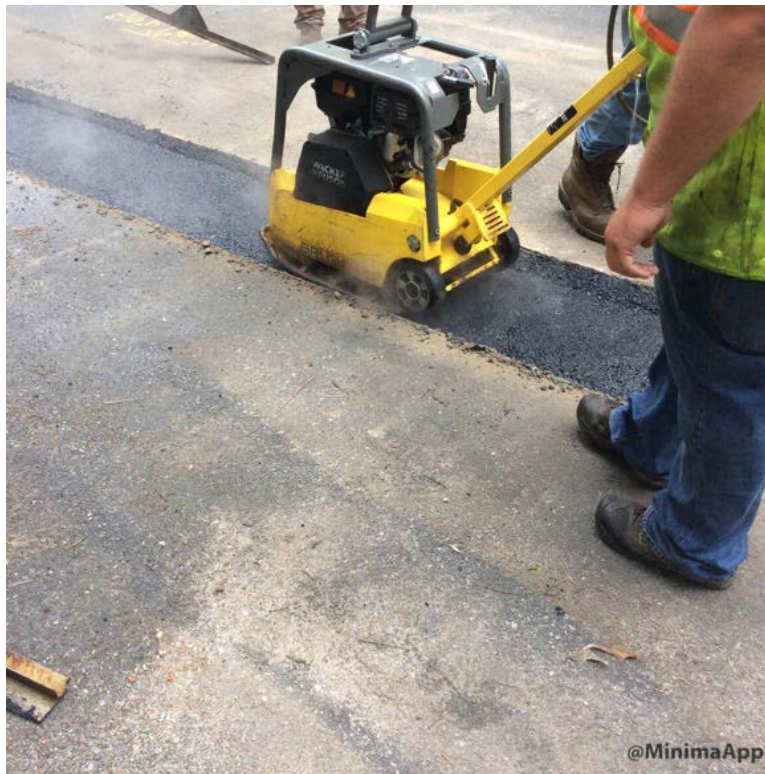
- All loads of 12.5mm HMA conformed to the MaineDOT Standard Specification temperature range.
- Crew placed 12.5mm HMA in the driveway trench in 2 lifts with the first lift compacted with a plate wacker only. The final lift was compacted with both a plate wacker and 3 ton vibratory roller.

Compacting first lift in driveway trench

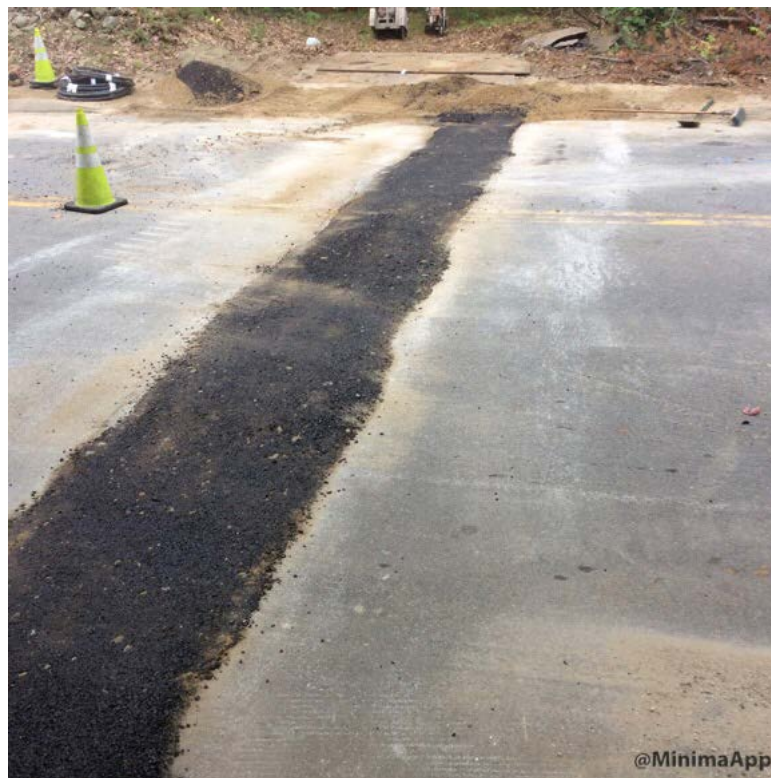
- Crew placed cold patch at the roadway crossing trench and longitudinal roadway trench near utility pole 27. Cold patch was compacted with a plate wacker.
- Crew cleaned worksite and traffic returned to normal by 5:00 PM.

Cold patch placed in roadway crossing trench
