FIELD OBSERVATION REPORT

Project: Gas Main – Cumberland-Falmouth-Yarmouth
Client: Towns of Cumberland, Falmouth and Yarmouth
GP Field Rep: Benjamin Grondin (BG)
Weather: cloudy
Temp. Range: 60-70°F
Time onsite: Multiple visits

GP Project No: 1636.87
Visit Date: September 19, 2017
Report Date: September 20, 2017

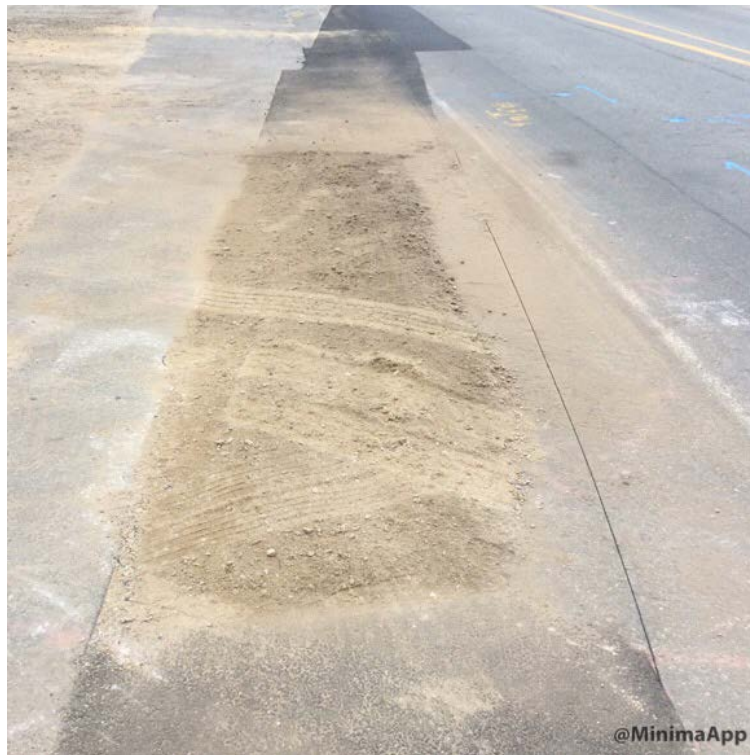
Gravel trench near Copp Motors backfilled.

- All gravel trenches within the roadway shall be monitored and repaired or treated for dust control as necessary.

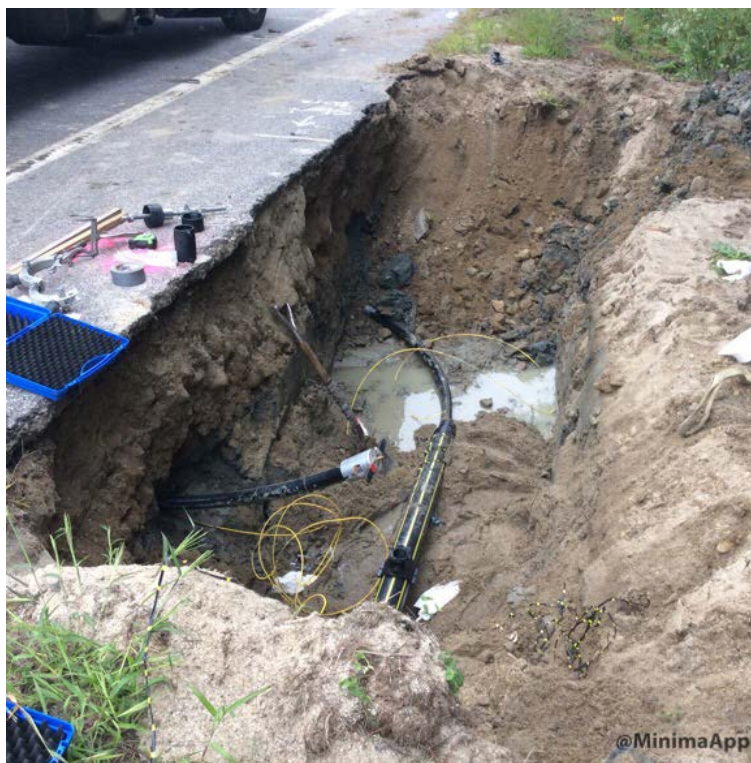
Trench on southbound lane side on Route 100

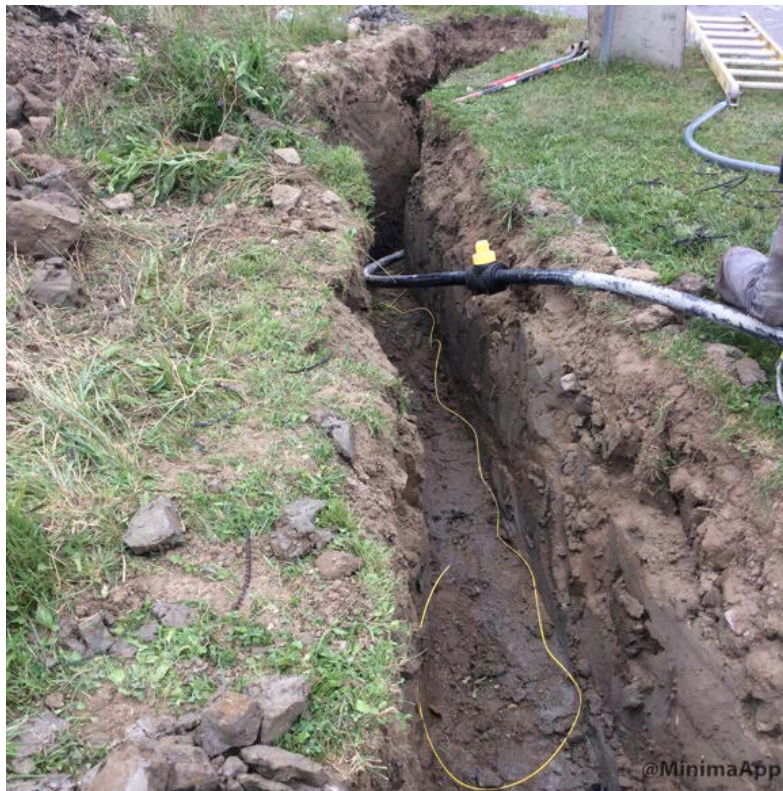
Trench on Castlerock Drive side in vegetated area.

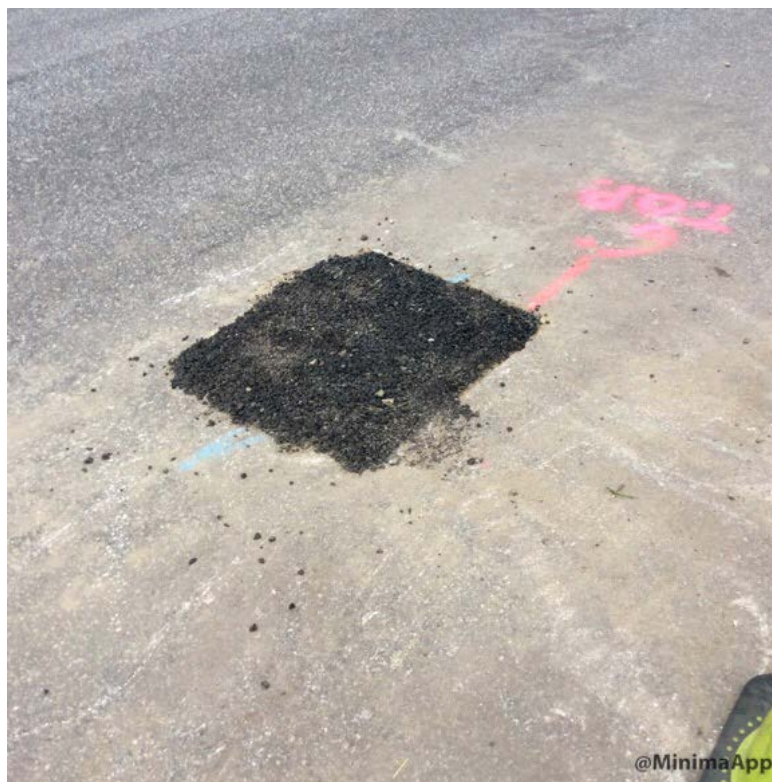
- Crew achieved >1' of separation at the 16" water main crossing.
- There did not appear to be any parallel utilities to the 2" gas main.
- Crew placed cold patch in the pothole to locate the water main in Route 100.
- Crew backfilled trench with sand around the gas main, with excavated material above the sand. Backfill was compacted in lifts with a plate wacker.
- Crew cleaned worksite and traffic returned to normal by 5:45PM.

Cold patch in pothole.
