GP Project No: 1636.87

Visit Date: September 20, 2017

FIELD OBSERVATION REPORT

Project: Gas Main – Cumberland-Falmouth-Yarmouth Client: Towns of Cumberland, Falmouth and Yarmouth

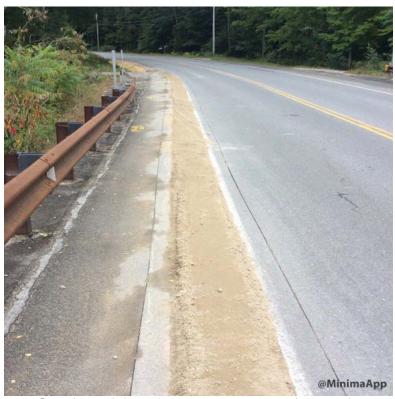
- Work Zone Closure: I lane closed on Skillin Road with flaggers maintaining alternating one way traffic
- The gravel trench near the large culvert had depressed approximately 2-3". Crew added gravel to the gravel trench to bring trench to the approximate roadway grade. Gravel was compacted with a plate wacker.
- Crew sawcut pavement at the previously marked areas of undermine on the eastbound shoulder.
- Crew did not install pipe. Therefore, no utilities were crossed.
- Crew cleaned worksite and traffic returned to normal by 12:00PM.

Gravel trench brought to approximate roadway grade.

All gravel trenches within the roadway shall be monitored and repaired or treated for dust control as necessary.

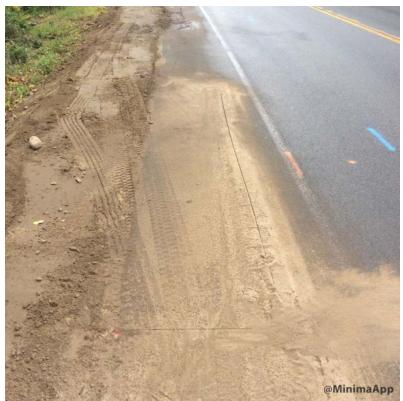
Pavement sawcut on east bound shoulder
