FIELD OBSERVATION REPORT

Project: Gas Main – Cumberland-Falmouth-Yarmouth
Client: Towns of Cumberland, Falmouth and Yarmouth
GP Field Rep: Benjamin Grondin (BG)
Weather: Sunny
Temp. Range: 70-85°F
Time onsite: Multiple visits

GP Project No: 1636.87
Visit Date: September 25, 2017
Report Date: September 26, 2017

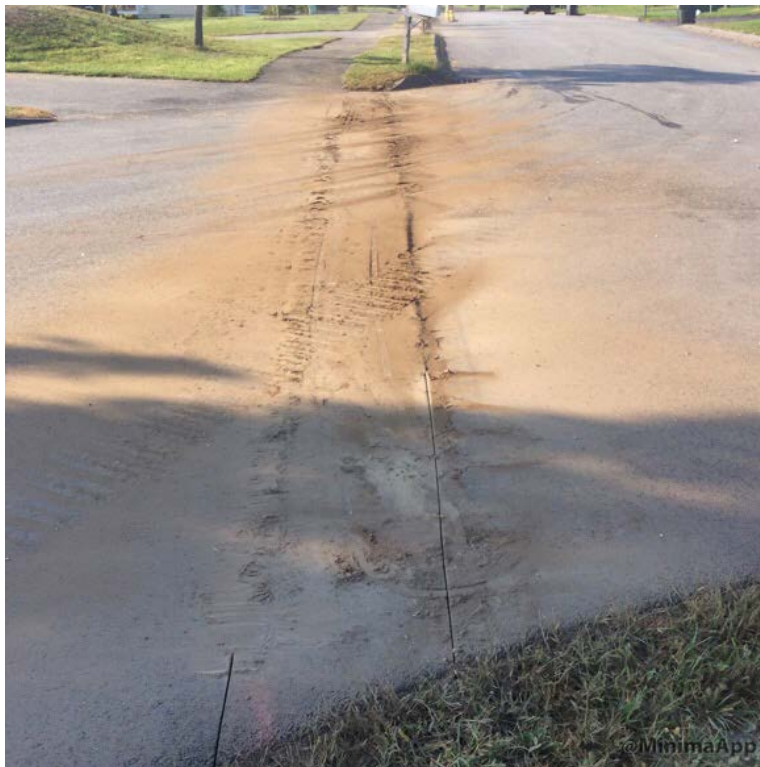
Pavement sawcut for roadway crossing trench on Castlerock Drive.

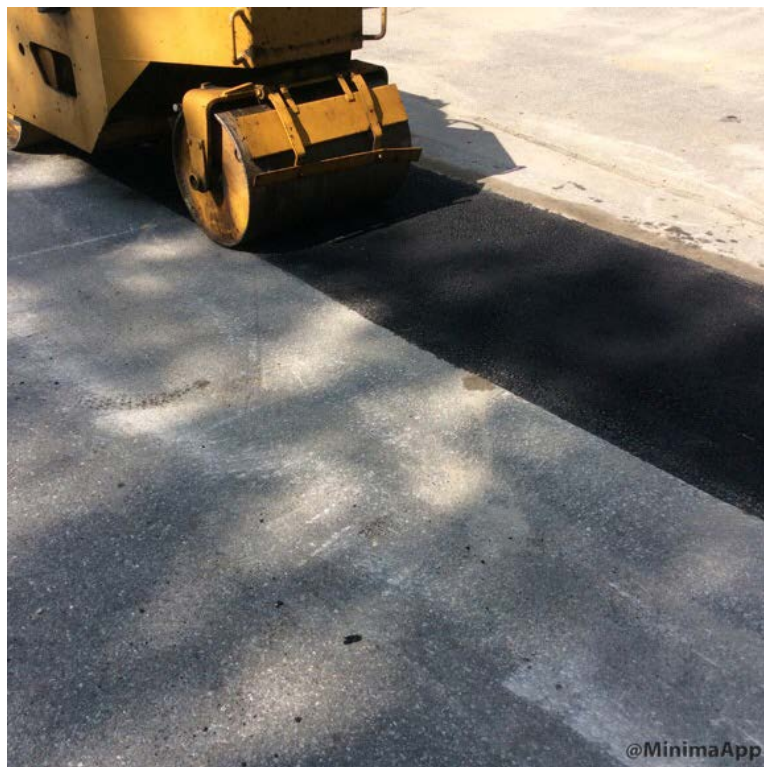
Compacting final lift of 12.5mm HMA with 3 ton vibratory roller

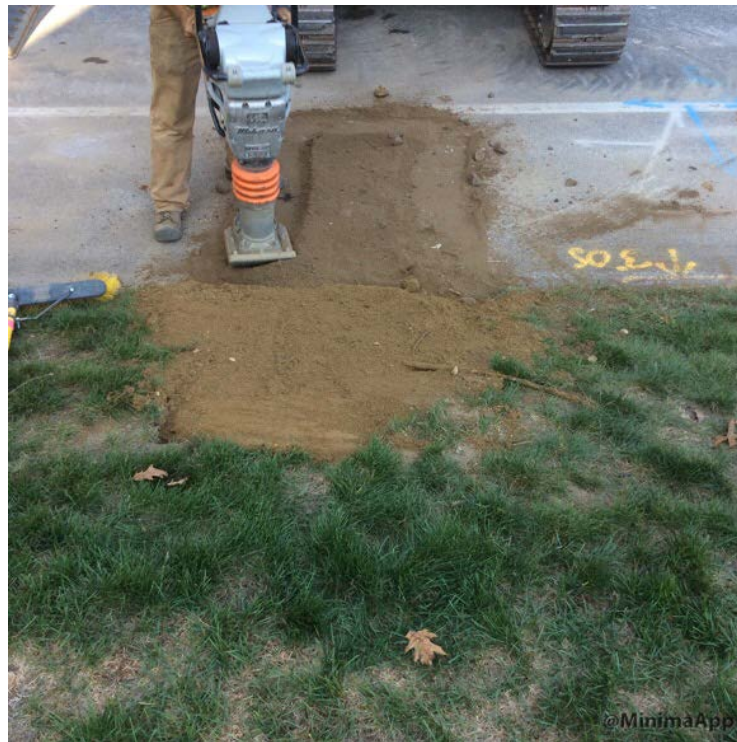
Compacting longitudinal trench on route 88

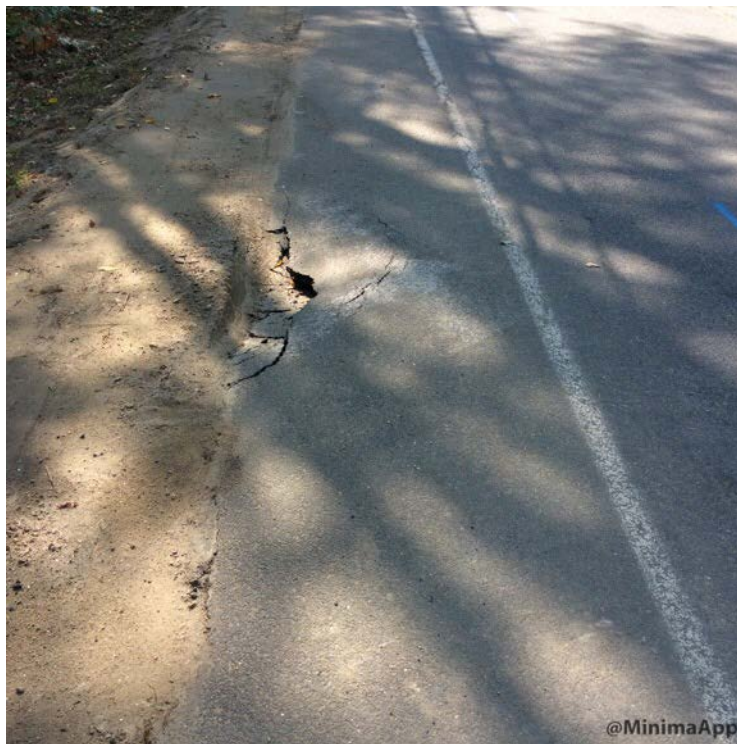
Failed section of pavement on Skillin Road

- All gravel trenches within the roadway shall be monitored and repaired or treated for dust control as necessary.
- Failed section of pavement on Skillin Road to be sawcut so gravel can be compacted and area can be paved.
