FIELD OBSERVATION REPORT

Project: Gas Main – Cumberland-Falmouth-Yarmouth
Client: Towns of Cumberland, Falmouth and Yarmouth
GP Field Rep: Benjamin Grondin (BG)
Weather: Sunny
Temp. Range: 70-85°F
Time onsite: Multiple visits

GP Project No: 1636.87
Visit Date: September 26, 2017
Report Date: September 27, 2017

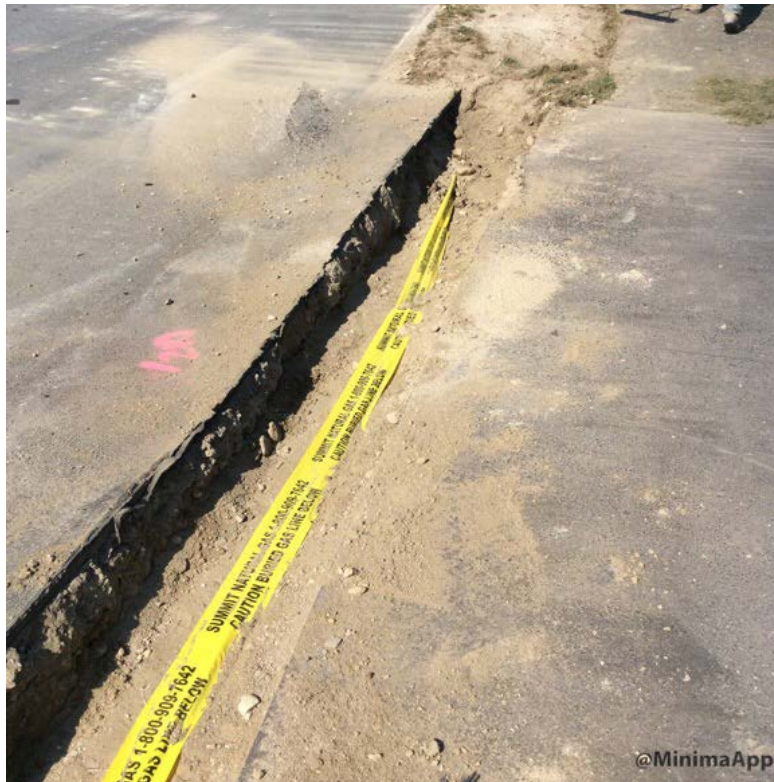
Backfill compacted and warning tape placed in driveway crossing on Castlerock Drive.

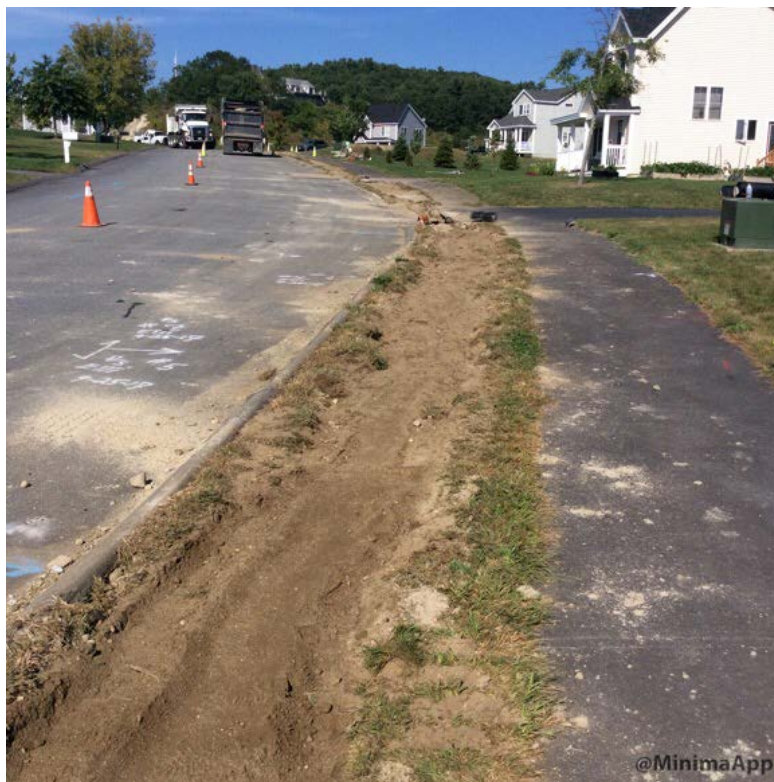
Trench in esplanade backfilled.

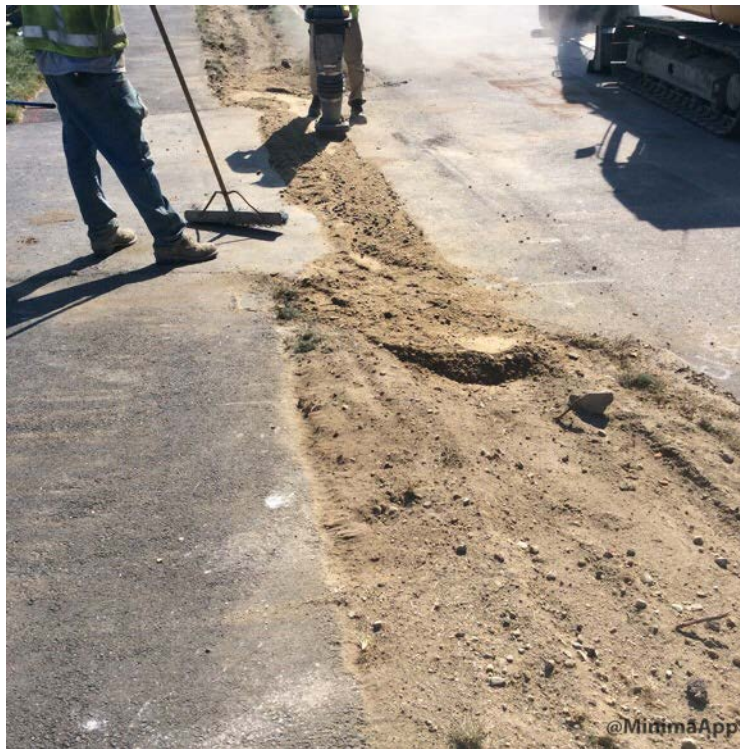
Compacting backfill at driveway crossing on Castlerock Drive.

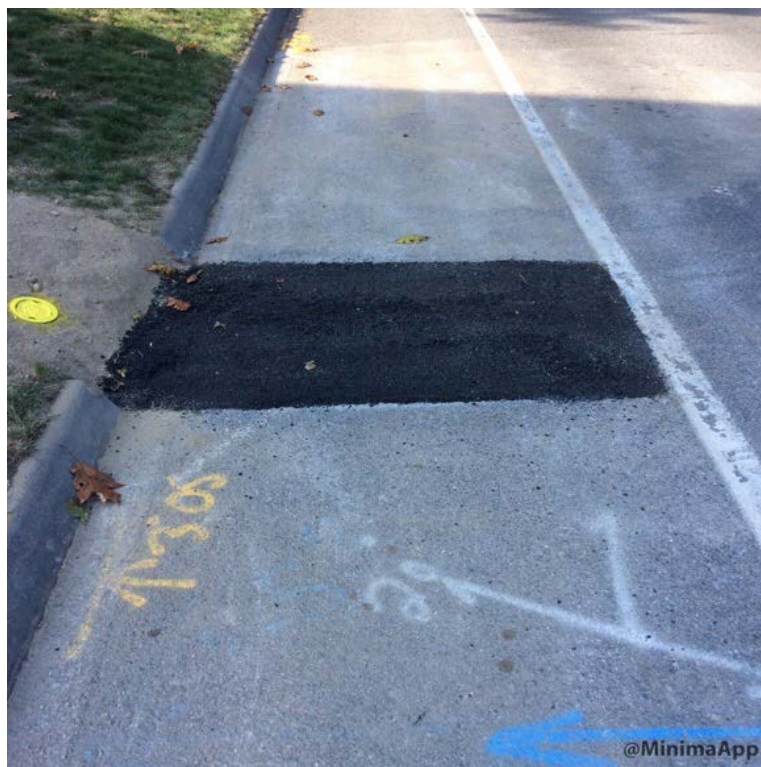
Cold patch placed in longitudinal trench on route 88.
