FIELD OBSERVATION REPORT

Project: Gas Main – Cumberland-Falmouth-Yarmouth
Client: Towns of Cumberland, Falmouth and Yarmouth
GP Field Rep: Benjamin Grondin (BG)
Weather: Sunny
Temp. Range: 70-85°F
Time onsite: Multiple visits

GP Project No: 1636.87
Visit Date: September 27, 2017
Report Date: September 28, 2017

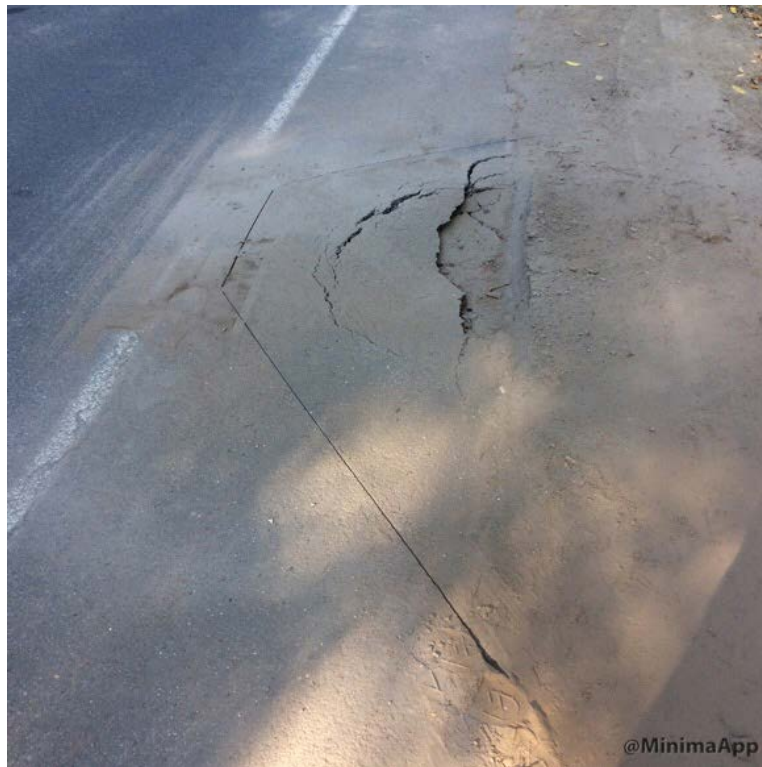
- Crew sawcut the section of failed pavement on Skillin Road.
- Crew cleaned worksite and traffic returned to normal by 4:30PM

Failed pavement section on Skillin Road sawcut.

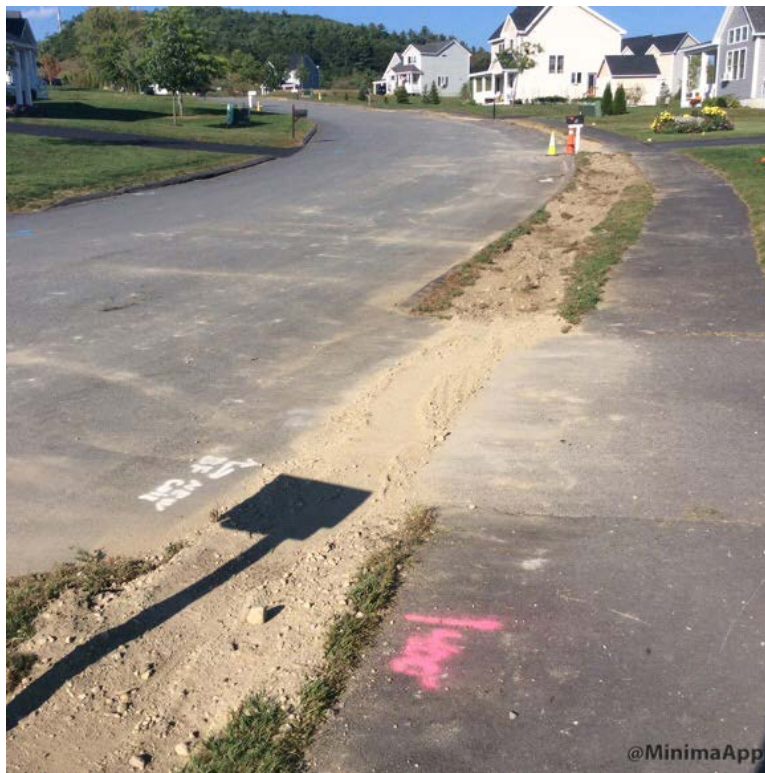
Driveway crossing at #3 Castlerock Drive backfilled.

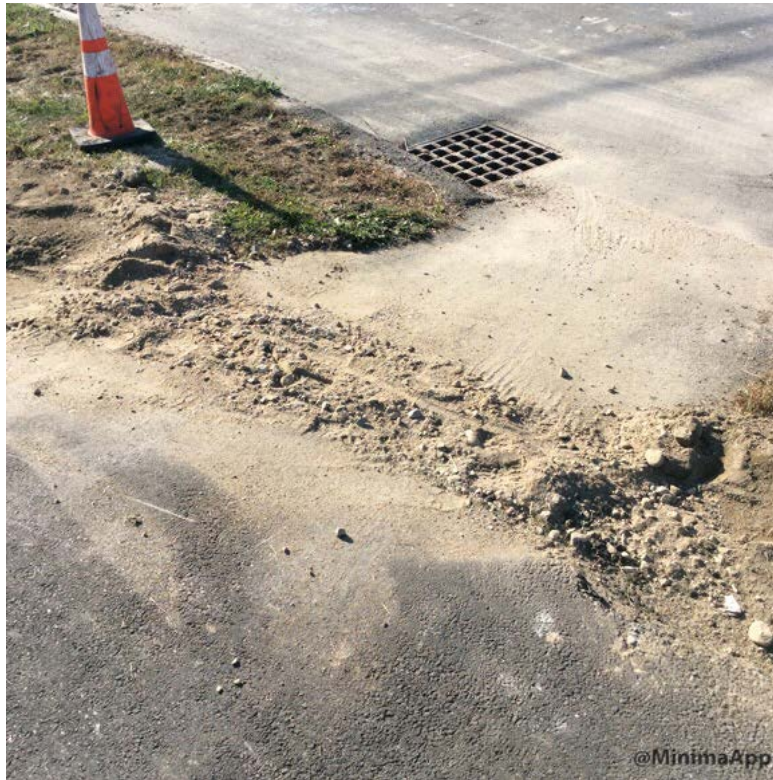
Sidewalk crossing backfilled on Castlerock Drive.
