FIELD OBSERVATION REPORT

Project: Gas Main – Cumberland-Falmouth-Yarmouth
Client: Towns of Cumberland, Falmouth and Yarmouth
GP Field Rep: Benjamin Grondin (BG)
Weather: Sunny
Temp. Range: 50-65°F
Time onsite: Multiple visits

GP Project No: 1636.87
Visit Date: September 28, 2017
Report Date: October 2, 2017

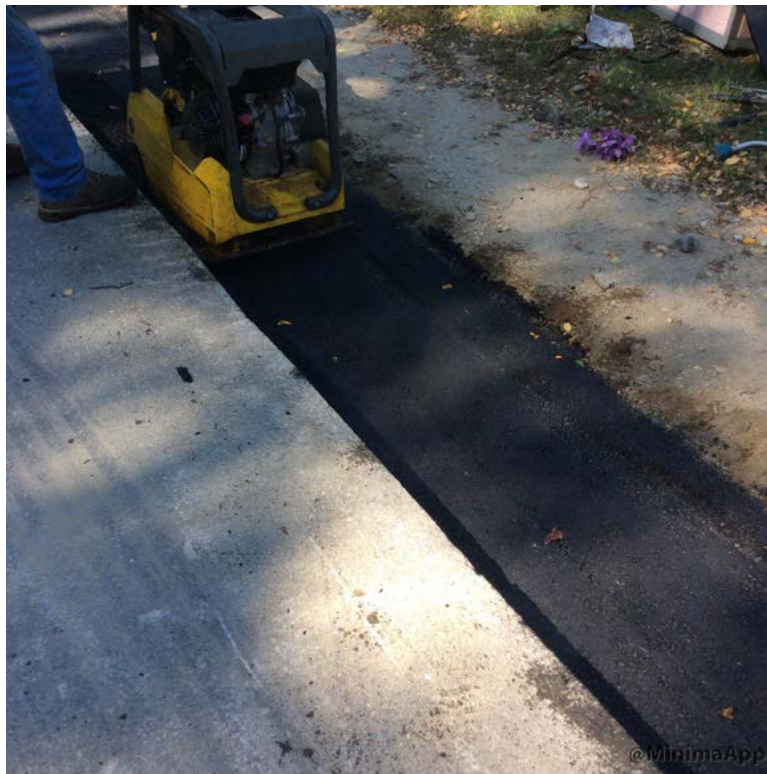
Compacting first lift of 12.5mm HMA with plate wacker.

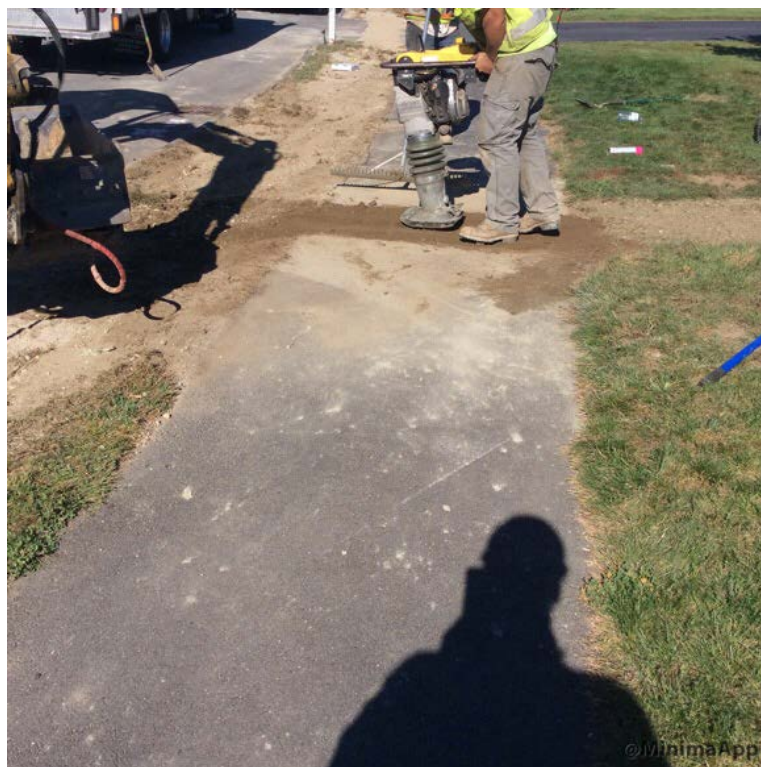
Compacting backfill with jumping jack on Castlerock Drive.

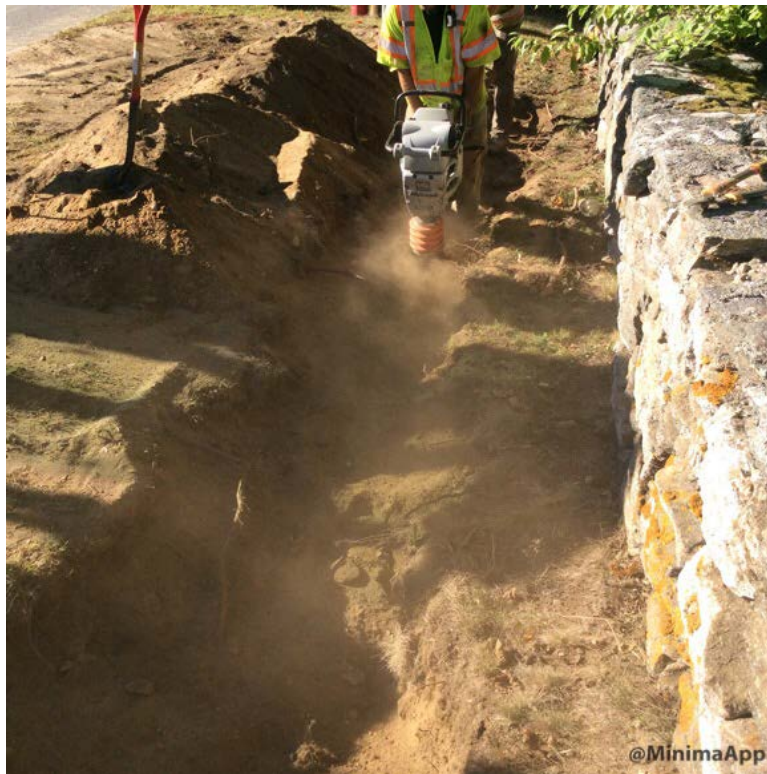
Compacting backfill with jumping jack near Deans Way.

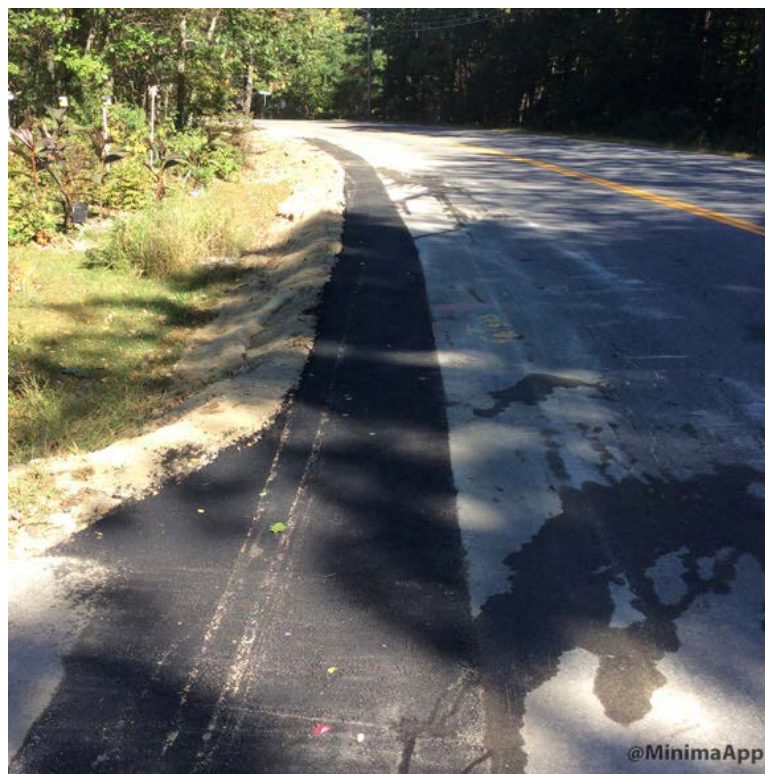
Completed roadway shoulder trench patch on Skillin Road.
