## FIELD OBSERVATION REPORT

Project: Longmeadow Rd & Ole Musket Rd – Drainage Improvements  
Client: Town of Cumberland  
GP Field Rep: Kassey Northrop (KN)  
Weather: Cloudy, Rain  
Time onsite: 10:00 – 11:00 AM/ 3:30 – 4:30 PM  
Contractor: A.H. Grover, Inc.  
Distribution: File; Town of Cumberland

GP Project No: 3656  
Visit Date: April 4, 2023  
Report Date: August 4, 2023  
Temp. Range: 45-50°F

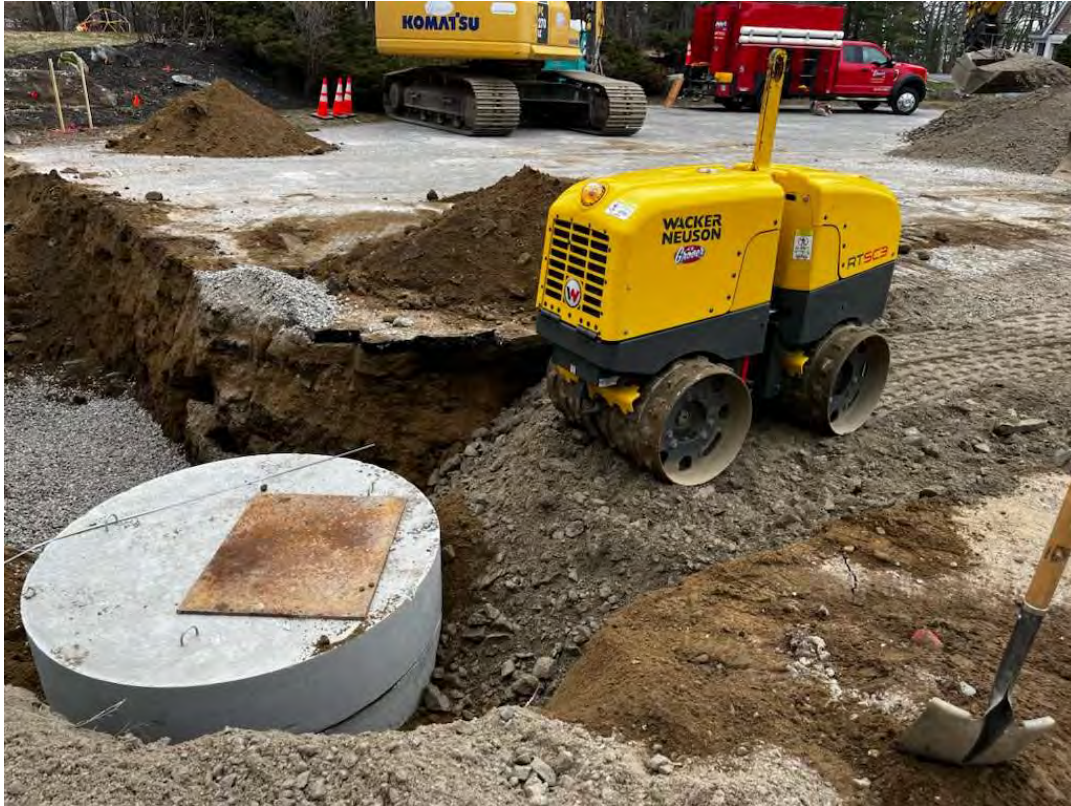
- Prior to arrival in the morning, A.H. Grover, Inc. had installed CB #28 on material consistent with  $\frac{3}{4}$ " crushed stone and continued the 63 feet of previously installed 15" SD pipe to CB #28, resulting in a total of 90 feet of pipe installed between Exist. CB #2 and CB #28. (Photo 1)

Photo 1 – CB #28 installed

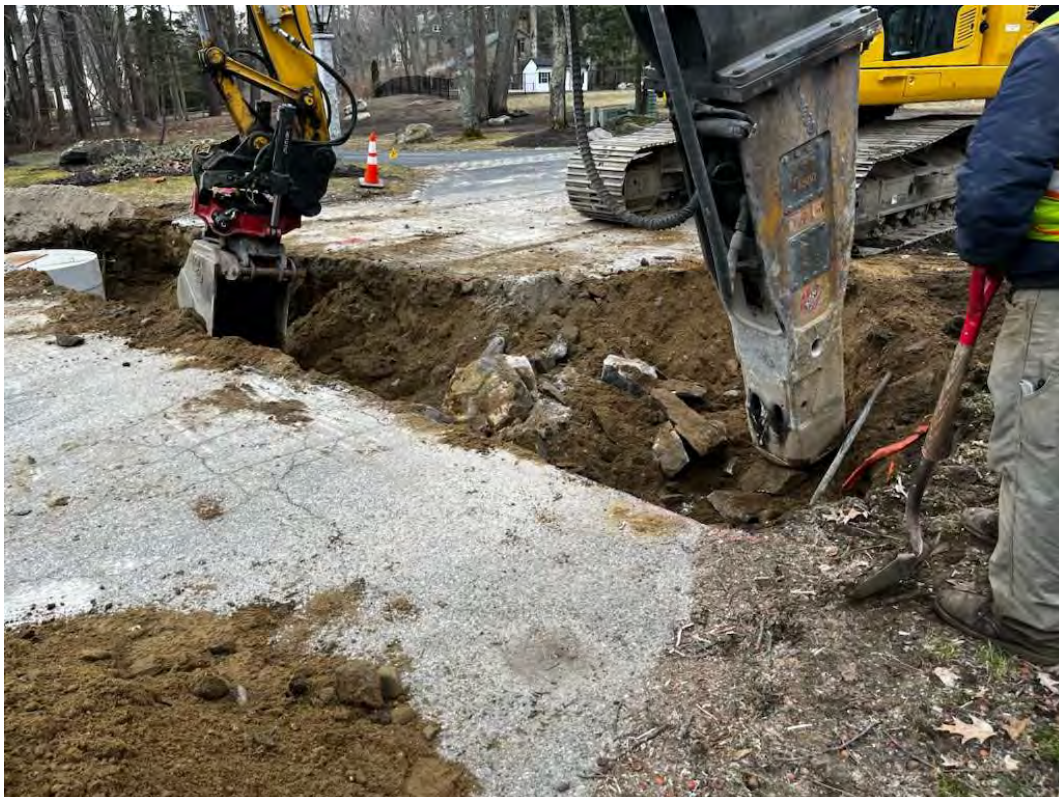
- Rock excavation was required to install the remaining pipe and CB #28.
- While on site, A.H. Grover, Inc. started excavating the trench area proposed for the 15" SD between CB's #27 & #28. (Photo 2)

Photo 2 – Excavating trench for proposed 15" SD between CB's #27 & #28

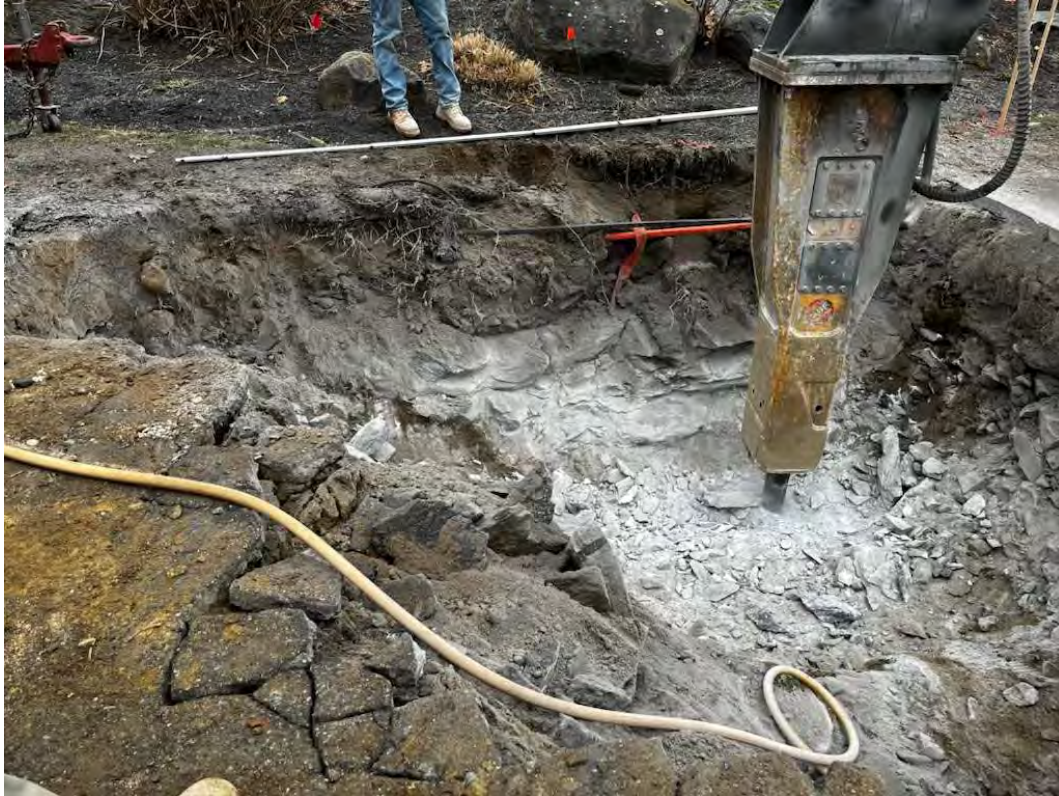
- Ledge rock was present there-after at a depth of approximately 2.5' below existing grade, to the base of the trench. The rock excavation continues to significantly slow down production. (Photo 3)

Photo 3 – Significant ledge rock in area proposed for CB #27

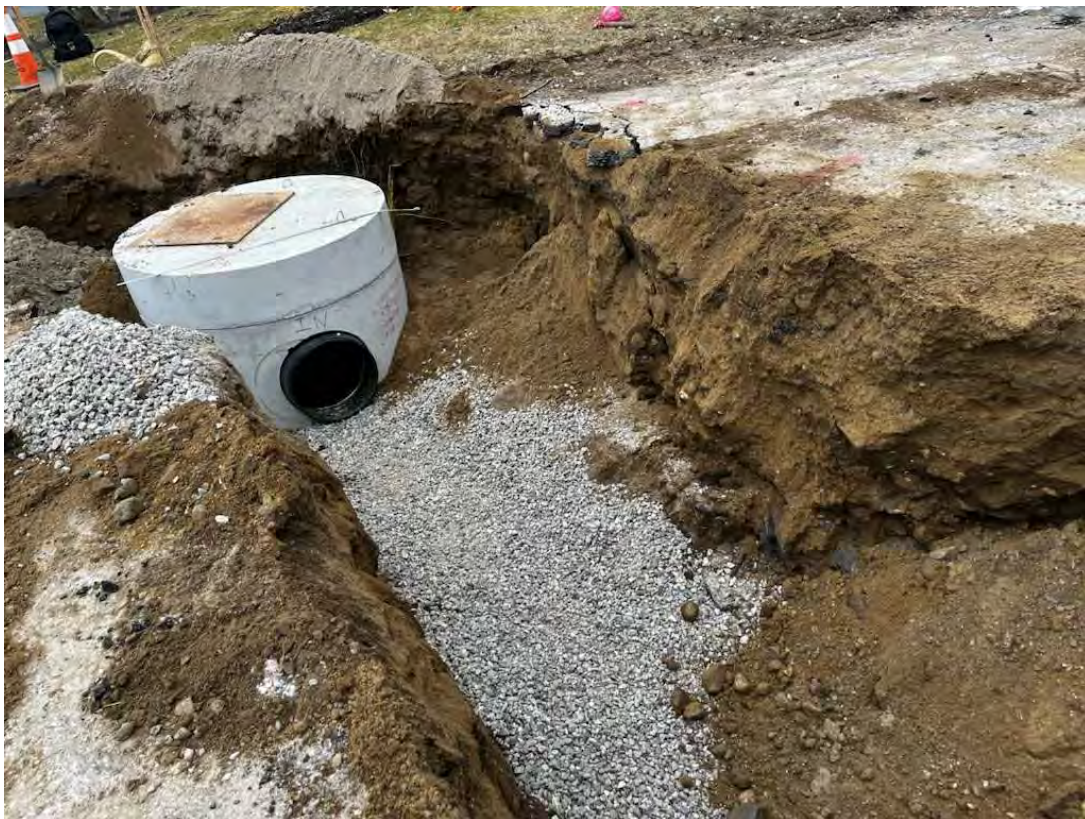
- Approximately 12 feet of 15" SD pipe was embedded with material consistent with MDOT 703.22 Type C –  $\frac{3}{4}$ " Crushed Stone (Photo 4) from CB #28 towards proposed CB #27 within the excavated area of the trench where ledge rock was not present. The 12 feet of 15" SD pipe was then backfilled approximately 1.75 feet from the spring line with material consistent with MDOT 703.22 Type B UD Backfill.

Photo 4 –  $\frac{3}{4}$ " crushed stone being placed for 15" SD pipe.

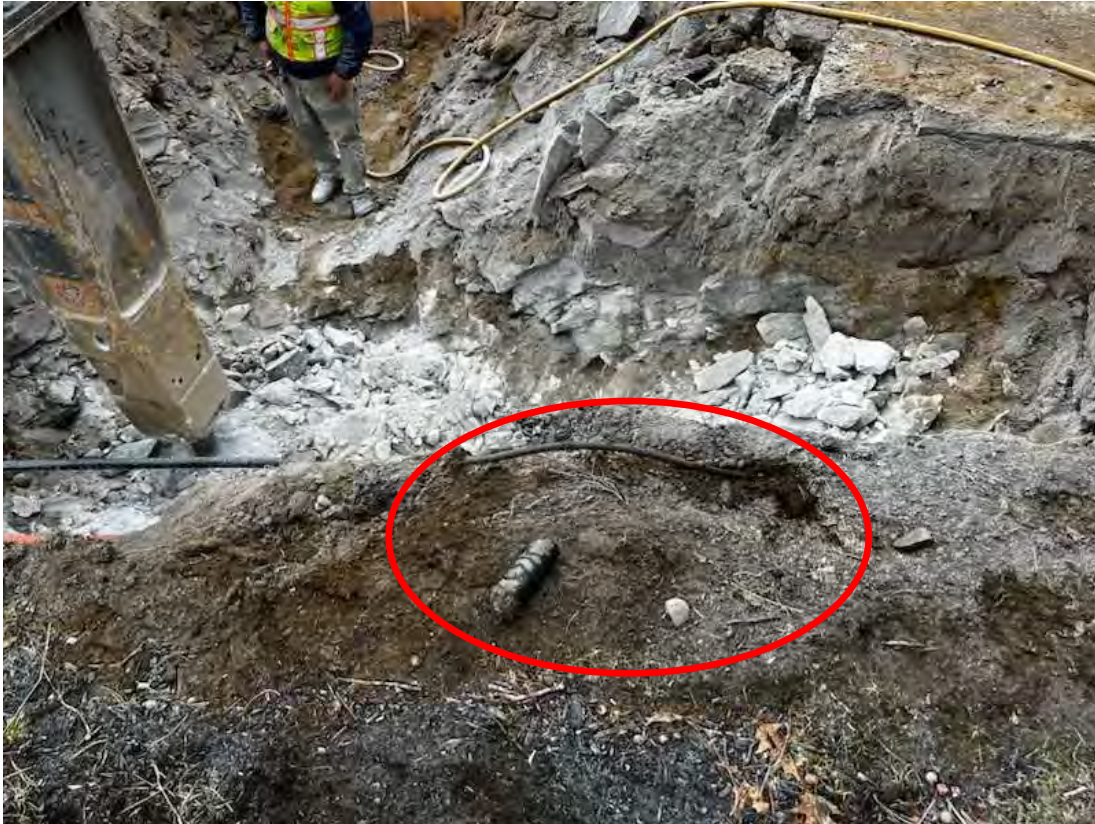
- While excavating this area, an irrigation system, belonging to Mark Segrist of house #16 was damaged. (Photo 5) The irrigation system was located within the right-of-way and it's presence was unknown to A.H. Grover, Inc. Ultimately due to it's location with the right-of-way, it is not A.H. Grover, Inc.'s responsibility to fix, although upon discussion with Lee and Ben Grover, if they are able to fix it without great effort, they will. KN notified Mark Segrist of the incident, and explained it was in the right-of-way in which he knew and was understanding about. It is assumed more irrigation systems may be damaged if in the right-of-way, therefore A.H. Grover, Inc. will make efforts to avoid them if practicable.

Photo 5 – Irrigation system (circled in red) damaged from excavation.
