## FIELD OBSERVATION REPORT

Project: Longmeadow Rd & Ole Musket Rd – Drainage Improvements  
Client: Town of Cumberland  
GP Field Rep: Kassey Northrop (KN)  
Weather: Cloudy  
Time onsite: 10:15 – 11:15 AM/ 3:30 – 4:15 PM  
Contractor: A.H. Grover, Inc.  
Distribution: File; Town of Cumberland

GP Project No: 3656  
Visit Date: April 5, 2023  
Report Date: August 5, 2023  
Temp. Range: 35-37°F

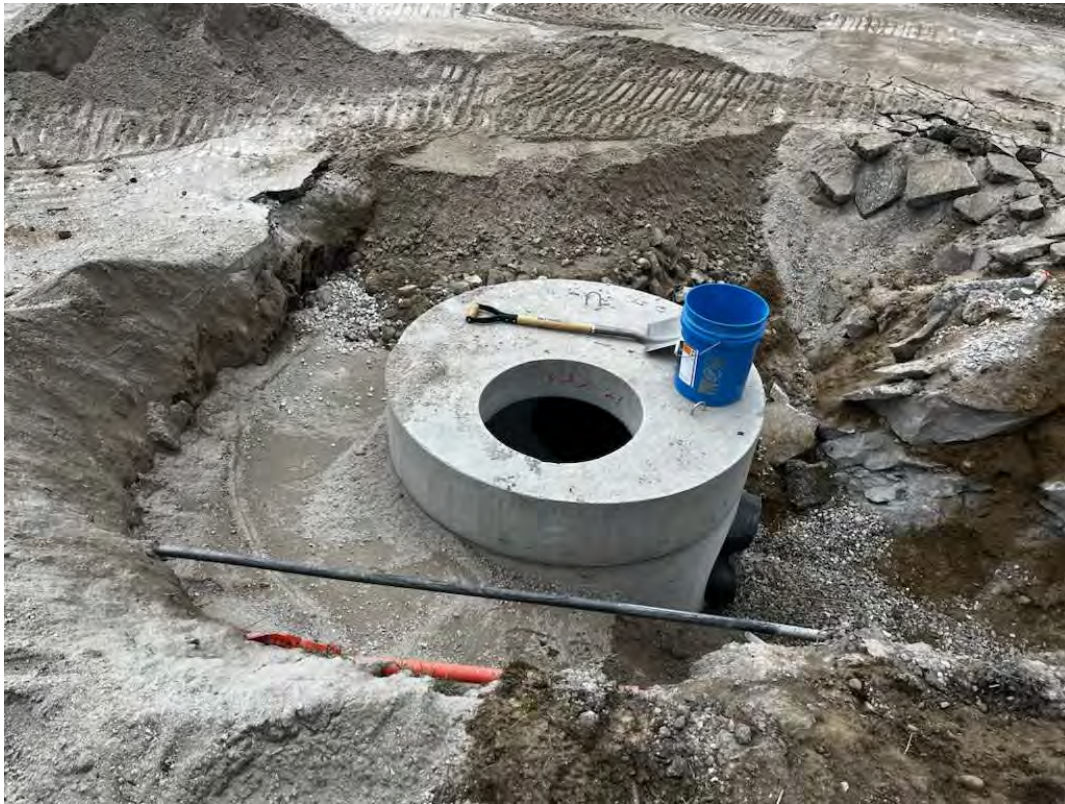
- Prior to arrival in the morning, A.H. Grover, Inc. had installed CB #27 on material consistent with ¾" crushed stone and continued the 12 feet of 15" SD pipe installed yesterday to CB #27, resulting in a total of 23.75 feet of 15" SD pipe installed between CB #27 and CB #28. (Photo 1)

Photo 1 – CB #27 installed.

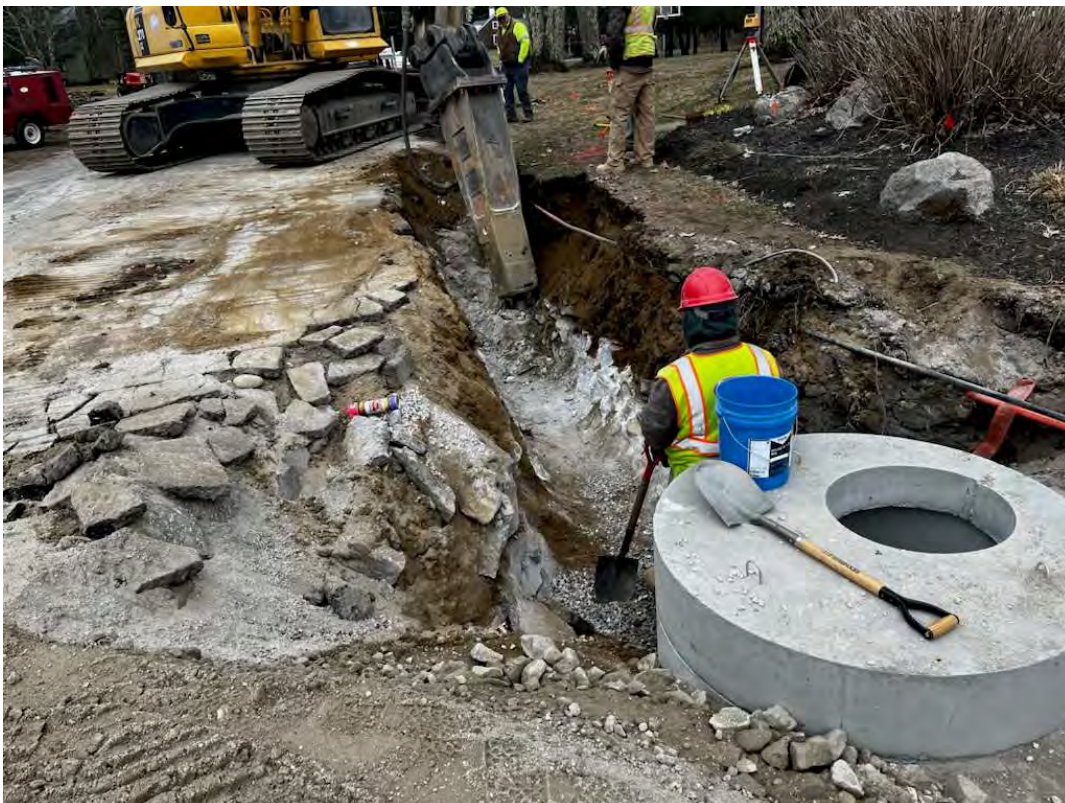
- Rock excavation for the trench area between CB #27 and CB #28, as well as the area for the installment of CB #27 was accounted for yesterday.
- While on site, A.H. Grover, Inc. started excavating the trench area proposed for the 15" Perf. SD between CB's #26 & #27. (Photo 2)

Photo 2 – Excavating trench for proposed 15" Perf. SD between CB's #26 & #27

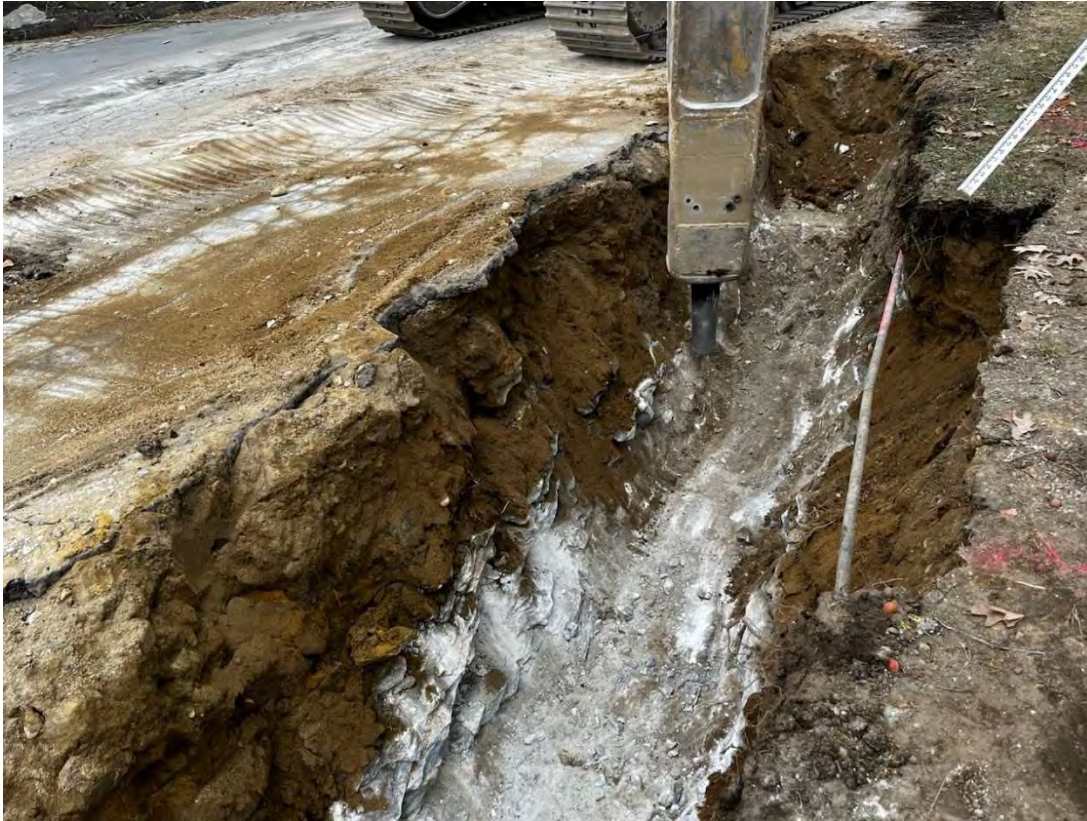
- Ledge rock continues to be present at depths of approximately 1.5 – 2.5' below existing grade, significantly slowing down production. (Photo 3) A high spot of ledge rock was present around station 17+00, KN to monitor and communicate if high spot continues or deteriorates as excavation continues. (Photo 4) While on site, the homeowner of house #14 stated that his property's subsurface is mostly sand. It is A.H. Grover, Inc's hope that once they move further out of the cul-de-sac, towards Route 88, ledge rock will be less present.

Photo 3 – Ledge rock present, pictured around STA 17+50.

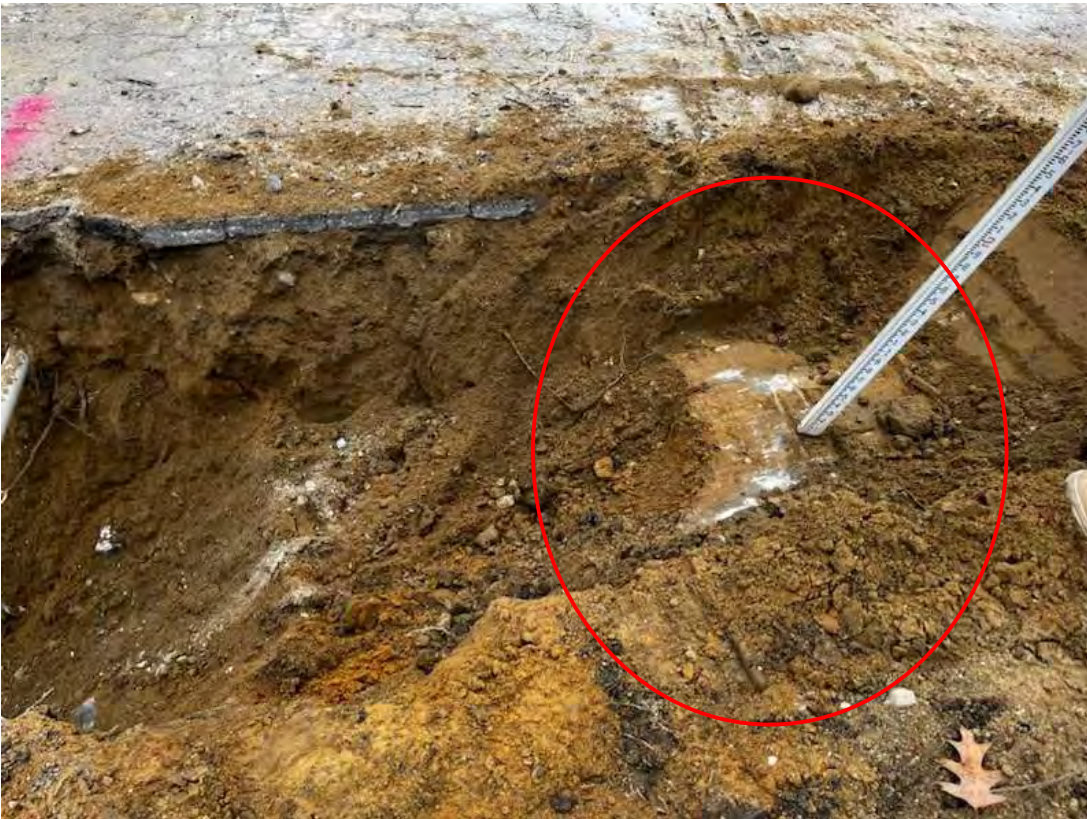
- **Ledge Rock**  
➤ **High spot of ledge rock around STA 17+00**

Photo 4 – High spot around STA 17+00

- **Communicate with homeowners as needed.**  
➤ **Monitor ledge rock, especially high spot around STA 17+00**

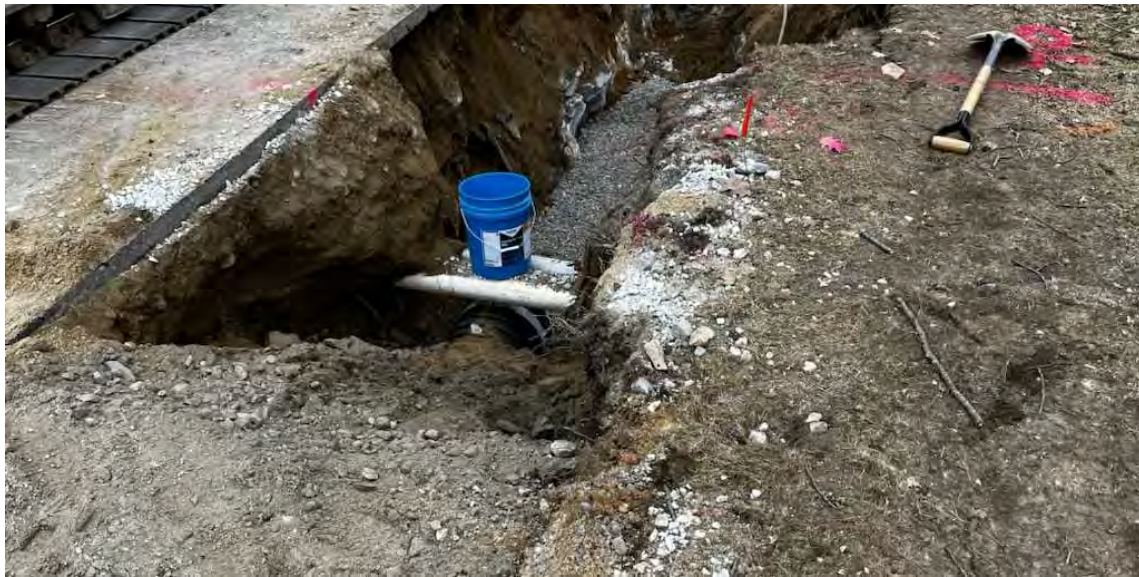
- Approximately 60 feet of 15" Perf. SD pipe was embedded with material consistent with MDOT 703.22 Type C – ¾" Crushed Stone from CB #27 towards proposed CB #26. (Photo 5) The 40 feet of 15" Perf. SD pipe was then backfilled approximately 1.75 feet from the spring line with material consistent with MDOT 703.22 Type C Crushed Stone.

Photo 5 – MDOT 703.22 Type C –  $\frac{3}{4}$ " Crushed Stone placed prior to 15" Perf. SD.

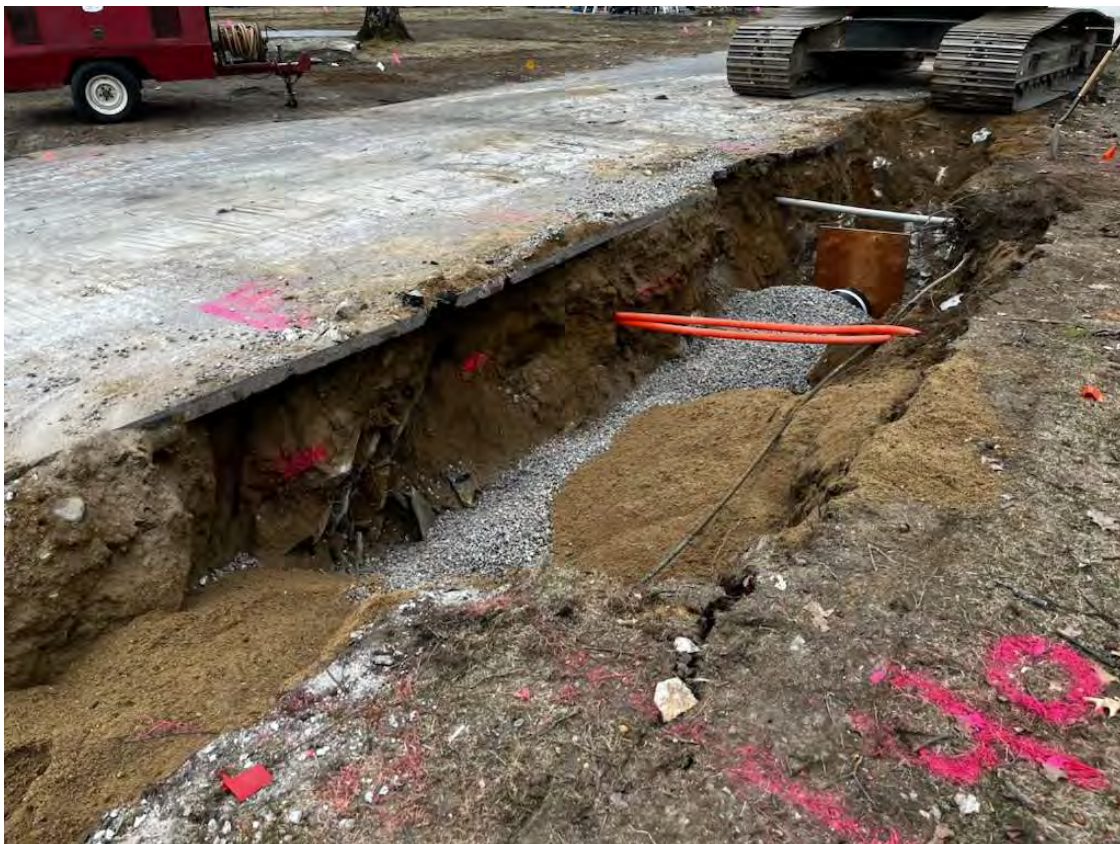
- Material consistent with MDOT 703.22 Type B Underdrain was used to backfill the installed pipe area of the trench to the subbase layer. (Photo 6) Approximately 18" of subbase consistent with MDOT 703.06 Type D was installed on the underdrain layer and compacted with a Remote Control RTSC3 Wacker Neuson compactor. A plate compactor was used in between underground utility areas as the space was limited.

Photo 6 – Backfill being installed with material consistent with MDOT 703.22 Type B Underdrain.

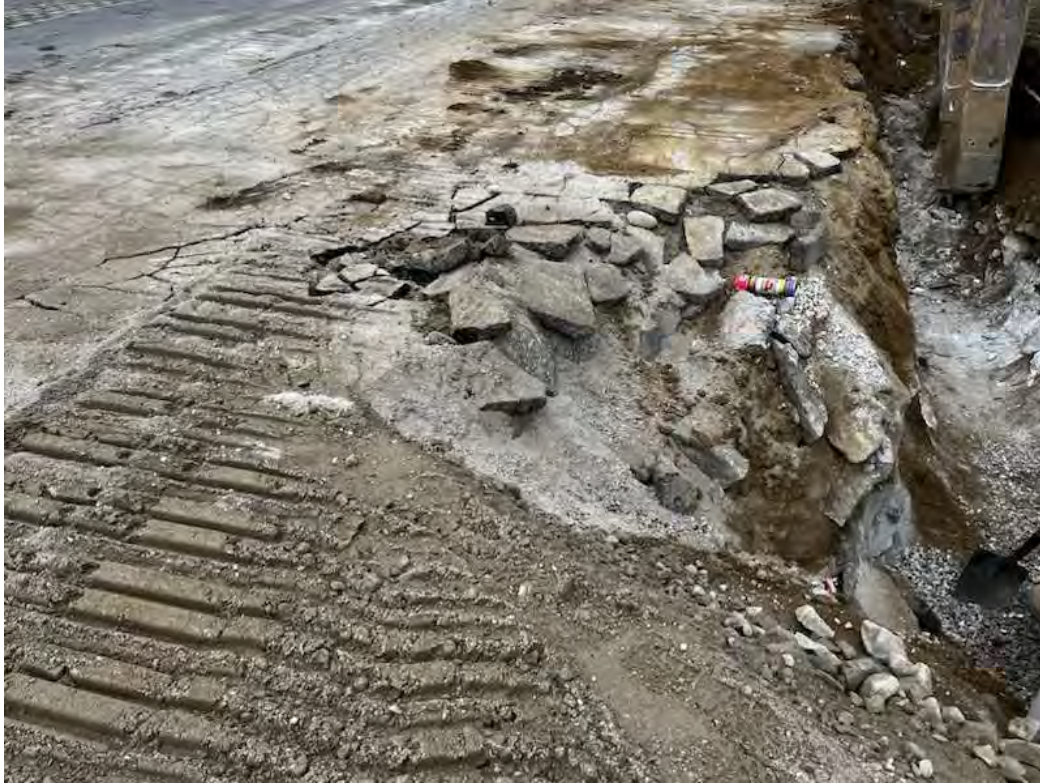
- As it was assumed and discussed during the preconstruction meeting on March 23, 2023, due to the condition of the road and the existing alligator cracking, the pavement has fallen apart outside of the trench limits approximately 0.5 – 1.0 feet respectively. (Photo 7) Additional 19mm HMA is anticipated to be needed for these areas.

Photo 6 – Alligator cracking causing additional existing pavement to break away.
