FIELD OBSERVATION REPORT

Project: Tuttle Road, Main Street, and Blanchard Road
Downtown Sidewalk Improvements
Client: Town of Cumberland
GP Field Rep: Kassey Northrop (KN)
Weather: Sunny
Time onsite: 9:00 AM – 10:00 AM/ 1:30 PM – 2:30 PM
Contractor: Glidden Excavating & Paving, Inc. (Glidden)
Distribution: File; Town of Cumberland

GP Project No: 3656.11
Visit Date: July 18, 2023
Report Date: July 18, 2023
Temp. Range: 75-77 °F

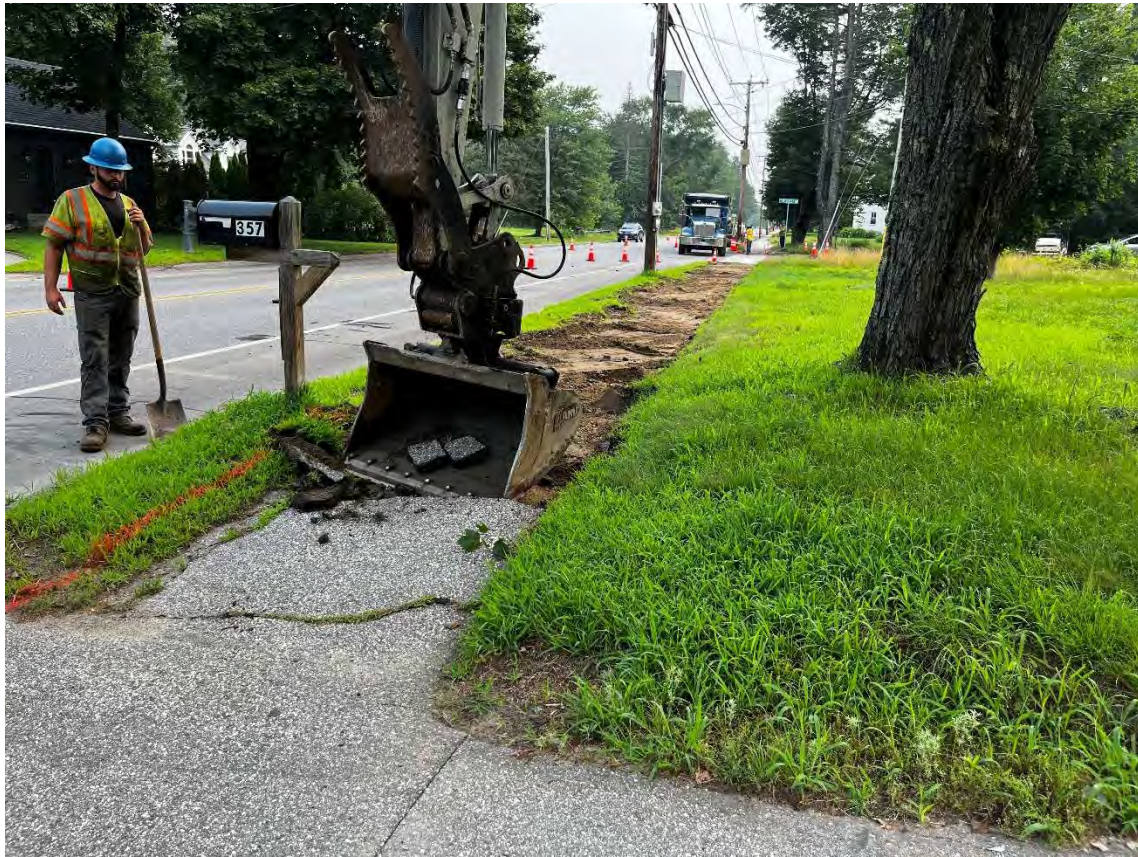
- On arrival in the morning, a crew member operating the Takeuchi TB290 compact excavator was actively removing the existing pavement up to the driveway apron at 357 Main Street (Photo 1).

Photo 1 – Existing pavement removed at 357 Main Street.

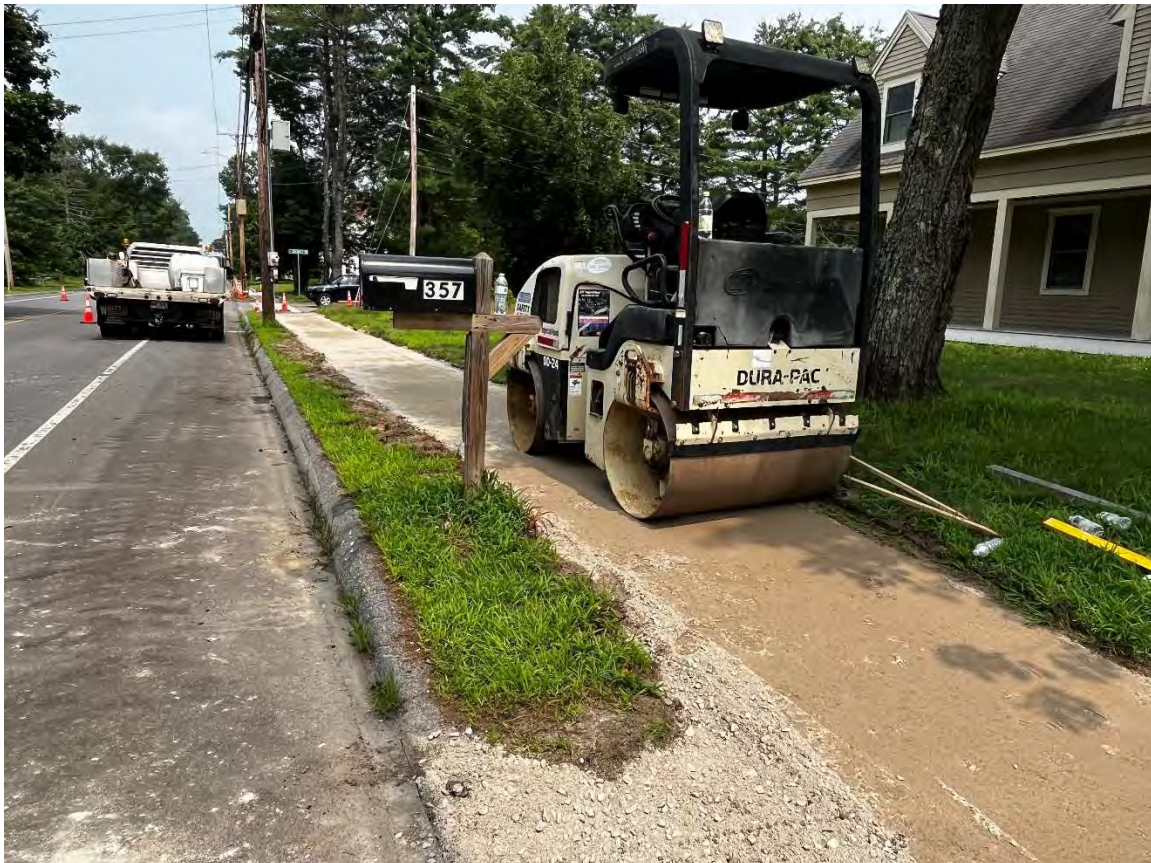
- Unsuitable material at the surface was observed to be scraped away between Hillcrest Drive and the driveway apron of 357 Main Street prior to shimming gravel consistent with MaineDOT 703.06 Type A. The base gravels were compacted with efforts of an Ingersoll-Rand DD-24 5-ton roller (Photo 2).

Photo 2 – Ingersoll-Rand DD-24 5-ton roller used to compact base gravels to 357 Main Street

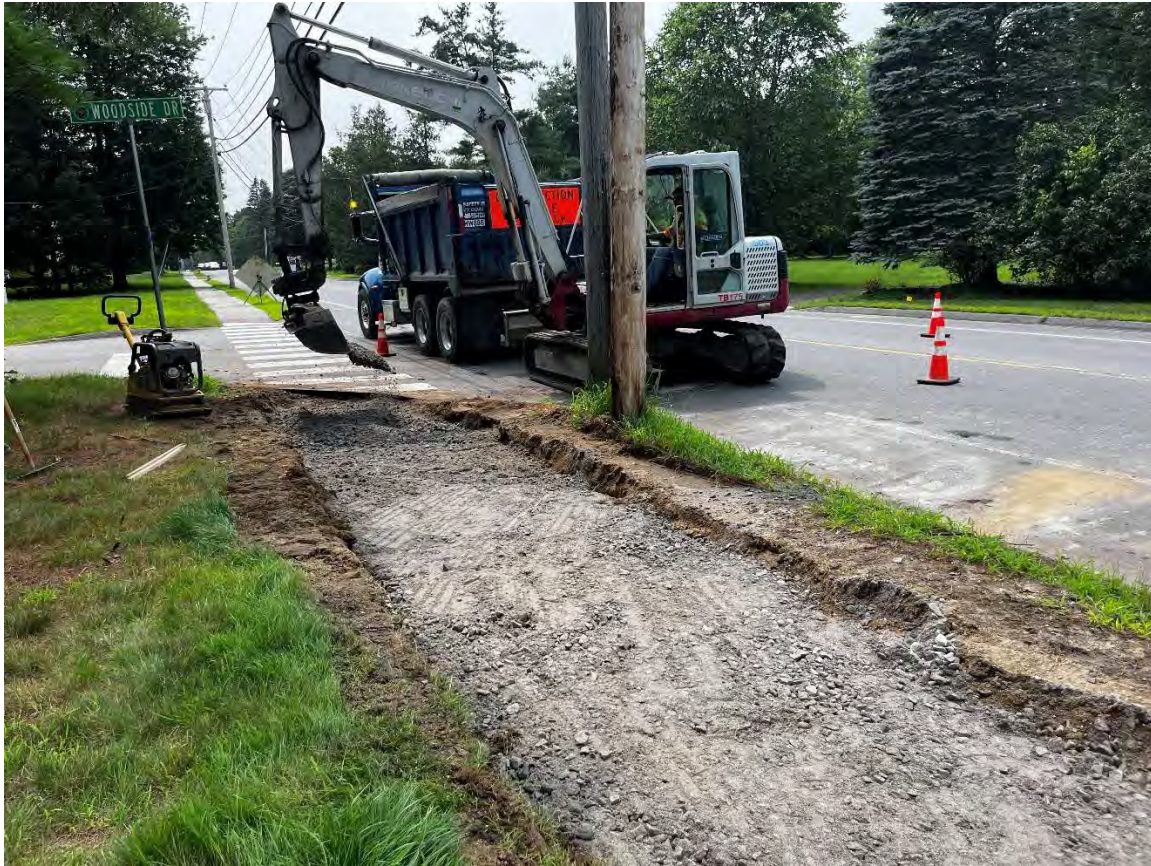
- While on site, the excavator operator was finishing installing material consistent with MaineDOT 703.06 Type D gravel for subbase at the joint of the sidewalk and Woodside Drive (Photo 3).

Photo 3 – Excavator operator placing subbase gravel at the apron of Woodside Drive.

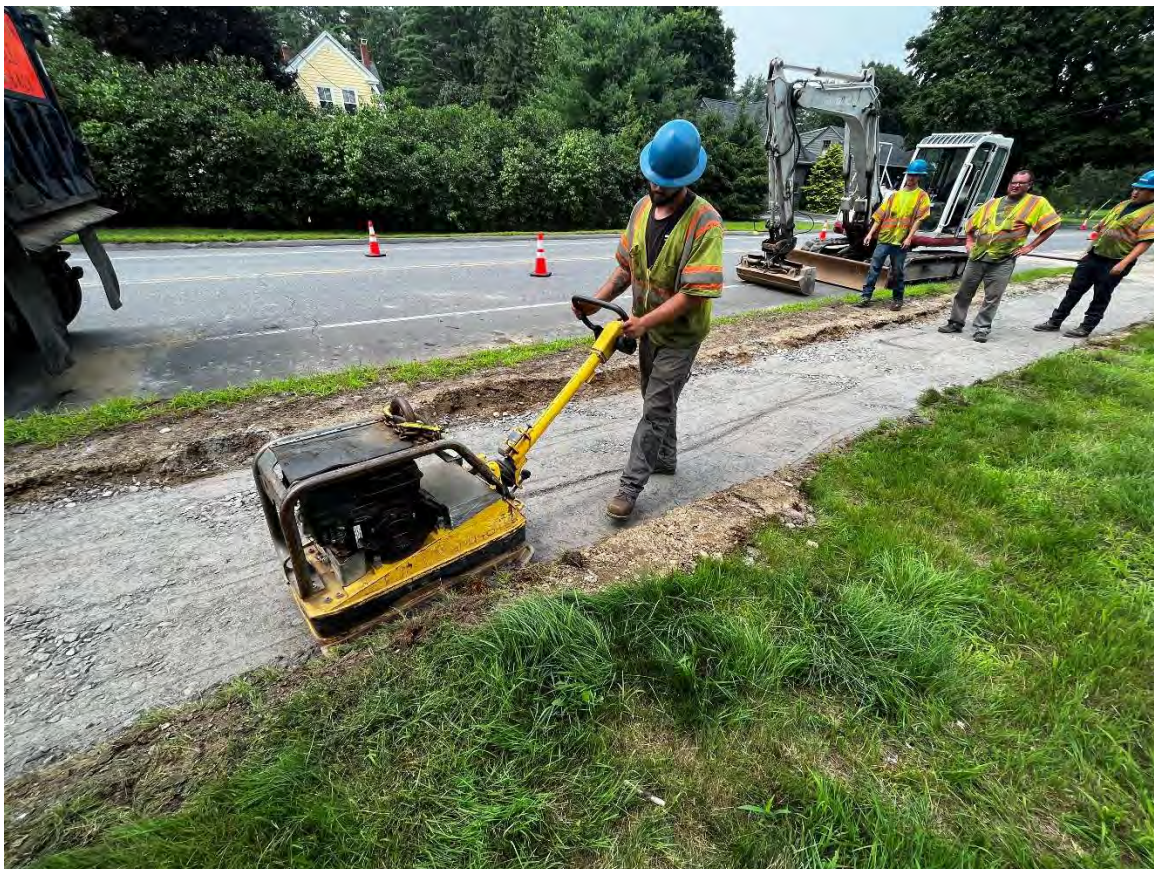
- The subbase material installed between 357 Main Street and Woodside Drive was compacted with efforts of a Wacker Neuson Plate Compactor, prior to placing base gravels (Photo 4).

Photo 4 – Crew member compacting subbase gravels with Wacker Neuson Plate Compactor.

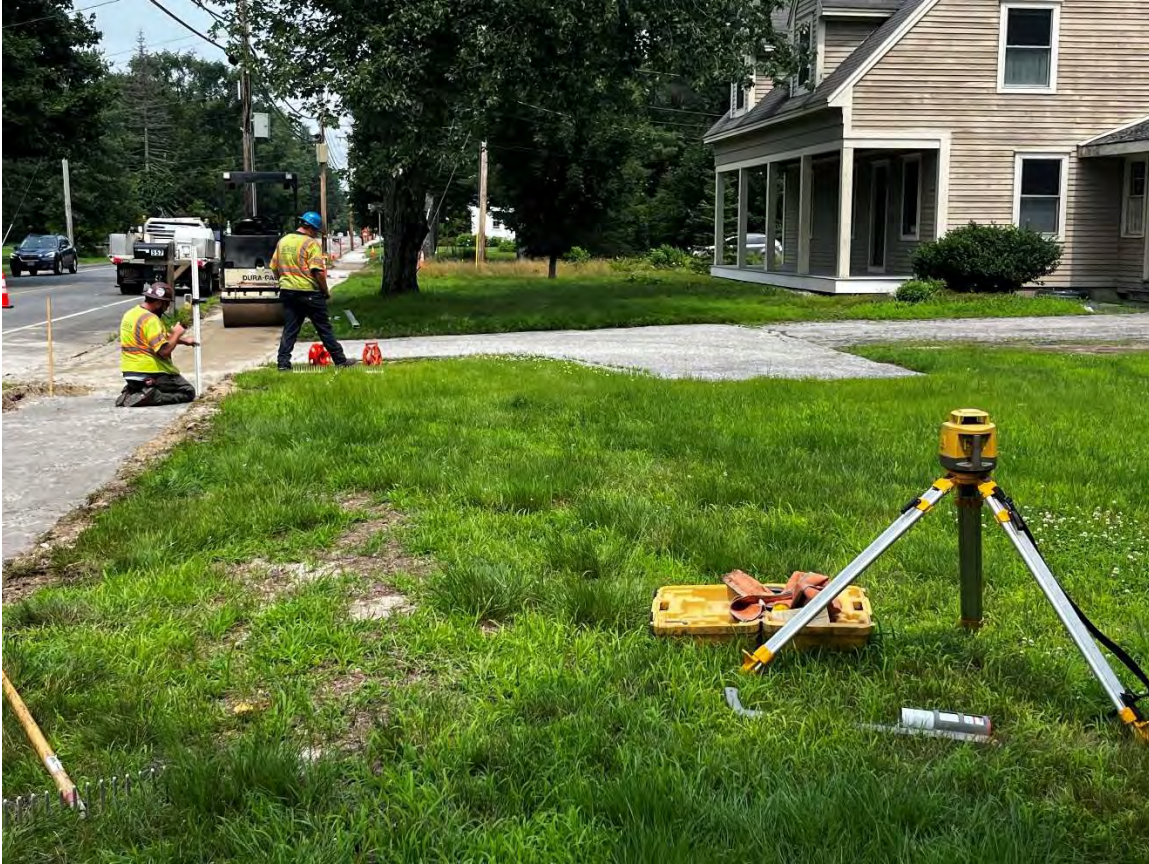
- Adam, foreman, was observed to be using a laser level while marking the appropriate grade on stakes for shimming material consistent with MaineDOT 703.06 Type A gravel by use of the string line method (Photo 5).

Photo 5 – Adam, foreman, using laser level to mark top of base gravel elevation for string-line method.

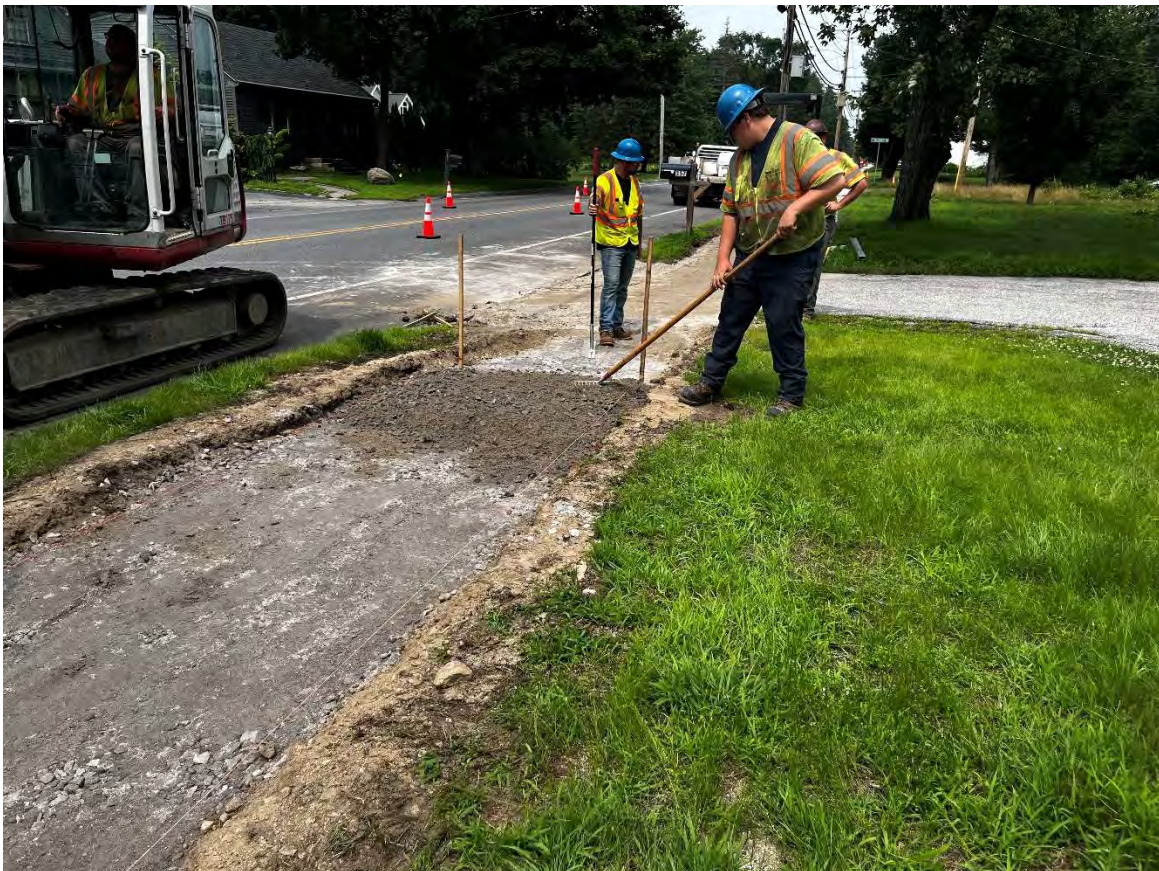
- An excavator operator placed material consistent with Type A gravel with the bucket of the excavator while other crew members used a rake to fine grade the gravels (Photo 6). A smart level was observed to be used to ensure grade at various locations upon fine grading the base gravels.

Photo 6 – Crew member raking base gravel placed by excavator.
