**GORRILL
PALMER**

DAILY FIELD OBSERVATION REPORT

Project: Route I Roadway Improvements

GPCEI Project No: 1636.83

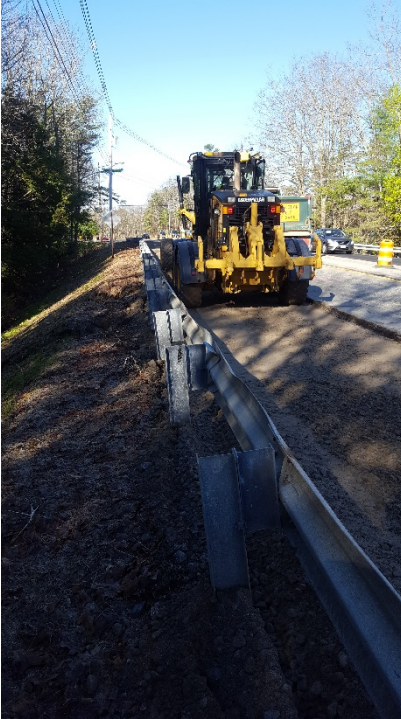
Fine grading in the right lane on the northern end of the project, looking south.

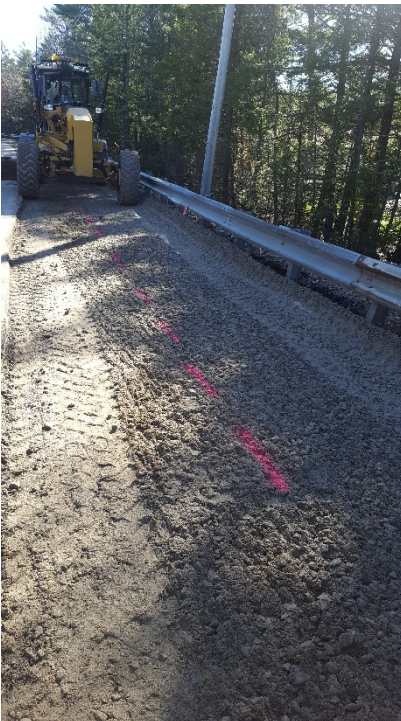
- 7:45 am – Crew voiced frustration to AJA regarding the requirement to break the shoulder slope on the high side of the superelevated curve. Crew noted the task was difficult with the equipment and was mostly hand work. No foreman was on site.

Break point marked out in the superelevated area.
